Profile/Photo Observation Report

Date:	06/13/2023	Weather:		Coding:	PACP 7.0
Pipe Length (ft):	282.0	Owner:	City of Hobart	Pre Clean:	Heavy Cleaning
P.O.#:	YES502259	Surveyor:	S. Bucklin	PSR:	P-902-039-032
Customer:	City of Hobart	Clean Date:	05/11/2023	Shape:	C

Street:	North Shelby Street	Flow Control:	Not Controlled
City:	Hobart, IN	Year Renewed:	
Location:	Easement/Right of Way	Tape/Media #:	
Purpose:	Routine Assessment	Dia/Height:	18"
Use:	Sanitary Sewage Pipe	Material:	RCP
Drain Area:		Lining:	None
Category:	NA		
Comment:			
Location Details:		Direction of Survey:	Downstream
US MH:	M-902-039	DS MH:	M-902-032
		Total Length Surveyed (ft):	281.5

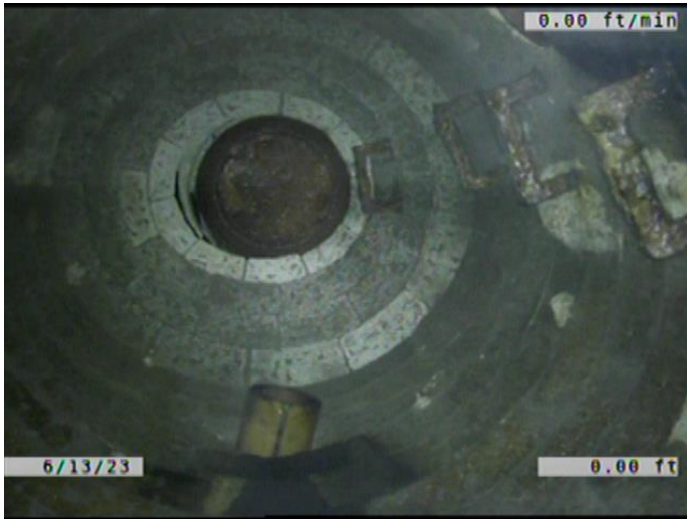
Code: **AMH**
 Description: **Manhole**

Distance (ft): **.0**
 Structural Grade: **0**
 O&M Grade: **0**
 Clock Start/From:
 Clock To:
 1st Value:
 2nd Value:
 Value Percent:
 Continuous Index:
 Within 8" of Joint: **NO**
 Remarks: **M-902-039**

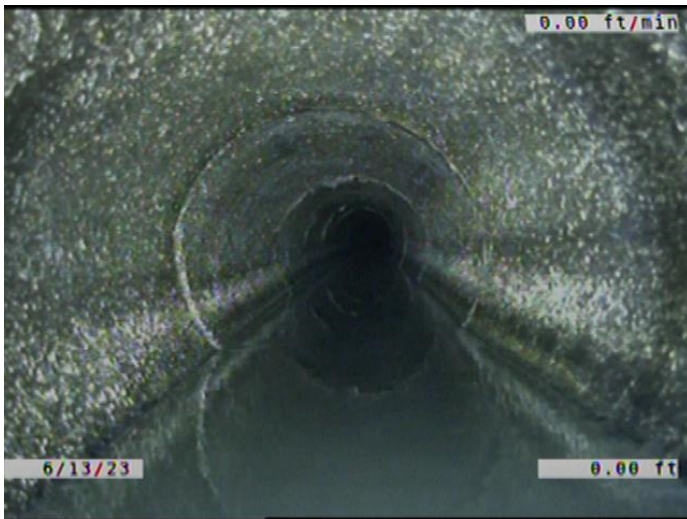
Code: **MWL**
 Description: **Miscellaneous Water Level**

Distance (ft): **.0**
 Structural Grade: **0**
 O&M Grade: **0**
 Clock Start/From:
 Clock To:
 1st Value:
 2nd Value:
 Value Percent: **20.000**
 Continuous Index:
 Within 8" of Joint: **NO**
 Remarks:

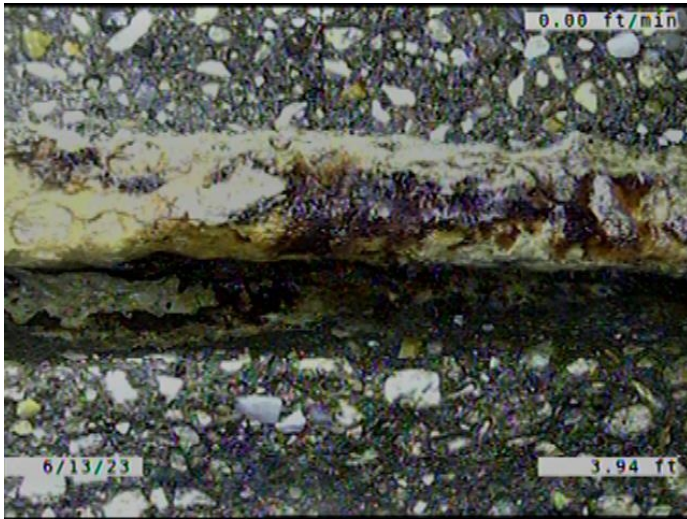
Code: **DAE**
Description: **Deposits Attached Encrustation**

Distance (ft): **3.9**
Structural Grade: **0**
O&M Grade: **2**
Clock Start/From: **8**
Clock To: **4**
1st Value:
2nd Value:
Value Percent: **5.000**
Continuous Index: **S01**
Within 8" of Joint: **YES**
Remarks:

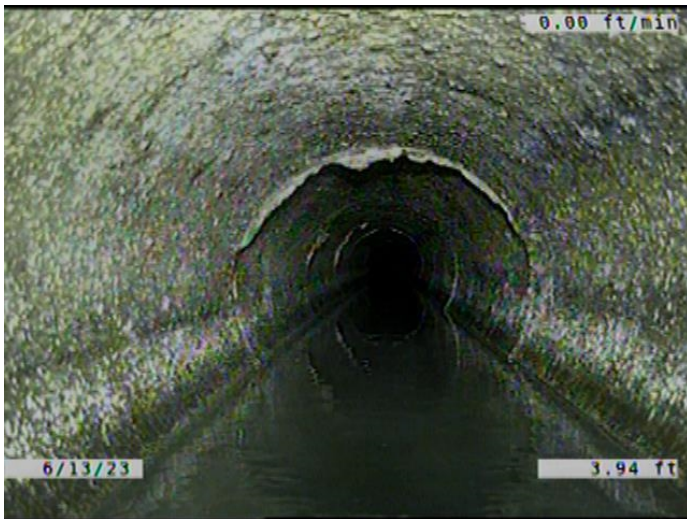
Code: **SAP**
Description: **Surface Damage Aggregate Projecting**

Distance (ft): **3.9**
Structural Grade: **3**
O&M Grade: **0**
Clock Start/From: **7**
Clock To: **5**
1st Value:
2nd Value:
Value Percent:
Continuous Index: **S02**
Within 8" of Joint: **YES**
Remarks:

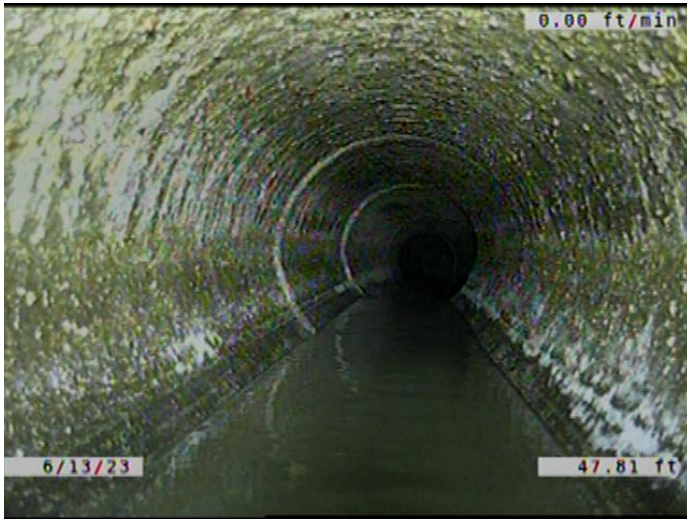
Code: **LR**
Description: **Line Right**

Distance (ft): **47.8**
Structural Grade: **0**
O&M Grade: **1**
Clock Start/From:
Clock To:
1st Value:
2nd Value:
Value Percent: **5.000**
Continuous Index:
Within 8" of Joint: **NO**
Remarks:

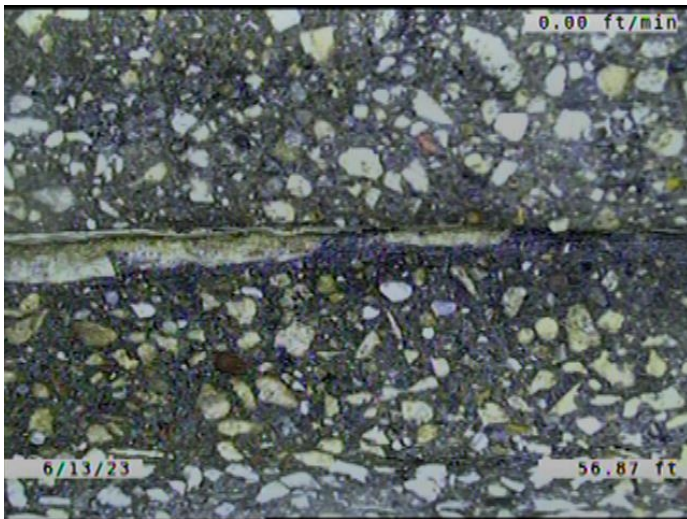
Code: **JAM**
Description: **Joint Angular Medium**

Distance (ft): **56.9**
Structural Grade: **3**
O&M Grade: **0**
Clock Start/From:
Clock To:
1st Value:
2nd Value:
Value Percent:
Continuous Index:
Within 8" of Joint: **NO**
Remarks:

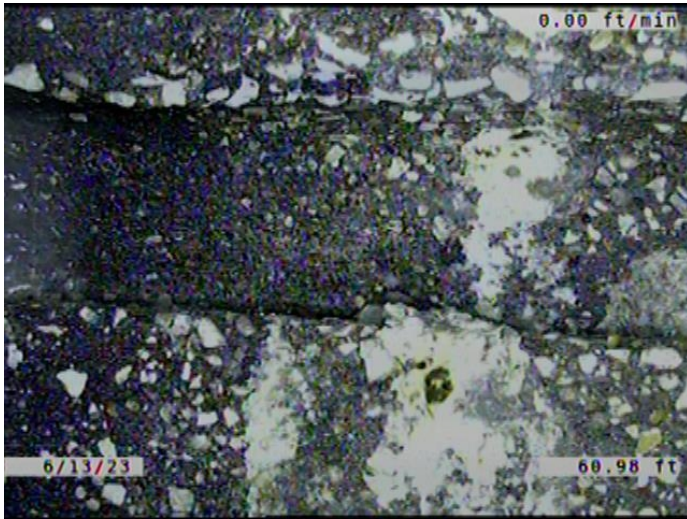
Code: **JAM**
Description: **Joint Angular Medium**

Distance (ft): **61.0**
Structural Grade: **3**
O&M Grade: **0**
Clock Start/From:
Clock To:
1st Value:
2nd Value:
Value Percent:
Continuous Index:
Within 8" of Joint: **NO**
Remarks:

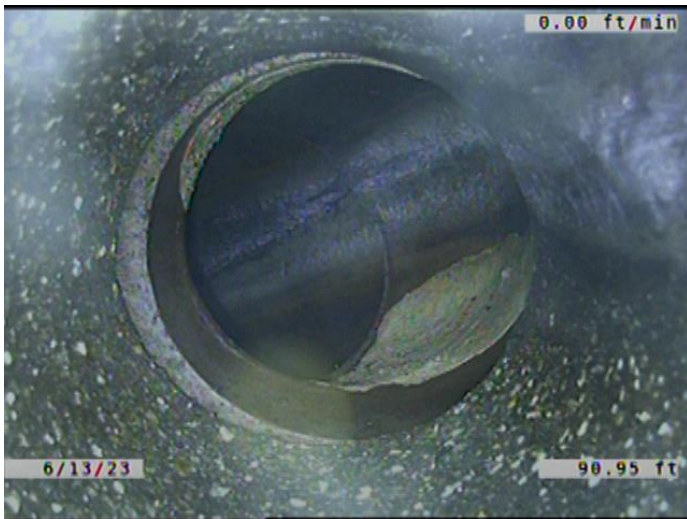
Code: **TF**
Description: **Tap Factory**

Distance (ft): **91.0**
Structural Grade: **0**
O&M Grade: **0**
Clock Start/From: **2**
Clock To:
1st Value: **6.000**
2nd Value:
Value Percent:
Continuous Index:
Within 8" of Joint: **YES**
Remarks: **ENCrustATION COMING FROM THE JOINTS OF THE SERVICE.**

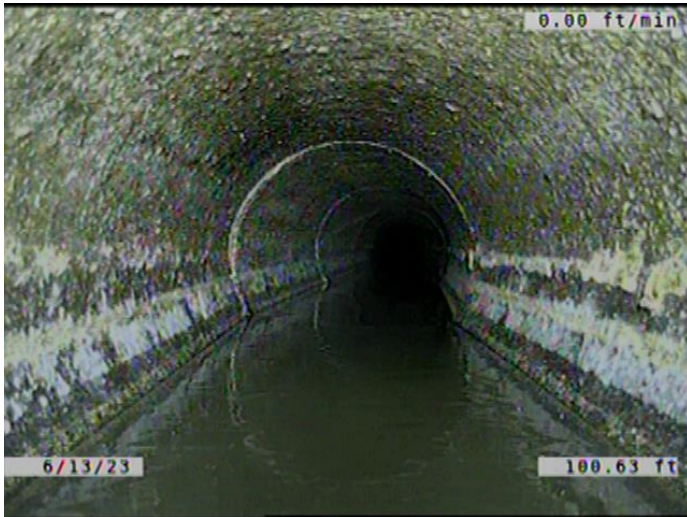
Code: **DAGS**
Description: **Deposits Attached Grease**

Distance (ft): **100.6**
Structural Grade: **0**
O&M Grade: **2**
Clock Start/From: **8**
Clock To: **4**
1st Value:
2nd Value:
Value Percent: **5.000**
Continuous Index: **S03**
Within 8" of Joint: **YES**
Remarks:

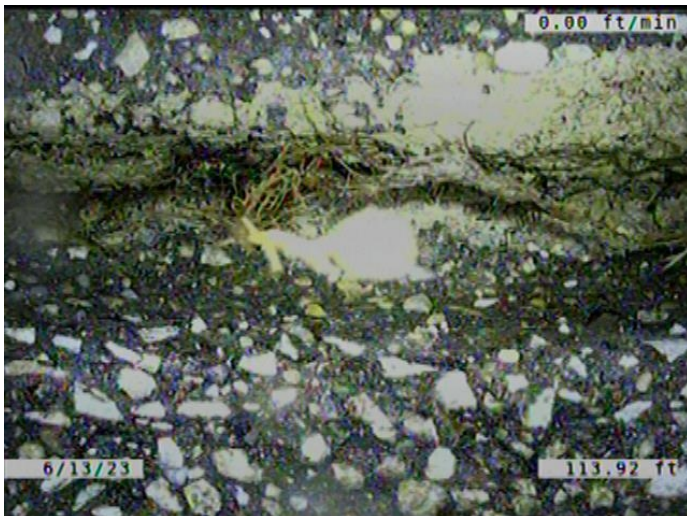
Code: **RFJ**
Description: **Roots Fine Joint**

Distance (ft): **113.9**
Structural Grade: **0**
O&M Grade: **1**
Clock Start/From: **8**
Clock To: **4**
1st Value:
2nd Value:
Value Percent:
Continuous Index:
Within 8" of Joint: **YES**
Remarks:

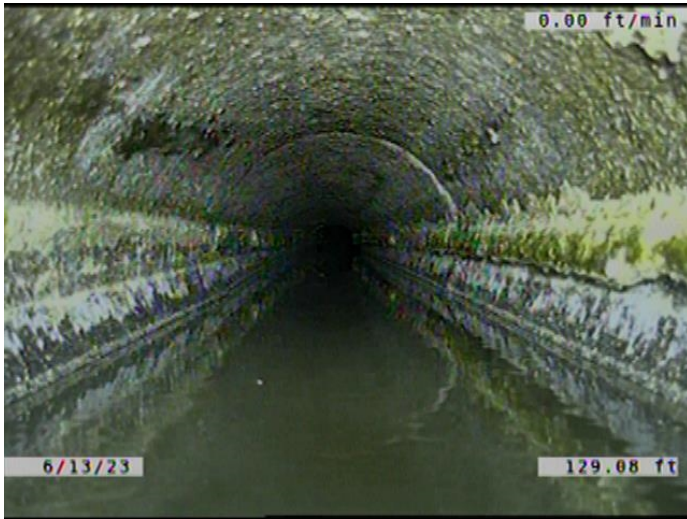
Code: **MWL**
Description: **Miscellaneous Water Level**

Distance (ft): **129.1**
Structural Grade: **0**
O&M Grade: **0**
Clock Start/From:
Clock To:
1st Value:
2nd Value:
Value Percent: **35.000**
Continuous Index:
Within 8" of Joint: **NO**
Remarks:

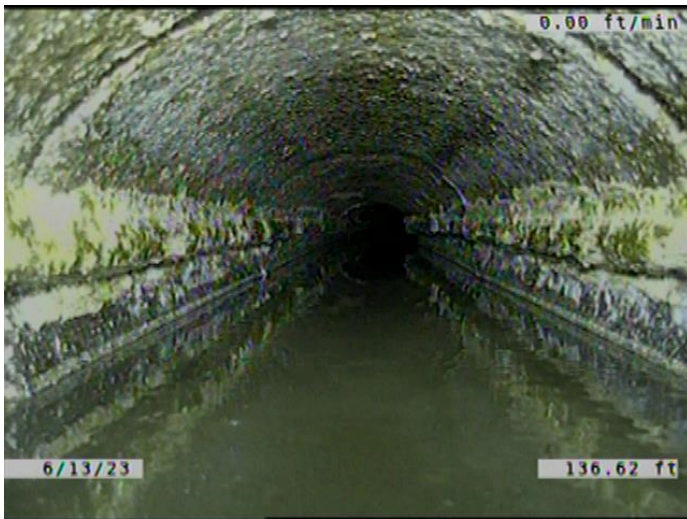
Code: **MWL**
Description: **Miscellaneous Water Level**

Distance (ft): **136.6**
Structural Grade: **0**
O&M Grade: **0**
Clock Start/From:
Clock To:
1st Value:
2nd Value:
Value Percent: **45.000**
Continuous Index:
Within 8" of Joint: **NO**
Remarks:

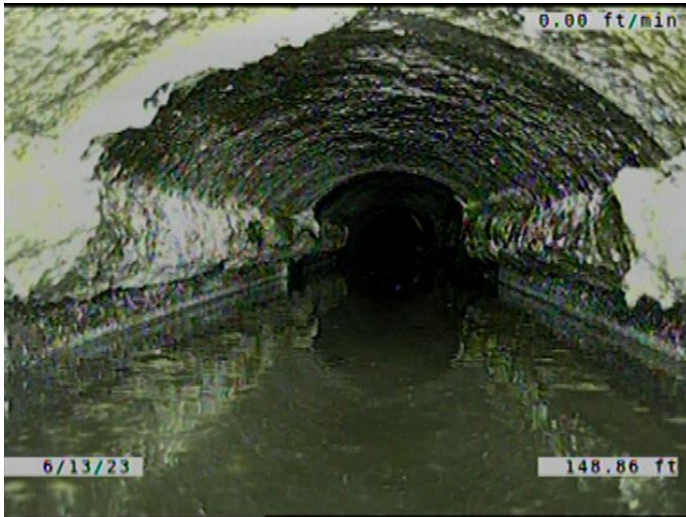
Code: **MWL**
 Description: **Miscellaneous Water Level**

Distance (ft): **148.9**
 Structural Grade: **0**
 O&M Grade: **0**
 Clock Start/From:
 Clock To:
 1st Value:
 2nd Value:
 Value Percent: **60.000**
 Continuous Index:
 Within 8" of Joint: **NO**
 Remarks:

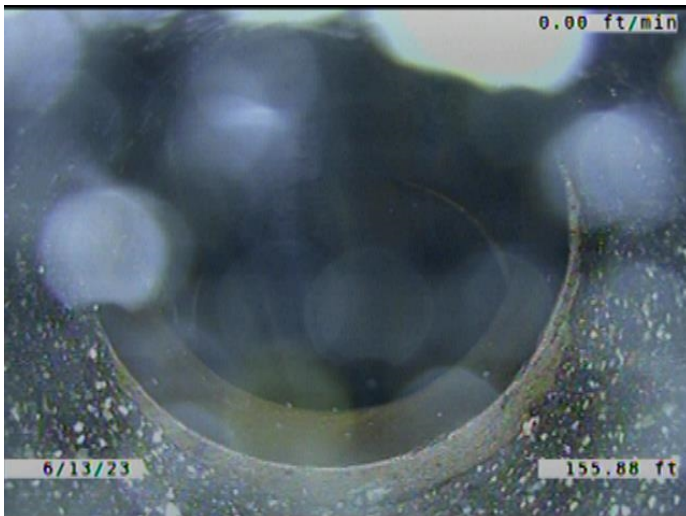
Code: **TF**
 Description: **Tap Factory**

Distance (ft): **155.9**
 Structural Grade: **0**
 O&M Grade: **0**
 Clock Start/From: **12**
 Clock To:
 1st Value: **6.000**
 2nd Value:
 Value Percent:
 Continuous Index:
 Within 8" of Joint: **YES**
 Remarks: **CONSTANTLY DRIPPING WATER.**

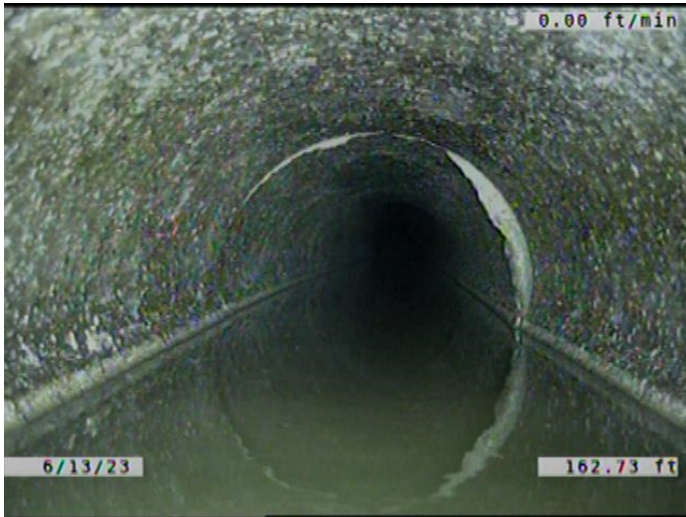
Code:	MWL
Description:	Miscellaneous Water Level
Distance (ft):	162.7
Structural Grade:	0
O&M Grade:	0
Clock Start/From:	
Clock To:	
1st Value:	
2nd Value:	
Value Percent:	35.000
Continuous Index:	
Within 8" of Joint:	NO
Remarks:

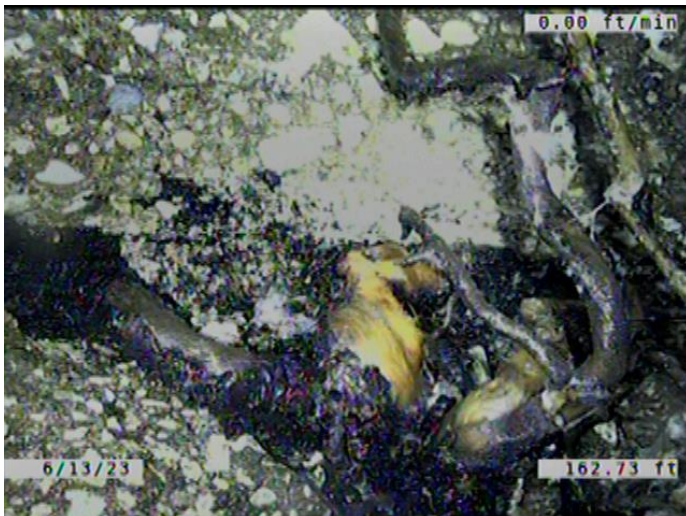
Code:	RFJ
Description:	Roots Fine Joint
Distance (ft):	162.7
Structural Grade:	0
O&M Grade:	1
Clock Start/From:	8
Clock To:	4
1st Value:	
2nd Value:	
Value Percent:	
Continuous Index:	
Within 8" of Joint:	YES
Remarks:

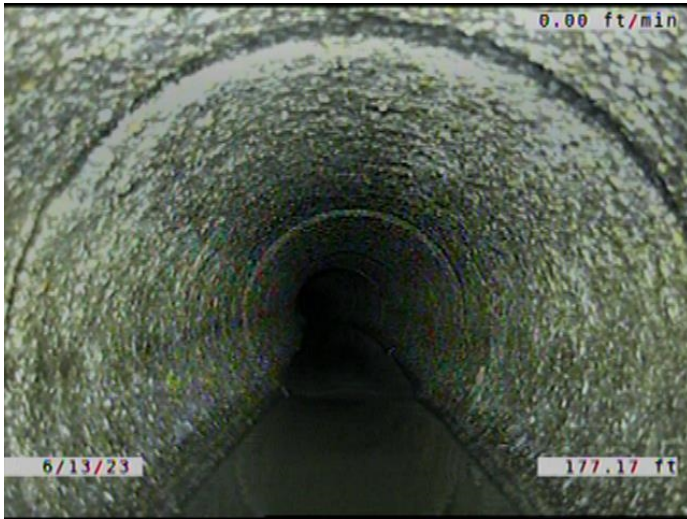
Code:	MWL
Description:	Miscellaneous Water Level
Distance (ft):	177.2
Structural Grade:	0
O&M Grade:	0
Clock Start/From:	
Clock To:	
1st Value:	
2nd Value:	
Value Percent:	15.000
Continuous Index:	
Within 8" of Joint:	NO
Remarks:

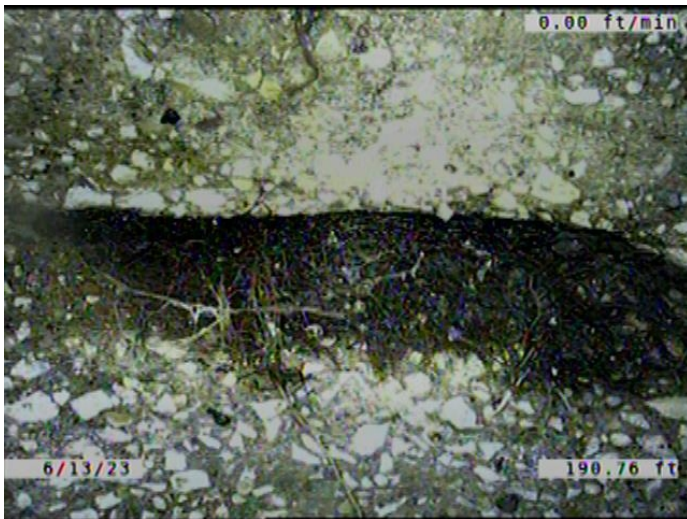
Code:	RFJ
Description:	Roots Fine Joint
Distance (ft):	190.8
Structural Grade:	0
O&M Grade:	1
Clock Start/From:	2
Clock To:	4
1st Value:	
2nd Value:	
Value Percent:	
Continuous Index:	
Within 8" of Joint:	YES
Remarks:

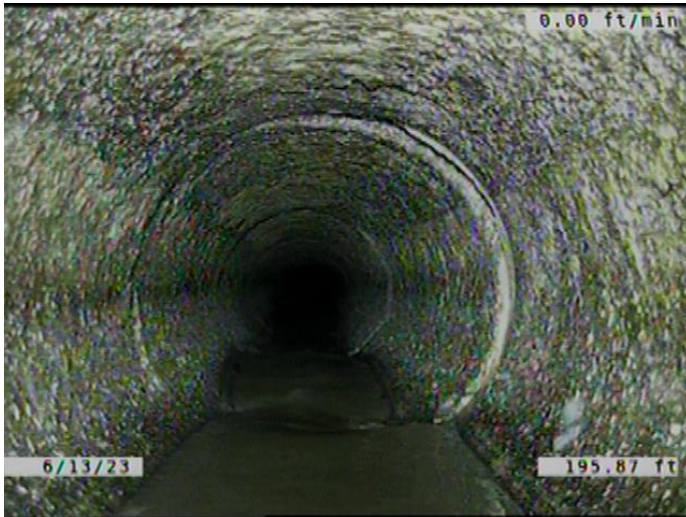
Code:	DAGS
Description:	Deposits Attached Grease
Distance (ft):	195.9
Structural Grade:	0
O&M Grade:	2
Clock Start/From:	8
Clock To:	4
1st Value:	
2nd Value:	
Value Percent:	5.000
Continuous Index:	F03
Within 8" of Joint:	YES
Remarks:

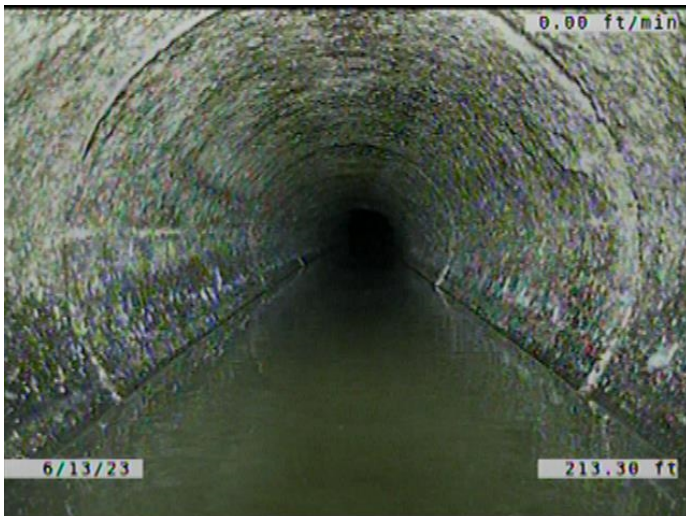
Code:	MWL
Description:	Miscellaneous Water Level
Distance (ft):	213.3
Structural Grade:	0
O&M Grade:	0
Clock Start/From:	
Clock To:	
1st Value:	
2nd Value:	
Value Percent:	35.000
Continuous Index:	
Within 8" of Joint:	NO
Remarks:

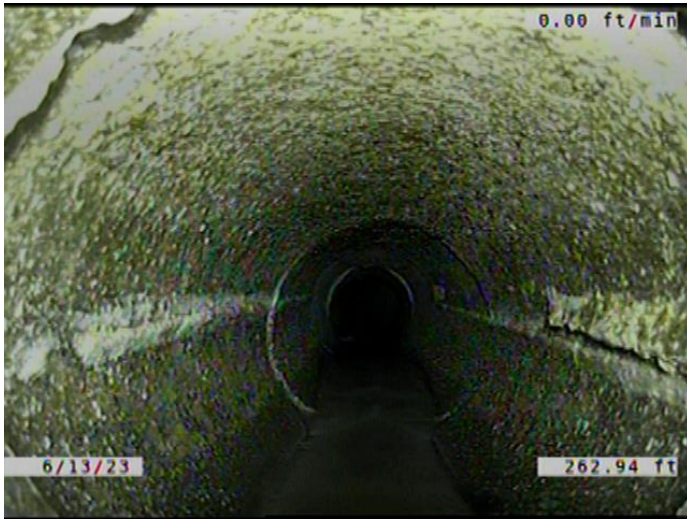
Code: **MWL**
Description: **Miscellaneous Water Level**

Distance (ft): **262.9**
Structural Grade: **0**
O&M Grade: **0**
Clock Start/From:
Clock To:
1st Value:
2nd Value:
Value Percent: **15.000**
Continuous Index:
Within 8" of Joint: **NO**
Remarks:

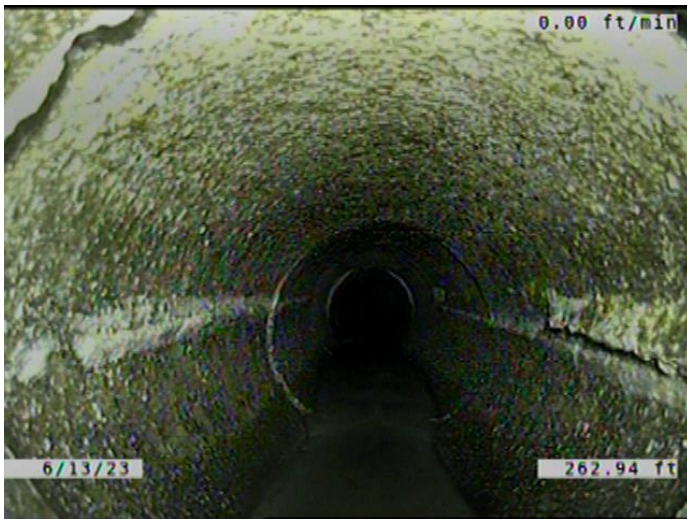
Code: **DAGS**
Description: **Deposits Attached Grease**

Distance (ft): **262.9**
Structural Grade: **0**
O&M Grade: **2**
Clock Start/From: **9**
Clock To: **3**
1st Value:
2nd Value:
Value Percent: **5.000**
Continuous Index: **S04**
Within 8" of Joint: **YES**
Remarks:

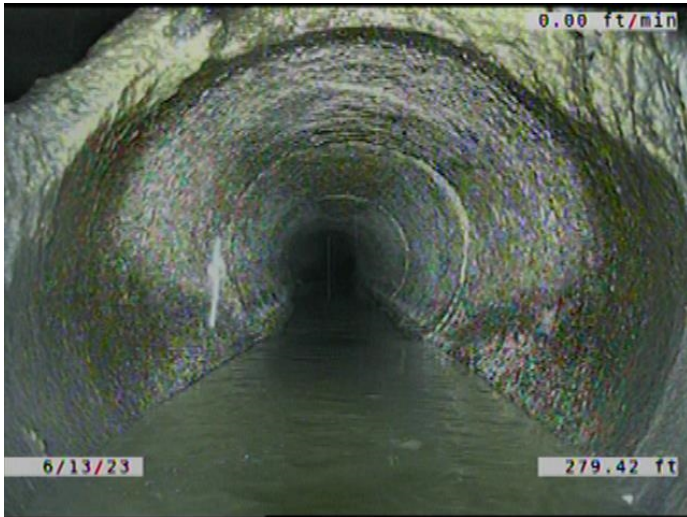
Code: **DAE**
Description: **Deposits Attached Encrustation**

Distance (ft): **279.4**
Structural Grade: **0**
O&M Grade: **2**
Clock Start/From: **8**
Clock To: **4**
1st Value:
2nd Value:
Value Percent: **5.000**
Continuous Index: **F01**
Within 8" of Joint: **YES**
Remarks:

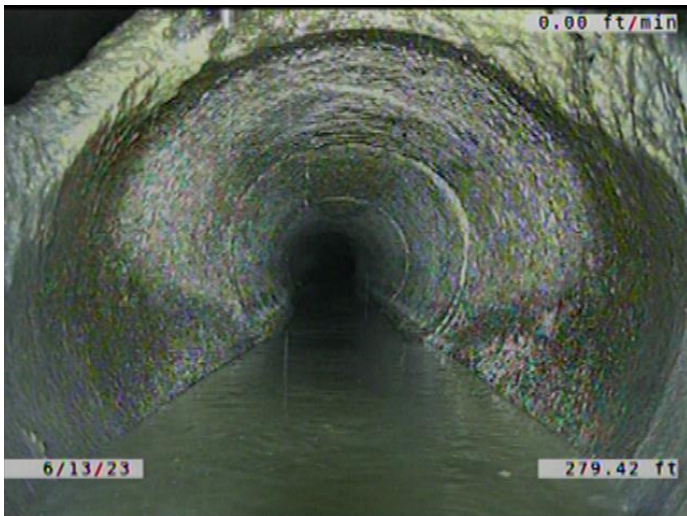
Code: **SAP**
Description: **Surface Damage Aggregate Projecting**

Distance (ft): **279.4**
Structural Grade: **3**
O&M Grade: **0**
Clock Start/From: **7**
Clock To: **5**
1st Value:
2nd Value:
Value Percent:
Continuous Index: **F02**
Within 8" of Joint: **YES**
Remarks:

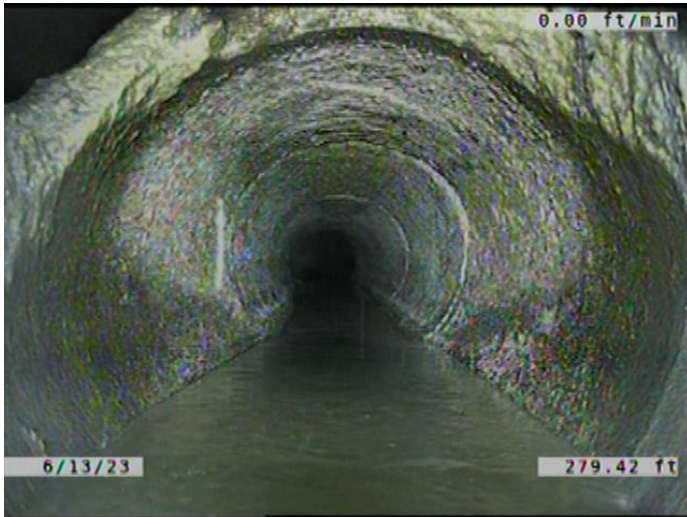
Code: **DAGS**
 Description: **Deposits Attached Grease**

Distance (ft): **279.4**
 Structural Grade: **0**
 O&M Grade: **2**
 Clock Start/From: **9**
 Clock To: **3**
 1st Value:
 2nd Value:
 Value Percent: **5.000**
 Continuous Index: **F04**
 Within 8" of Joint: **YES**
 Remarks:

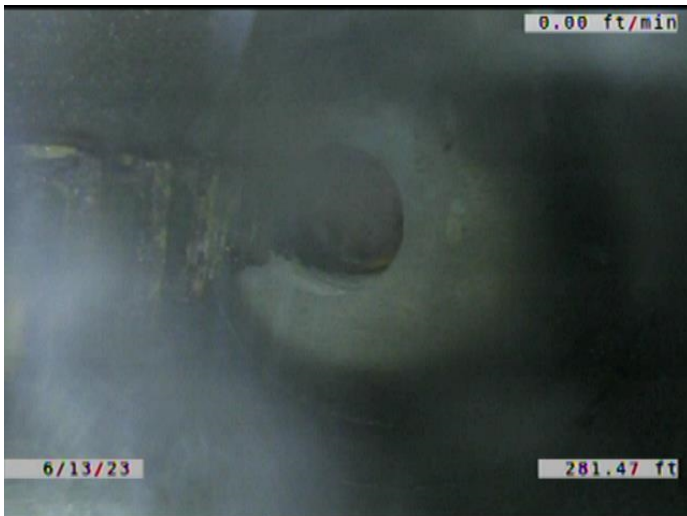
Code: **AMH**
 Description: **Manhole**

Distance (ft): **281.5**
 Structural Grade: **0**
 O&M Grade: **0**
 Clock Start/From:
 Clock To:
 1st Value:
 2nd Value:
 Value Percent:
 Continuous Index:
 Within 8" of Joint: **NO**
 Remarks: **M-902-032**
