Profile/Photo Observation Report

| Street: | ALLEY BETWEEN E 34TH AVE & E 34T | Flow Control: | Not Controlled |

| US MH: | M-902-040 | DS MH: | M-902-039 |

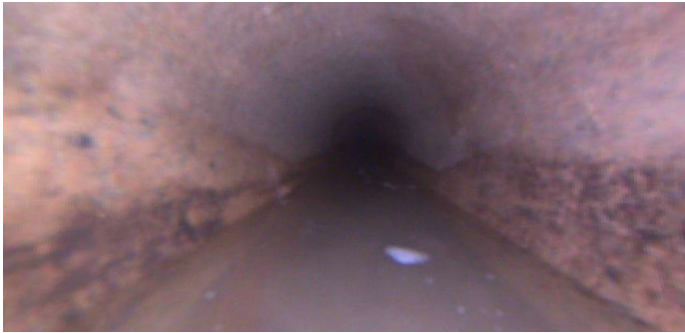
| Code: | MWL |
| Description: | Water Level |

| Value Percent: | 5.000 |

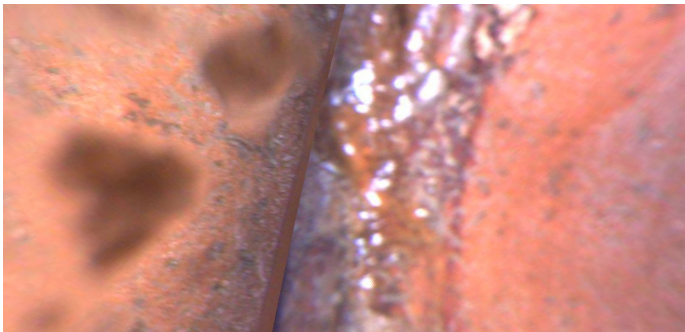
| Position | Code | Observation | Video (sec) | Grade |
|---|---|---|---|---|
| 6.8 | CL | Crack Longitudinal | 47 | S 2 |

| Code: | CL |
| Description: | Crack Longitudinal |

| Distance (ft): | 6.8 |
| Structural Grade: | 2 |
| Clock Start/From: | 10 |
| Within 8" of Joint: | YES |
