Profile/Photo Observation Report

Street:	e 34th st	Flow Control:	Not Controlled
City:	Hobart, IN	Year Renewed:	
Location:	Other	Tape/Media #:	
Purpose:	Not Known	Dia/Height:	10"
Use:	Sanitary	Material:	VCP
Drain Area:	NA	Lining:	
Category:	NA		
Comment:

Location Details:		Direction of Survey:	Upstream
US MH:	M-902-040	DS MH:	M-902-039
		Total Length Surveyed (ft):	9.7

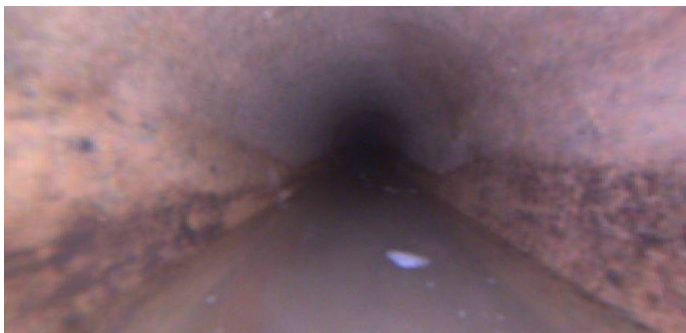
Code: **AMH**
Description: **Manhole**

Distance (ft): **.0**
Structural Grade: **0**
O&M Grade: **0**
Clock Start/From:
Clock To:
1st Value:
2nd Value:
Value Percent:
Continuous Index:
Within 8" of Joint: **NO**
Remarks: **M-902-039**

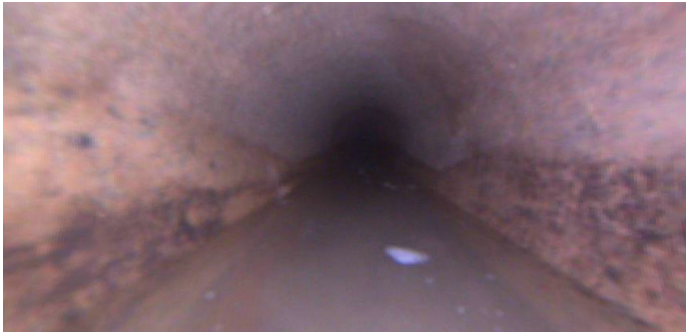
Code:	MWL
Description:	Water Level

Distance (ft):	.0
Structural Grade:	0
O&M Grade:	0
Clock Start/From:	
Clock To:	
1st Value:	
2nd Value:	
Value Percent:	5.000
Continuous Index:	
Within 8" of Joint:	NO
Remarks:

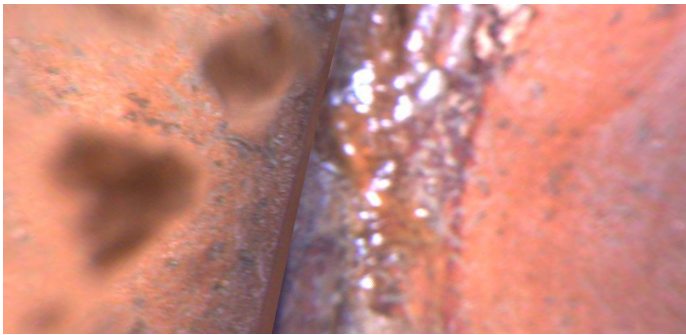
Code:	CL
Description:	Crack Longitudinal

Distance (ft):	6.8
Structural Grade:	2
O&M Grade:	0
Clock Start/From:	10
Clock To:	
1st Value:	
2nd Value:	
Value Percent:	
Continuous Index:	
Within 8" of Joint:	YES
Remarks:
