Profile/Photo Observation Report

Street:	ALLEY BETWEEN E 34TH AVE & E 34T	Flow Control:	Not Controlled
City:	Hobart, IN	Year Renewed:	
Location:	Other	Tape/Media #:	
Purpose:	Not Known	Dia/Height:	10"
Use:	Sanitary	Material:	VCP
Drain Area:	NA	Lining:	
Category:	NA		
Comment:

Location Details:		Direction of Survey:	Upstream
US MH:	M-902-041	DS MH:	M-902-040
		Total Length Surveyed (ft):	73.3

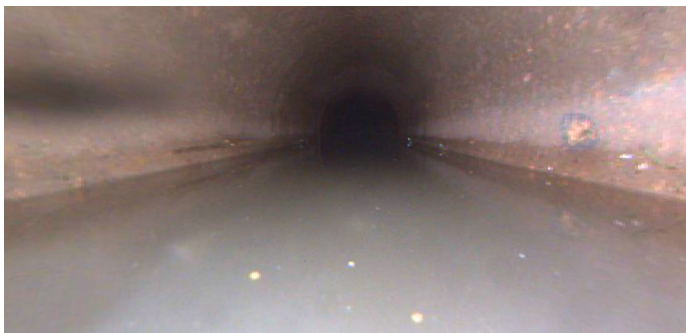
Code: **AMH**
Description: **Manhole**

Distance (ft): **.0**
Structural Grade: **0**
O&M Grade: **0**
Clock Start/From:
Clock To:
1st Value:
2nd Value:
Value Percent:
Continuous Index:
Within 8" of Joint: **NO**
Remarks: **M-902-040**

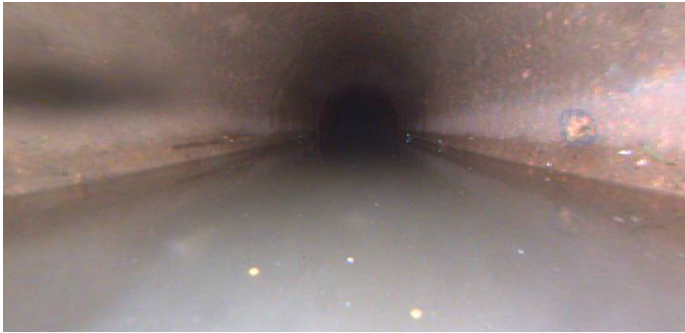
Code:	MWL
Description:	Water Level

Distance (ft):	.0
Structural Grade:	0
O&M Grade:	0
Clock Start/From:	
Clock To:	
1st Value:	
2nd Value:	
Value Percent:	25.000
Continuous Index:	
Within 8" of Joint:	NO
Remarks:

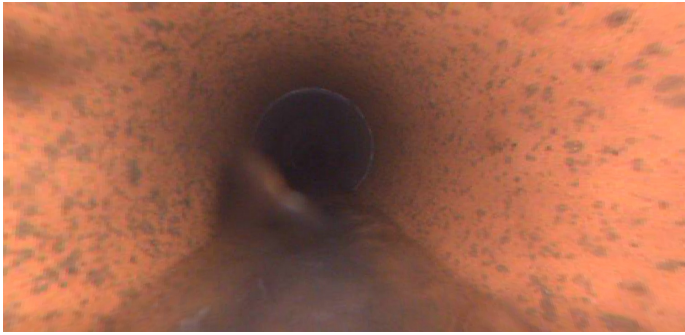
Code: **MCU**
Description: **Camera Underwater**

Distance (ft): **47.9**
Structural Grade: **0**
O&M Grade: **4**
Clock Start/From:
Clock To:
1st Value:
2nd Value:
Value Percent:
Continuous Index: **F01**
Within 8" of Joint: **NO**
Remarks:

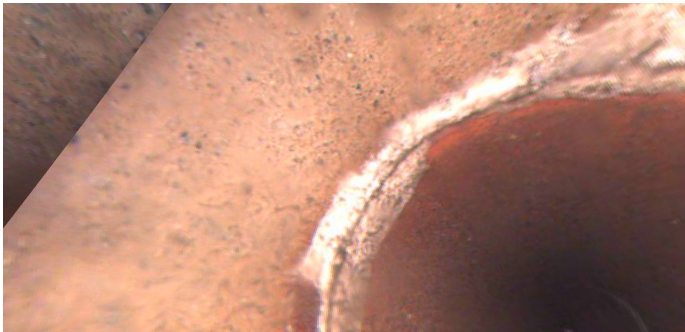
Code: **DAZ**
Description: **Deposits Attached Other**

Distance (ft): **62.4**
Structural Grade: **0**
O&M Grade: **2**
Clock Start/From: **8**
Clock To: **4**
1st Value:
2nd Value:
Value Percent: **5.000**
Continuous Index:
Within 8" of Joint: **YES**
Remarks:

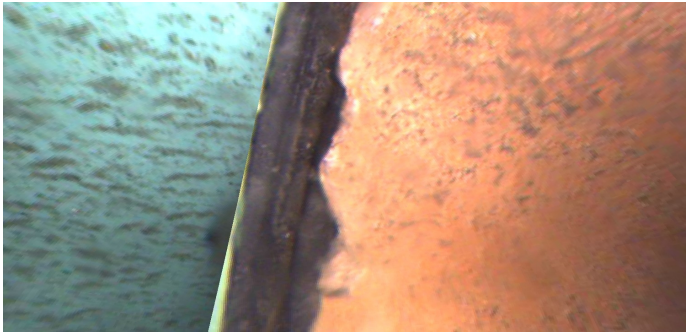
Code: **MMC**
Description: **Material Change**

Distance (ft): **71.2**
Structural Grade: **0**
O&M Grade: **0**
Clock Start/From:
Clock To:
1st Value:
2nd Value:
Value Percent:
Continuous Index:
Within 8" of Joint: **NO**
Remarks: **pvc**

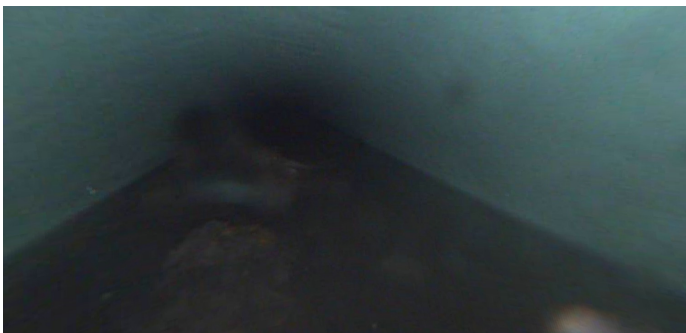
Code: **MGO**
Description: **General Observation**

Distance (ft): **73.3**
Structural Grade: **0**
O&M Grade: **0**
Clock Start/From:
Clock To:
1st Value:
2nd Value:
Value Percent:
Continuous Index:
Within 8" of Joint: **NO**
Remarks: **heavy debris**

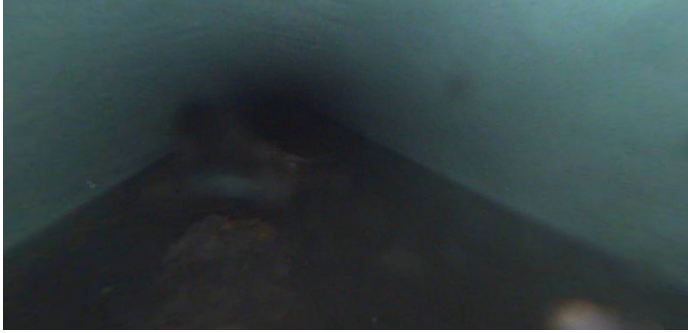
Code:	MSA
Description:	Abandoned Survey
Distance (ft):	73.3
Structural Grade:	0
O&M Grade:	0
Clock Start/From:	
Clock To:	
1st Value:	
2nd Value:	
Value Percent:	
Continuous Index:	
Within 8" of Joint:	NO
Remarks:	stopped by debris?
