## Profile/Photo Observation Report

Street:	<b>e 34th st</b>	Flow Control:	<b>Not Controlled</b>
City:	<b>Hobart, IN</b>	Year Renewed:	
Location:	<b>Other</b>	Tape/Media #:	
Purpose:	<b>Not Known</b>	Dia/Height:	<b>10"</b>
Use:	<b>Sanitary</b>	Material:	<b>VCP</b>
Drain Area:	<b>NA</b>	Lining:	
Category:	<b>NA</b>		
Comment:

Location Details:		Direction of Survey:	<b>Upstream</b>
US MH:	<b>M-902-041</b>	DS MH:	<b>M-902-040</b>
		Total Length Surveyed (ft):	<b>73.3</b>

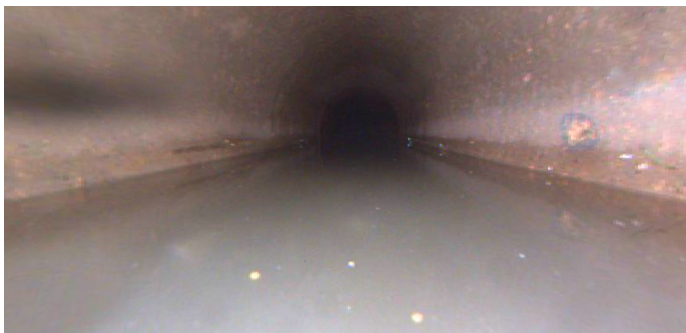
Code: **AMH**  
Description: **Manhole**

Distance (ft): **.0**  
Structural Grade: **0**  
O&M Grade: **0**  
Clock Start/From:  
Clock To:  
1st Value:  
2nd Value:  
Value Percent:  
Continuous Index:  
Within 8" of Joint: **NO**  
Remarks: **M-902-040**

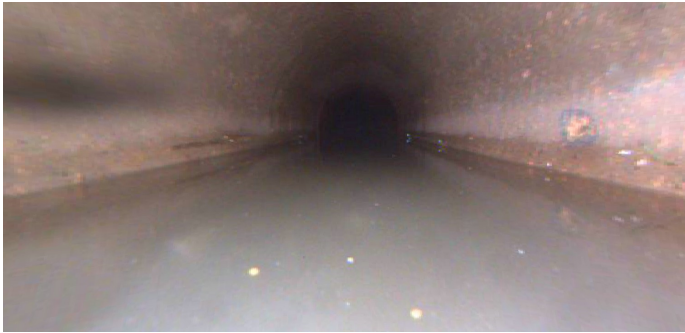
Code:	<b>MWL</b>
Description:	<b>Water Level</b>

Distance (ft):	<b>.0</b>
Structural Grade:	<b>0</b>
O&M Grade:	<b>0</b>
Clock Start/From:	
Clock To:	
1st Value:	
2nd Value:	
Value Percent:	<b>25.000</b>
Continuous Index:	
Within 8" of Joint:	<b>NO</b>
Remarks:

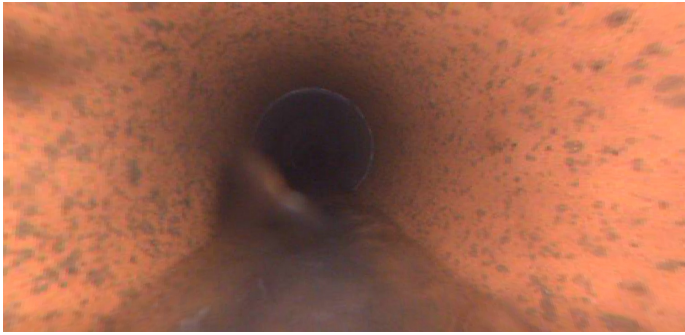
Code: **MCU**  
Description: **Camera Underwater**

Distance (ft): **47.9**  
Structural Grade: **0**  
O&M Grade: **4**  
Clock Start/From:  
Clock To:  
1st Value:  
2nd Value:  
Value Percent:  
Continuous Index: **F01**  
Within 8" of Joint: **NO**  
Remarks:

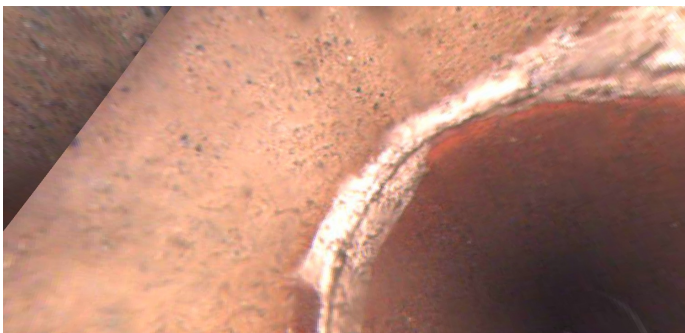
Code: **DAZ**  
Description: **Deposits Attached Other**

Distance (ft): **62.4**  
Structural Grade: **0**  
O&M Grade: **2**  
Clock Start/From: **8**  
Clock To: **4**  
1st Value:  
2nd Value:  
Value Percent: **5.000**  
Continuous Index:  
Within 8" of Joint: **YES**  
Remarks:

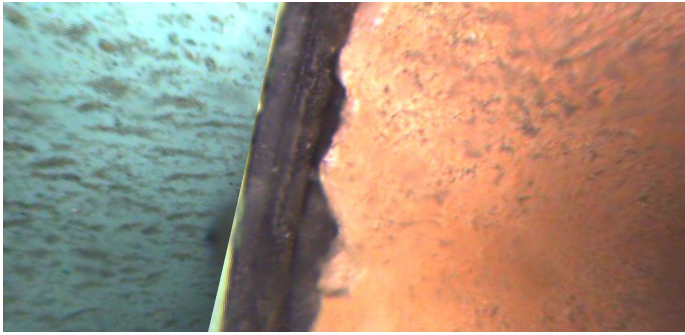
Code: **MMC**  
Description: **Material Change**

Distance (ft): **71.2**  
Structural Grade: **0**  
O&M Grade: **0**  
Clock Start/From:  
Clock To:  
1st Value:  
2nd Value:  
Value Percent:  
Continuous Index:  
Within 8" of Joint: **NO**  
Remarks: **pvc**

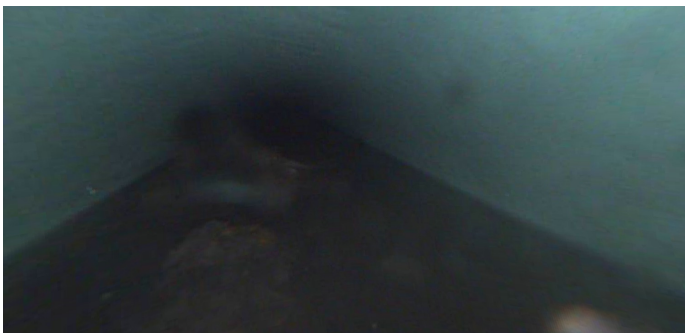
Code: **MGO**  
Description: **General Observation**

Distance (ft): **73.3**  
Structural Grade: **0**  
O&M Grade: **0**  
Clock Start/From:  
Clock To:  
1st Value:  
2nd Value:  
Value Percent:  
Continuous Index:  
Within 8" of Joint: **NO**  
Remarks: **heavy debris**

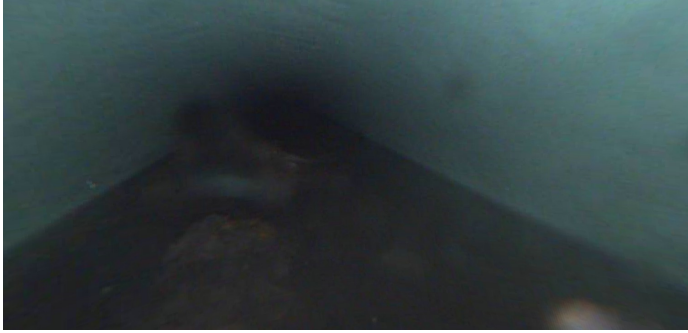
Code:	<b>MSA</b>
Description:	<b>Abandoned Survey</b>
Distance (ft):	<b>73.3</b>
Structural Grade:	<b>0</b>
O&M Grade:	<b>0</b>
Clock Start/From:	
Clock To:	
1st Value:	
2nd Value:	
Value Percent:	
Continuous Index:	
Within 8" of Joint:	<b>NO</b>
Remarks:	<b>stopped by debris?</b>
