Profile/Photo Observation Report

Date:	03/24/2018	Weather:		Coding:	PACP 6.0
Pipe Length (ft):	200.6	Owner:	NA	Pre Clean:	Not Known
P.O.#:		Surveyor:	Byrd Fitzgerald	PSR:	P-902-042-041
Customer:		Clean Date:	01/01/1900	Shape:	C

Street:	ALLEY BETWEEN E 34TH AVE & E 34T	Flow Control:	Not Controlled
City:	Hobart, IN	Year Renewed:	
Location:	Other	Tape/Media #:	
Purpose:	Not Known	Dia/Height:	10"
Use:	Sanitary	Material:	VCP
Drain Area:	NA	Lining:	
Category:	NA		
Comment:

Location Details:		Direction of Survey:	Downstream
US MH:	M-902-042	DS MH:	M-902-041
		Total Length Surveyed (ft):	177.0

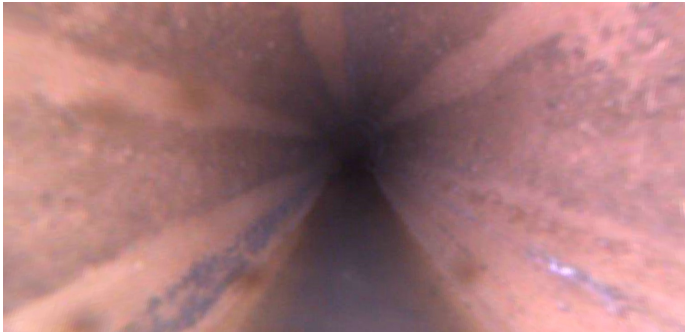
Code: **AMH**
Description: **Manhole**

Distance (ft): **.0**
Structural Grade: **0**
O&M Grade: **0**
Clock Start/From:
Clock To:
1st Value:
2nd Value:
Value Percent:
Continuous Index:
Within 8" of Joint: **NO**
Remarks: **M-902-042**

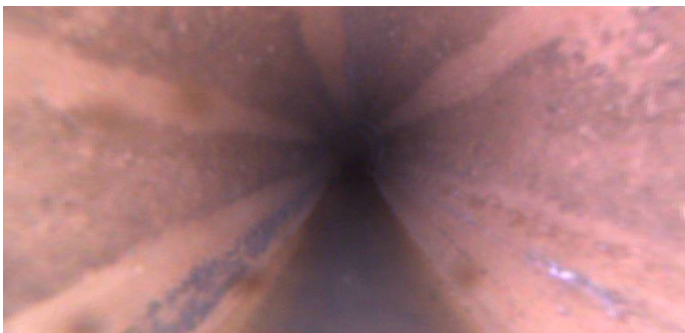
Code: **MWL**
Description: **Water Level**

Distance (ft): **.0**
Structural Grade: **0**
O&M Grade: **0**
Clock Start/From:
Clock To:
1st Value:
2nd Value:
Value Percent: **5.000**
Continuous Index:
Within 8" of Joint: **NO**
Remarks:

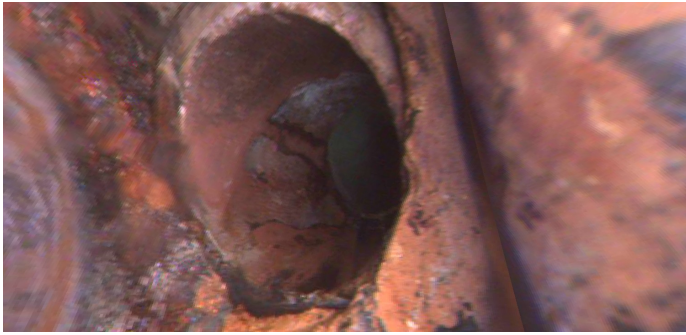
Code: **TB**
Description: **Tap Break-in**

Distance (ft): **6.1**
Structural Grade: **0**
O&M Grade: **0**
Clock Start/From: **10**
Clock To:
1st Value: **4.000**
2nd Value:
Value Percent:
Continuous Index:
Within 8" of Joint: **YES**
Remarks:

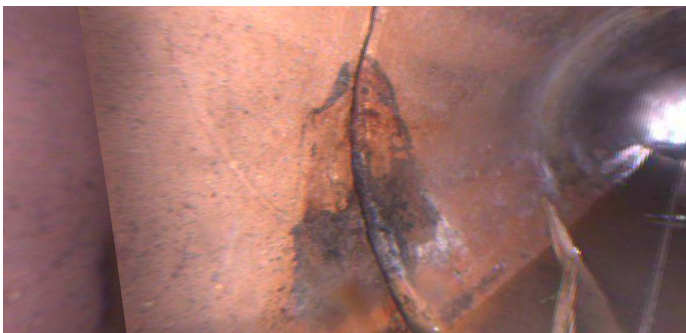
Code: **IS**
Description: **Infil Stain**

Distance (ft): **7.2**
Structural Grade: **0**
O&M Grade: **0**
Clock Start/From: **3**
Clock To:
1st Value:
2nd Value:
Value Percent:
Continuous Index:
Within 8" of Joint: **YES**
Remarks:

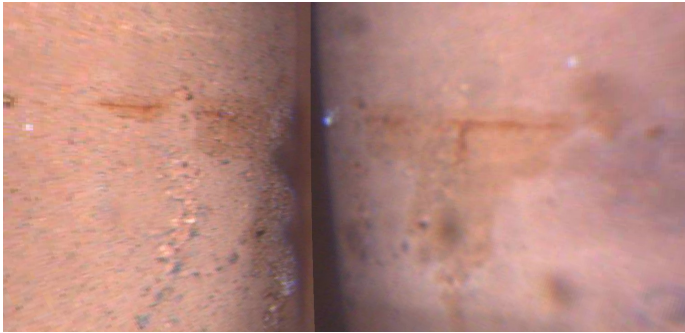
Code: **CL**
Description: **Crack Longitudinal**

Distance (ft): **8.0**
Structural Grade: **2**
O&M Grade: **0**
Clock Start/From: **9**
Clock To:
1st Value:
2nd Value:
Value Percent:
Continuous Index:
Within 8" of Joint:
Remarks:

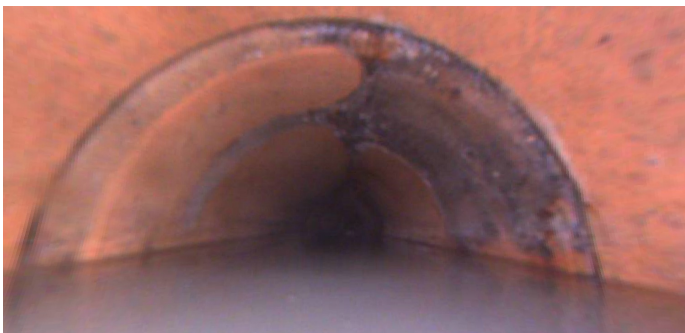
Code: **MWL**
Description: **Water Level**

Distance (ft): **18.4**
Structural Grade: **0**
O&M Grade: **0**
Clock Start/From:
Clock To:
1st Value:
2nd Value:
Value Percent: **50.000**
Continuous Index:
Within 8" of Joint: **NO**
Remarks:

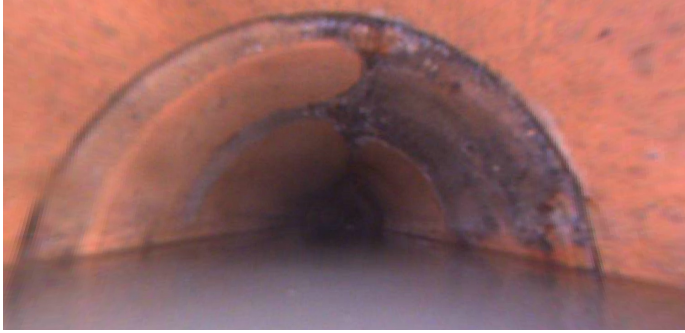
Code: **FL**
Description: **Fracture Longitudinal**

Distance (ft): **18.4**
Structural Grade: **3**
O&M Grade: **0**
Clock Start/From: **12**
Clock To:
1st Value:
2nd Value:
Value Percent:
Continuous Index: **S01**
Within 8" of Joint: **YES**
Remarks:

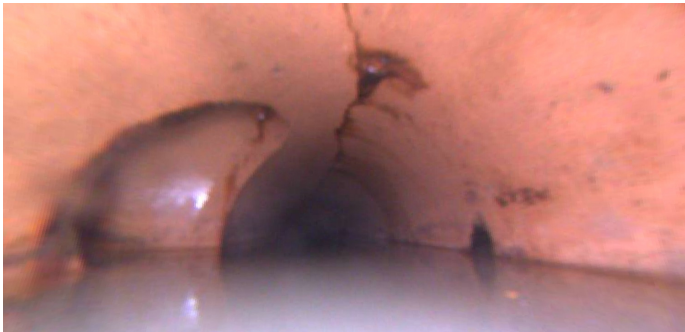
Code: **TF**
Description: **Tap Factory**

Distance (ft): **21.7**
Structural Grade: **0**
O&M Grade: **0**
Clock Start/From: **9**
Clock To:
1st Value: **4.000**
2nd Value:
Value Percent:
Continuous Index:
Within 8" of Joint:
Remarks:

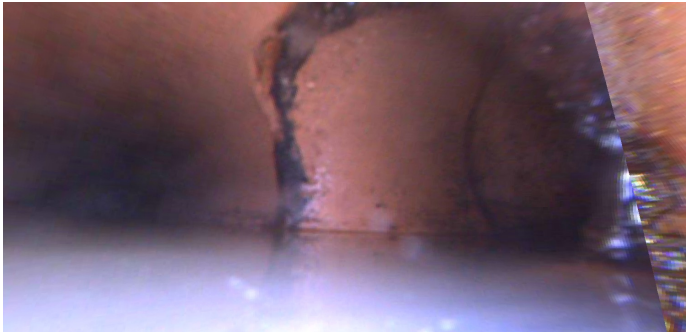
Code: **TB**
Description: **Tap Break-in**

Distance (ft): **25.1**
Structural Grade: **0**
O&M Grade: **0**
Clock Start/From: **3**
Clock To:
1st Value: **4.000**
2nd Value:
Value Percent:
Continuous Index:
Within 8" of Joint: **YES**
Remarks:

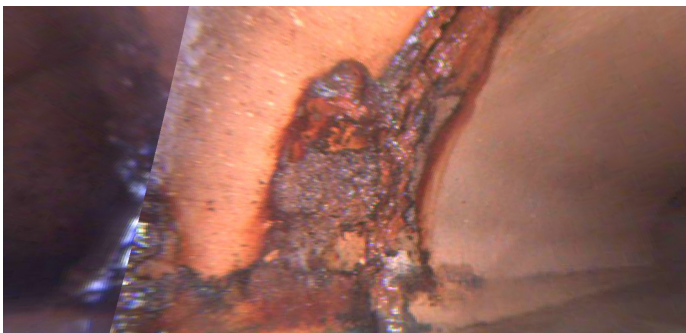
Code: **DAE**
Description: **Deposits Attached Encrustation**

Distance (ft): **25.1**
Structural Grade: **0**
O&M Grade: **2**
Clock Start/From: **3**
Clock To: **5**
1st Value:
2nd Value:
Value Percent: **5.000**
Continuous Index:
Within 8" of Joint: **YES**
Remarks:

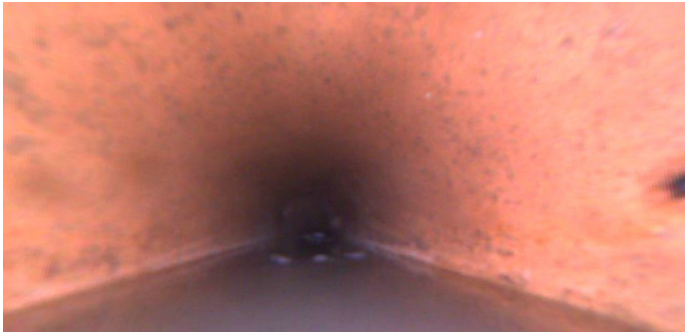
Code: **FL**
Description: **Fracture Longitudinal**

Distance (ft): **27.7**
Structural Grade: **3**
O&M Grade: **0**
Clock Start/From: **12**
Clock To:
1st Value:
2nd Value:
Value Percent:
Continuous Index: **F01**
Within 8" of Joint: **YES**
Remarks:

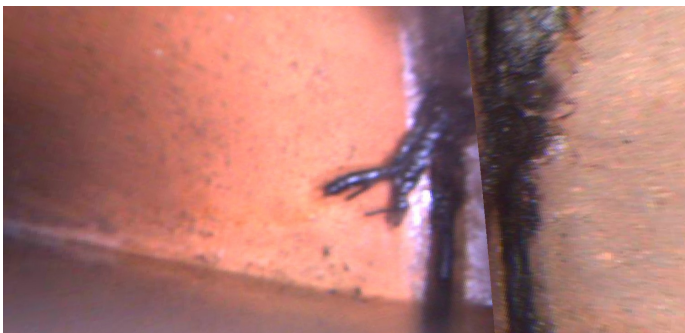
Code: **RFJ**
Description: **Roots Fine Joint**

Distance (ft): **27.7**
Structural Grade: **0**
O&M Grade: **1**
Clock Start/From: **7**
Clock To: **5**
1st Value:
2nd Value:
Value Percent:
Continuous Index:
Within 8" of Joint: **YES**
Remarks:

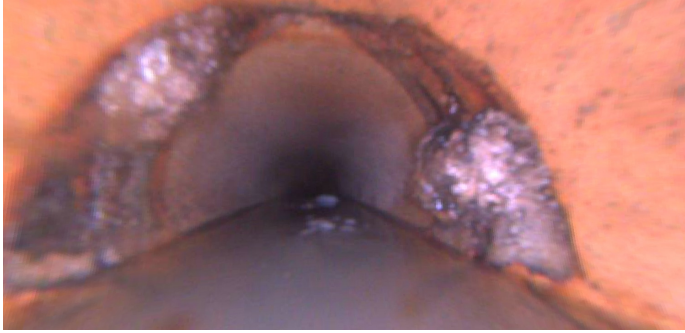
Code: **DAE**
Description: **Deposits Attached Encrustation**

Distance (ft): **30.2**
Structural Grade: **0**
O&M Grade: **2**
Clock Start/From: **8**
Clock To: **4**
1st Value:
2nd Value:
Value Percent: **5.000**
Continuous Index:
Within 8" of Joint: **YES**
Remarks:

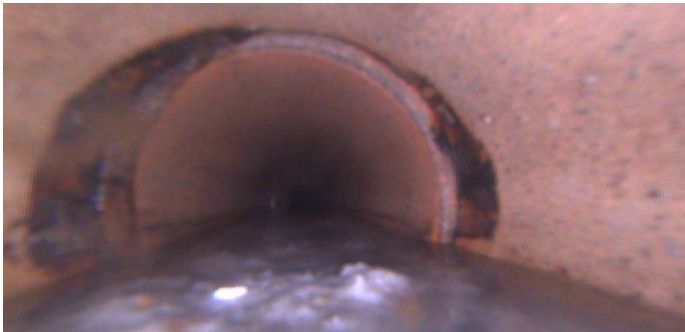
Code: **IS**
Description: **Infil Stain**

Distance (ft): **39.1**
Structural Grade: **0**
O&M Grade: **0**
Clock Start/From: **8**
Clock To: **4**
1st Value:
2nd Value:
Value Percent:
Continuous Index: **S03**
Within 8" of Joint: **YES**
Remarks: **wandering**

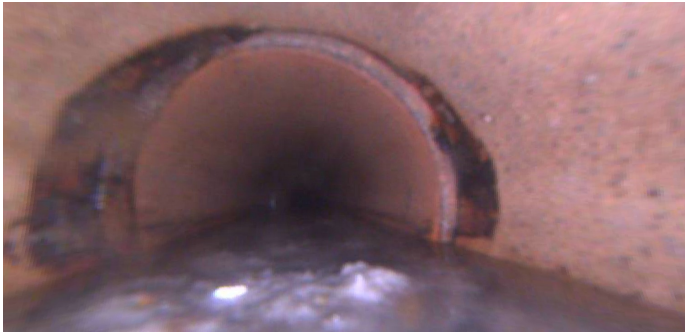
Code: **MWL**
Description: **Water Level**

Distance (ft): **39.1**
Structural Grade: **0**
O&M Grade: **0**
Clock Start/From:
Clock To:
1st Value:
2nd Value:
Value Percent: **25.000**
Continuous Index:
Within 8" of Joint: **NO**
Remarks:

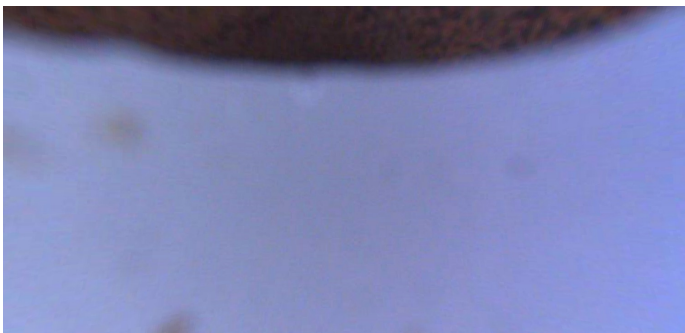
Code: **MCU**
Description: **Camera Underwater**

Distance (ft): **53.1**
Structural Grade: **0**
O&M Grade: **4**
Clock Start/From:
Clock To:
1st Value:
2nd Value:
Value Percent:
Continuous Index: **S04**
Within 8" of Joint: **NO**
Remarks:

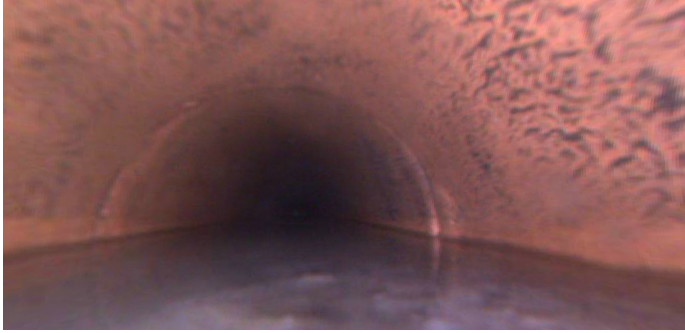
Code: **MCU**
Description: **Camera Underwater**

Distance (ft): **65.9**
Structural Grade: **0**
O&M Grade: **4**
Clock Start/From:
Clock To:
1st Value:
2nd Value:
Value Percent:
Continuous Index: **F04**
Within 8" of Joint: **NO**
Remarks:

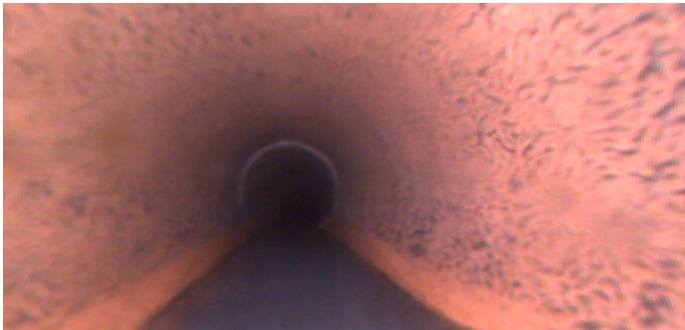
Code: **MWL**
Description: **Water Level**

Distance (ft): **73.6**
Structural Grade: **0**
O&M Grade: **0**
Clock Start/From:
Clock To:
1st Value:
2nd Value:
Value Percent: **5.000**
Continuous Index:
Within 8" of Joint: **NO**
Remarks:

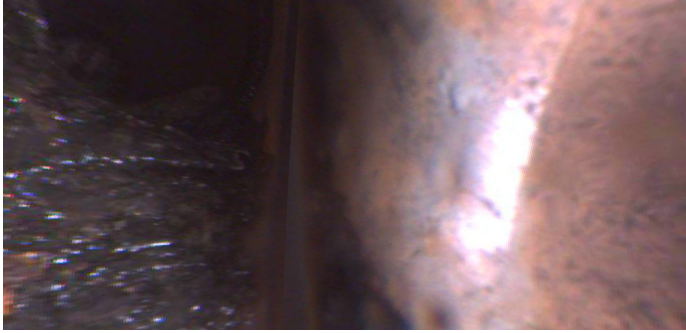
Code: **TFD**
Description: **Tap Factory Defective**

Distance (ft): **91.1**
Structural Grade: **0**
O&M Grade: **2**
Clock Start/From: **10**
Clock To:
1st Value: **4.000**
2nd Value:
Value Percent:
Continuous Index:
Within 8" of Joint: **YES**
Remarks: **partially blocked by debris**

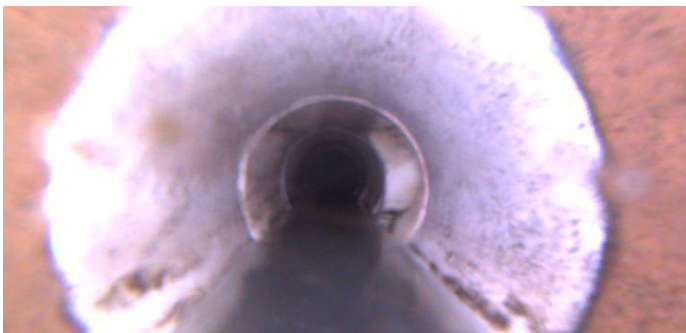
Code: **MMC**
Description: **Material Change**

Distance (ft): **93.1**
Structural Grade: **0**
O&M Grade: **0**
Clock Start/From:
Clock To:
1st Value:
2nd Value:
Value Percent:
Continuous Index:
Within 8" of Joint: **NO**
Remarks: **PVC**

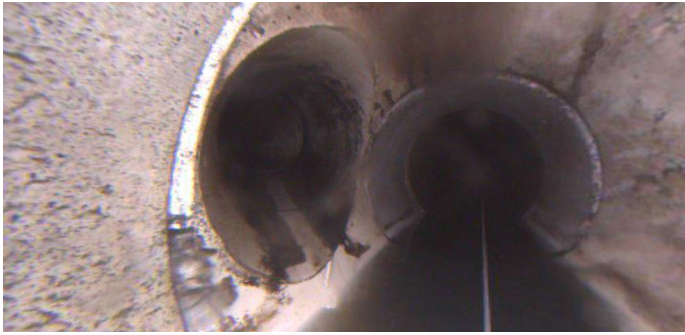
Code: **TFA**
Description: **Tap Factory Active**

Distance (ft): **95.2**
Structural Grade: **0**
O&M Grade: **0**
Clock Start/From: **3**
Clock To:
1st Value: **4.000**
2nd Value:
Value Percent:
Continuous Index:
Within 8" of Joint:
Remarks:

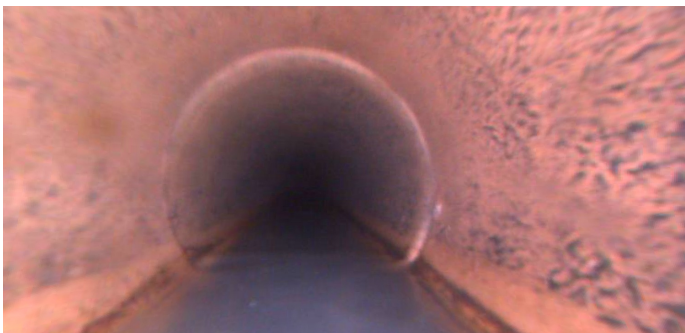
Code: **MMC**
Description: **Material Change**

Distance (ft): **95.8**
Structural Grade: **0**
O&M Grade: **0**
Clock Start/From:
Clock To:
1st Value:
2nd Value:
Value Percent:
Continuous Index:
Within 8" of Joint: **NO**
Remarks: **vcp**

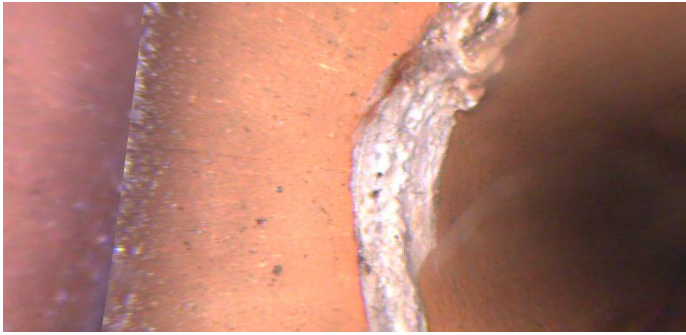
Code: **DAZ**
Description: **Deposits Attached Other**

Distance (ft): **108.8**
Structural Grade: **0**
O&M Grade: **2**
Clock Start/From: **2**
Clock To: **5**
1st Value:
2nd Value:
Value Percent: **5.000**
Continuous Index:
Within 8" of Joint: **YES**
Remarks:

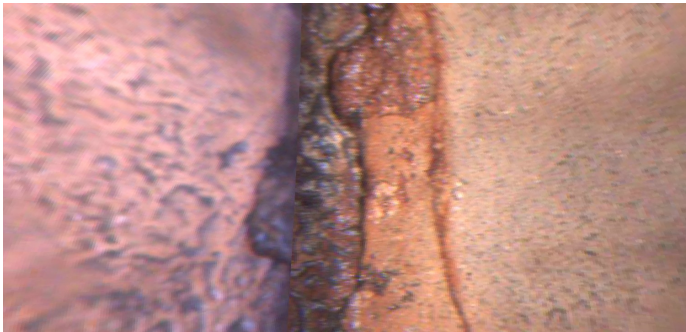
Code: **DAE**
Description: **Deposits Attached Encrustation**

Distance (ft): **123.4**
Structural Grade: **0**
O&M Grade: **2**
Clock Start/From: **2**
Clock To: **5**
1st Value:
2nd Value:
Value Percent: **5.000**
Continuous Index:
Within 8" of Joint: **YES**
Remarks:

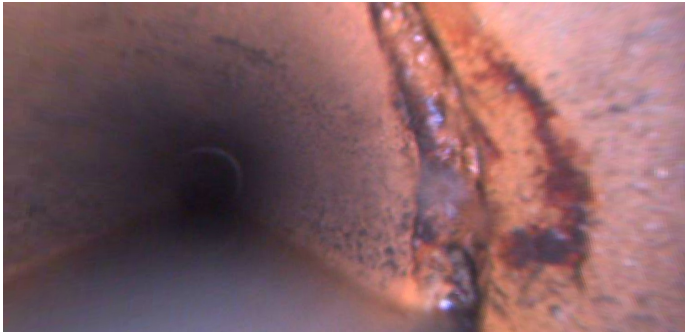
Code: **DAE**
Description: **Deposits Attached Encrustation**

Distance (ft): **129.2**
Structural Grade: **0**
O&M Grade: **2**
Clock Start/From: **7**
Clock To: **5**
1st Value:
2nd Value:
Value Percent: **5.000**
Continuous Index: **S05**
Within 8" of Joint: **YES**
Remarks: **wandering**

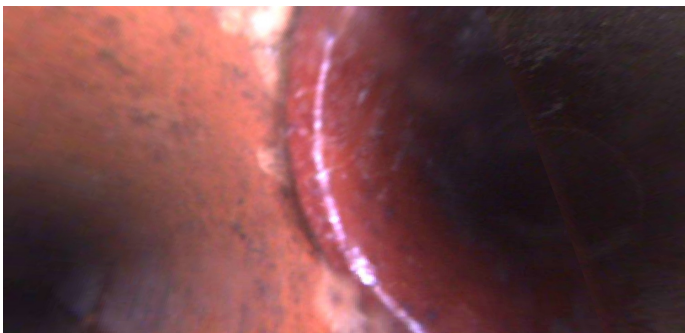
Code: **TBI**
Description: **Tap Break-in Intruding**

Distance (ft): **154.5**
Structural Grade: **0**
O&M Grade: **2**
Clock Start/From: **2**
Clock To:
1st Value: **4.000**
2nd Value: **1.000**
Value Percent:
Continuous Index:
Within 8" of Joint:
Remarks:

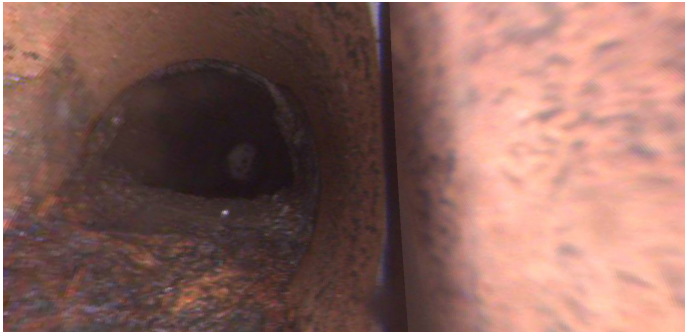
Code: **TFD**
Description: **Tap Factory Defective**

Distance (ft): **166.1**
Structural Grade: **0**
O&M Grade: **2**
Clock Start/From: **10**
Clock To:
1st Value: **4.000**
2nd Value:
Value Percent:
Continuous Index:
Within 8" of Joint: **YES**
Remarks: **partially blocked by deposits**

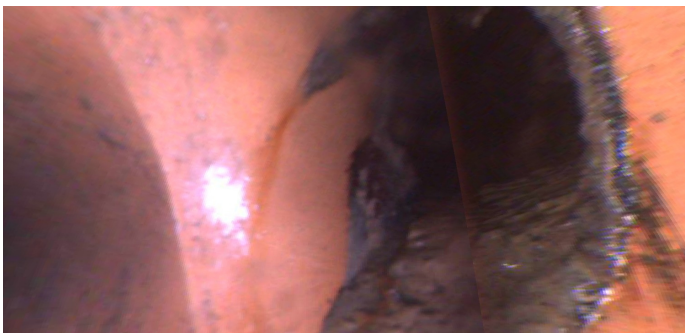
Code: **TFD**
Description: **Tap Factory Defective**

Distance (ft): **168.6**
Structural Grade: **0**
O&M Grade: **2**
Clock Start/From: **2**
Clock To:
1st Value: **4.000**
2nd Value:
Value Percent:
Continuous Index:
Within 8" of Joint: **YES**
Remarks: **partially blocked**

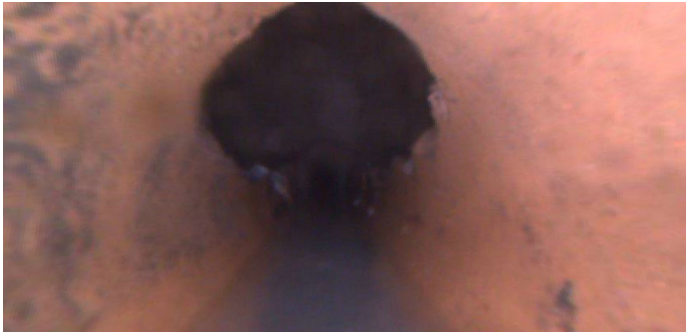
Code: **DAE**
Description: **Deposits Attached Encrustation**

Distance (ft): **174.7**
Structural Grade: **0**
O&M Grade: **2**
Clock Start/From: **7**
Clock To: **5**
1st Value:
2nd Value:
Value Percent: **5.000**
Continuous Index: **F05**
Within 8" of Joint: **YES**
Remarks: **wandering**

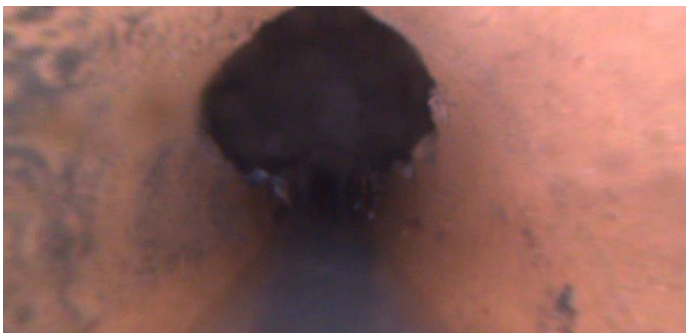
Code: **IS**
Description: **Infil Stain**

Distance (ft): **174.7**
Structural Grade: **0**
O&M Grade: **0**
Clock Start/From: **8**
Clock To: **4**
1st Value:
2nd Value:
Value Percent:
Continuous Index: **F03**
Within 8" of Joint: **YES**
Remarks: **wandering**

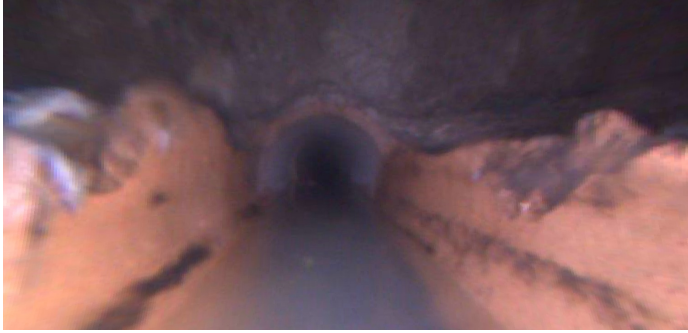
Code:	AMH
Description:	Manhole
Distance (ft):	177.0
Structural Grade:	0
O&M Grade:	0
Clock Start/From:	
Clock To:	
1st Value:	
2nd Value:	
Value Percent:	
Continuous Index:	
Within 8" of Joint:	NO
Remarks:	M-902-041
