Profile/Photo Observation Report

Date:	03/24/2018	Weather:		Coding:	PACP 6.0
Pipe Length (ft):	200.6	Owner:	NA	Pre Clean:	Not Known
P.O.#:		Surveyor:	Byrd Fitzgerald	PSR:	P-902-042-041
Customer:		Clean Date:	01/01/1900	Shape:	C

Street:	e 34th st	Flow Control:	Not Controlled
City:	Hobart, IN	Year Renewed:	
Location:	Other	Tape/Media #:	
Purpose:	Not Known	Dia/Height:	10"
Use:	Sanitary	Material:	VCP
Drain Area:	NA	Lining:	
Category:	NA		
Comment:

Location Details:		Direction of Survey:	Downstream
US MH:	M-902-042	DS MH:	M-902-041
		Total Length Surveyed (ft):	177.0

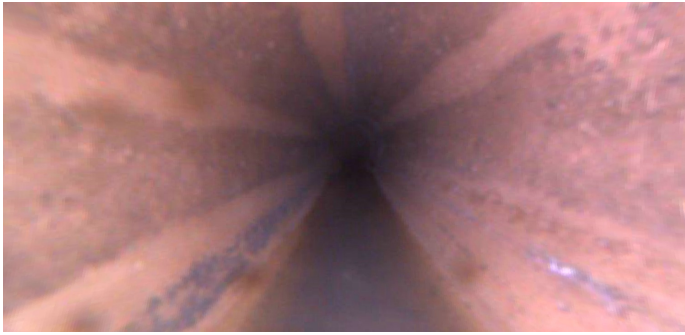
Code: **AMH**
Description: **Manhole**

Distance (ft): **.0**
Structural Grade: **0**
O&M Grade: **0**
Clock Start/From:
Clock To:
1st Value:
2nd Value:
Value Percent:
Continuous Index:
Within 8" of Joint: **NO**
Remarks: **M-902-042**

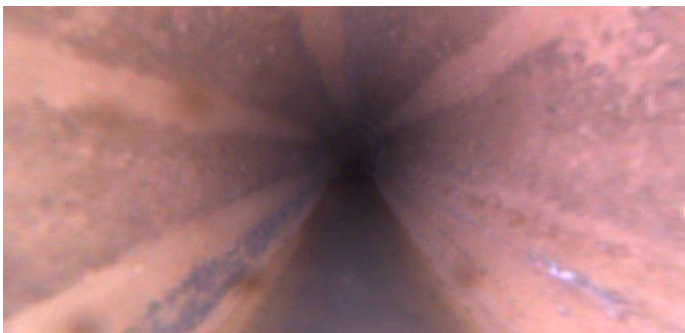
Code: **MWL**
Description: **Water Level**

Distance (ft): **.0**
Structural Grade: **0**
O&M Grade: **0**
Clock Start/From:
Clock To:
1st Value:
2nd Value:
Value Percent: **5.000**
Continuous Index:
Within 8" of Joint: **NO**
Remarks:

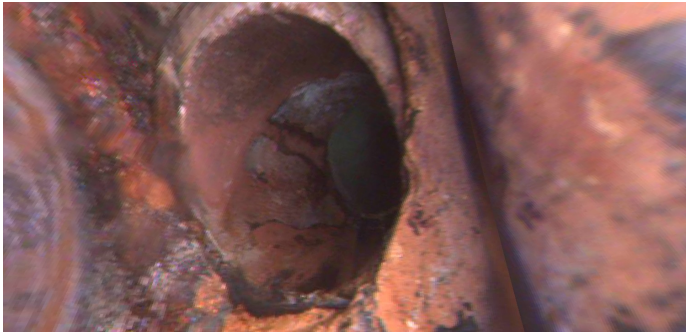
Code: **TB**
Description: **Tap Break-in**

Distance (ft): **6.1**
Structural Grade: **0**
O&M Grade: **0**
Clock Start/From: **10**
Clock To:
1st Value: **4.000**
2nd Value:
Value Percent:
Continuous Index:
Within 8" of Joint: **YES**
Remarks:

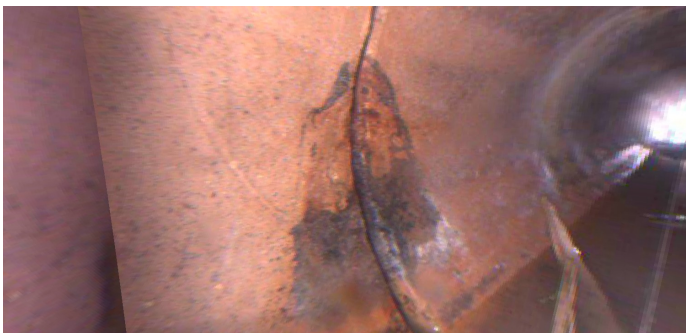
Code: **IS**
Description: **Infil Stain**

Distance (ft): **7.2**
Structural Grade: **0**
O&M Grade: **0**
Clock Start/From: **3**
Clock To:
1st Value:
2nd Value:
Value Percent:
Continuous Index:
Within 8" of Joint: **YES**
Remarks:

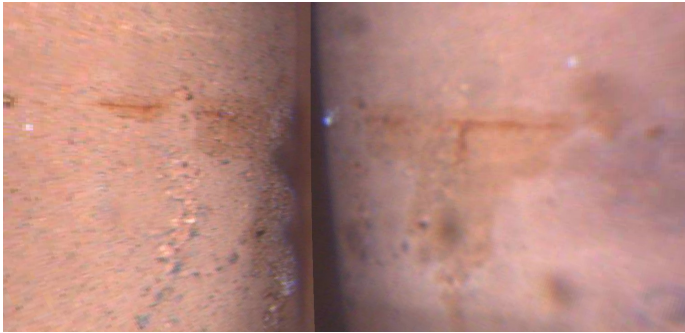
Code: **CL**
Description: **Crack Longitudinal**

Distance (ft): **8.0**
Structural Grade: **2**
O&M Grade: **0**
Clock Start/From: **9**
Clock To:
1st Value:
2nd Value:
Value Percent:
Continuous Index:
Within 8" of Joint:
Remarks:

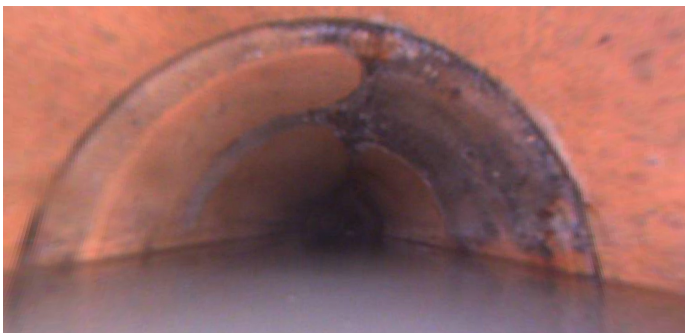
Code: **MWL**
Description: **Water Level**

Distance (ft): **18.4**
Structural Grade: **0**
O&M Grade: **0**
Clock Start/From:
Clock To:
1st Value:
2nd Value:
Value Percent: **50.000**
Continuous Index:
Within 8" of Joint: **NO**
Remarks:

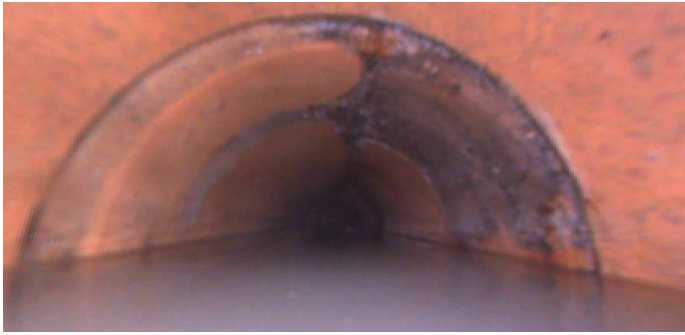
Code: **FL**
Description: **Fracture Longitudinal**

Distance (ft): **18.4**
Structural Grade: **3**
O&M Grade: **0**
Clock Start/From: **12**
Clock To:
1st Value:
2nd Value:
Value Percent:
Continuous Index: **S01**
Within 8" of Joint: **YES**
Remarks:

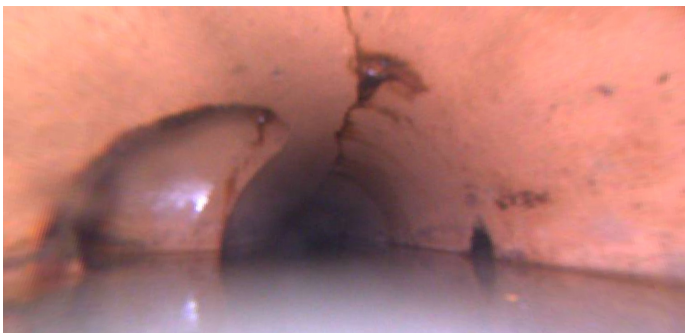
Code: **TF**
Description: **Tap Factory**

Distance (ft): **21.7**
Structural Grade: **0**
O&M Grade: **0**
Clock Start/From: **9**
Clock To:
1st Value: **4.000**
2nd Value:
Value Percent:
Continuous Index:
Within 8" of Joint:
Remarks:

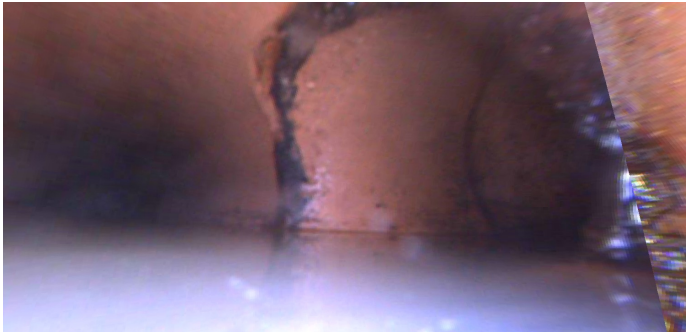
Code: **TB**
Description: **Tap Break-in**

Distance (ft): **25.1**
Structural Grade: **0**
O&M Grade: **0**
Clock Start/From: **3**
Clock To:
1st Value: **4.000**
2nd Value:
Value Percent:
Continuous Index:
Within 8" of Joint: **YES**
Remarks:

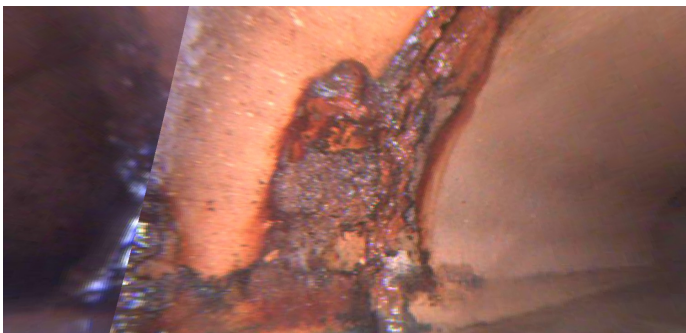
Code: **DAE**
Description: **Deposits Attached Encrustation**

Distance (ft): **25.1**
Structural Grade: **0**
O&M Grade: **2**
Clock Start/From: **3**
Clock To: **5**
1st Value:
2nd Value:
Value Percent: **5.000**
Continuous Index:
Within 8" of Joint: **YES**
Remarks:

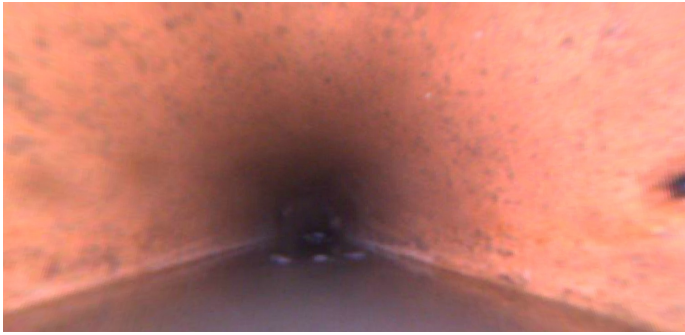
Code: **FL**
Description: **Fracture Longitudinal**

Distance (ft): **27.7**
Structural Grade: **3**
O&M Grade: **0**
Clock Start/From: **12**
Clock To:
1st Value:
2nd Value:
Value Percent:
Continuous Index: **F01**
Within 8" of Joint: **YES**
Remarks:

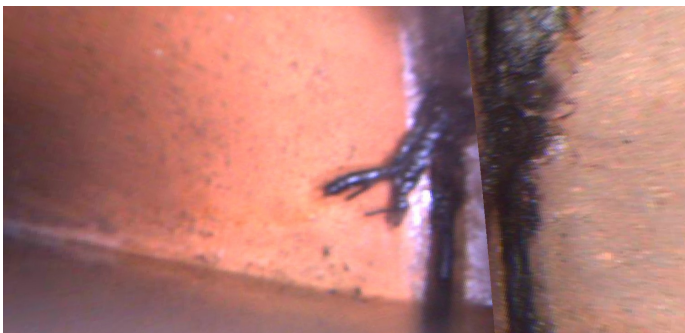
Code: **RFJ**
Description: **Roots Fine Joint**

Distance (ft): **27.7**
Structural Grade: **0**
O&M Grade: **1**
Clock Start/From: **7**
Clock To: **5**
1st Value:
2nd Value:
Value Percent:
Continuous Index:
Within 8" of Joint: **YES**
Remarks:

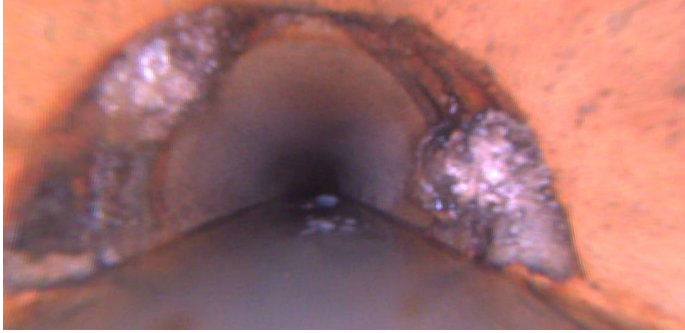
Code: **DAE**
Description: **Deposits Attached Encrustation**

Distance (ft): **30.2**
Structural Grade: **0**
O&M Grade: **2**
Clock Start/From: **8**
Clock To: **4**
1st Value:
2nd Value:
Value Percent: **5.000**
Continuous Index:
Within 8" of Joint: **YES**
Remarks:

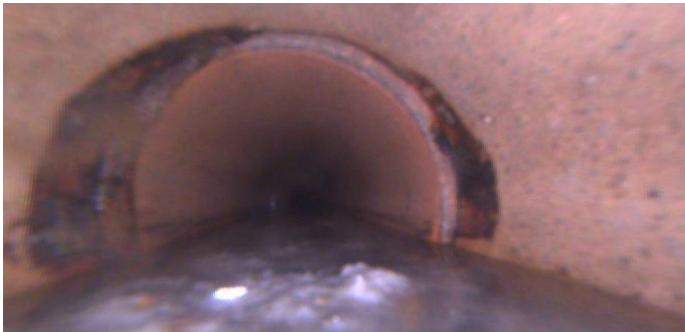
Code: **IS**
Description: **Infil Stain**

Distance (ft): **39.1**
Structural Grade: **0**
O&M Grade: **0**
Clock Start/From: **8**
Clock To: **4**
1st Value:
2nd Value:
Value Percent:
Continuous Index: **S03**
Within 8" of Joint: **YES**
Remarks: **wandering**

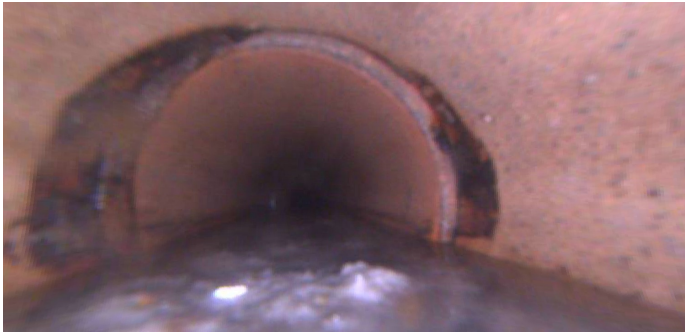
Code: **MWL**
Description: **Water Level**

Distance (ft): **39.1**
Structural Grade: **0**
O&M Grade: **0**
Clock Start/From:
Clock To:
1st Value:
2nd Value:
Value Percent: **25.000**
Continuous Index:
Within 8" of Joint: **NO**
Remarks:

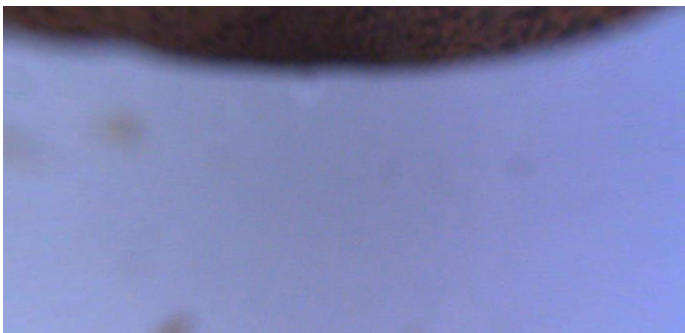
Code: **MCU**
Description: **Camera Underwater**

Distance (ft): **53.1**
Structural Grade: **0**
O&M Grade: **4**
Clock Start/From:
Clock To:
1st Value:
2nd Value:
Value Percent:
Continuous Index: **S04**
Within 8" of Joint: **NO**
Remarks:

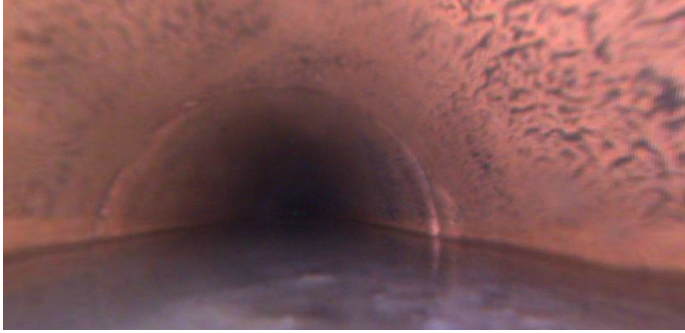
Code: **MCU**
Description: **Camera Underwater**

Distance (ft): **65.9**
Structural Grade: **0**
O&M Grade: **4**
Clock Start/From:
Clock To:
1st Value:
2nd Value:
Value Percent:
Continuous Index: **F04**
Within 8" of Joint: **NO**
Remarks:

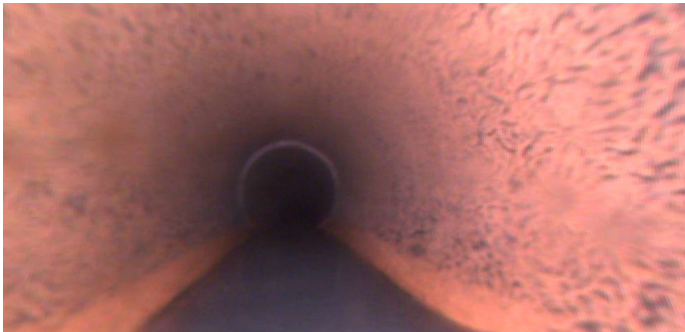
Code: **MWL**
Description: **Water Level**

Distance (ft): **73.6**
Structural Grade: **0**
O&M Grade: **0**
Clock Start/From:
Clock To:
1st Value:
2nd Value:
Value Percent: **5.000**
Continuous Index:
Within 8" of Joint: **NO**
Remarks:

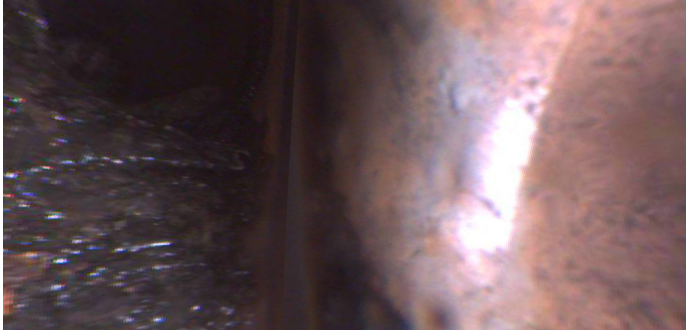
Code: **TFD**
Description: **Tap Factory Defective**

Distance (ft): **91.1**
Structural Grade: **0**
O&M Grade: **2**
Clock Start/From: **10**
Clock To:
1st Value: **4.000**
2nd Value:
Value Percent:
Continuous Index:
Within 8" of Joint: **YES**
Remarks: **partially blocked by debris**

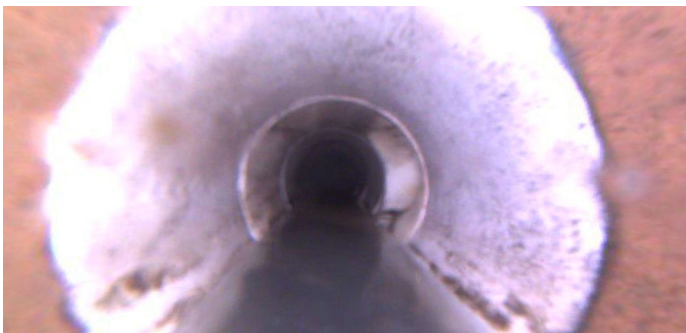
Code: **MMC**
Description: **Material Change**

Distance (ft): **93.1**
Structural Grade: **0**
O&M Grade: **0**
Clock Start/From:
Clock To:
1st Value:
2nd Value:
Value Percent:
Continuous Index:
Within 8" of Joint: **NO**
Remarks: **PVC**

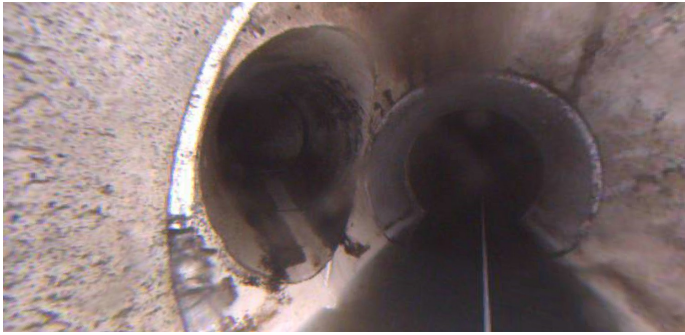
Code: **TFA**
Description: **Tap Factory Active**

Distance (ft): **95.2**
Structural Grade: **0**
O&M Grade: **0**
Clock Start/From: **3**
Clock To:
1st Value: **4.000**
2nd Value:
Value Percent:
Continuous Index:
Within 8" of Joint:
Remarks:

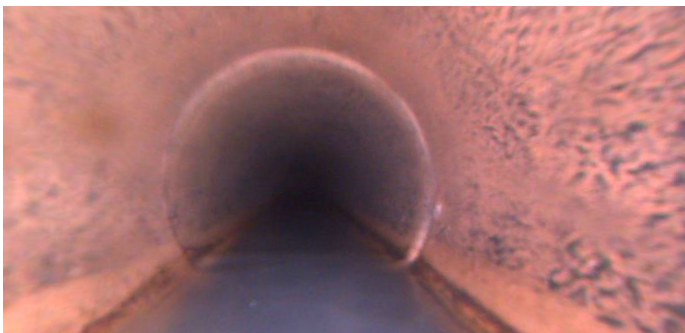
Code: **MMC**
Description: **Material Change**

Distance (ft): **95.8**
Structural Grade: **0**
O&M Grade: **0**
Clock Start/From:
Clock To:
1st Value:
2nd Value:
Value Percent:
Continuous Index:
Within 8" of Joint: **NO**
Remarks: **vcp**

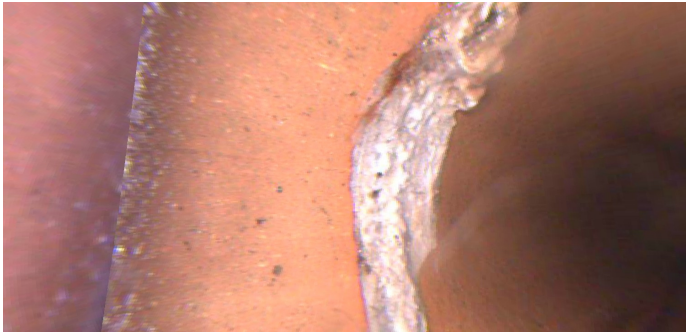
Code: **DAZ**
Description: **Deposits Attached Other**

Distance (ft): **108.8**
Structural Grade: **0**
O&M Grade: **2**
Clock Start/From: **2**
Clock To: **5**
1st Value:
2nd Value:
Value Percent: **5.000**
Continuous Index:
Within 8" of Joint: **YES**
Remarks:

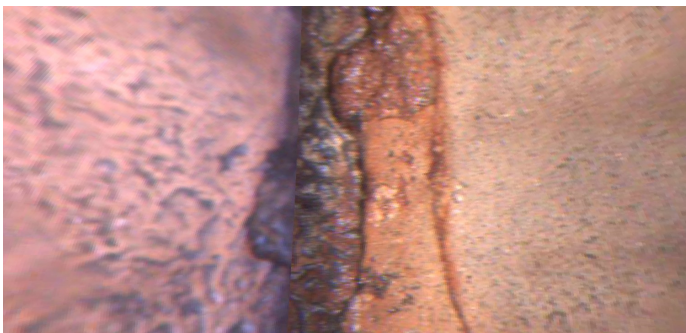
Code: **DAE**
Description: **Deposits Attached Encrustation**

Distance (ft): **123.4**
Structural Grade: **0**
O&M Grade: **2**
Clock Start/From: **2**
Clock To: **5**
1st Value:
2nd Value:
Value Percent: **5.000**
Continuous Index:
Within 8" of Joint: **YES**
Remarks:

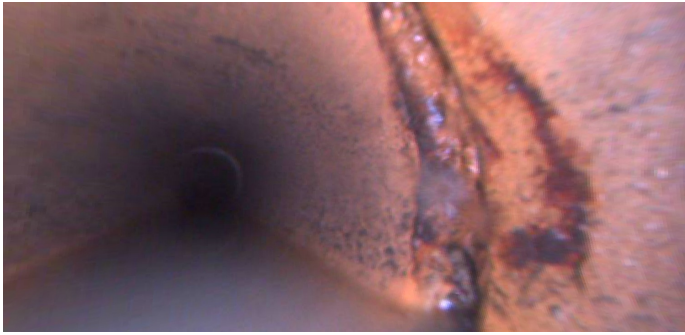
Code: **DAE**
Description: **Deposits Attached Encrustation**

Distance (ft): **129.2**
Structural Grade: **0**
O&M Grade: **2**
Clock Start/From: **7**
Clock To: **5**
1st Value:
2nd Value:
Value Percent: **5.000**
Continuous Index: **S05**
Within 8" of Joint: **YES**
Remarks: **wandering**

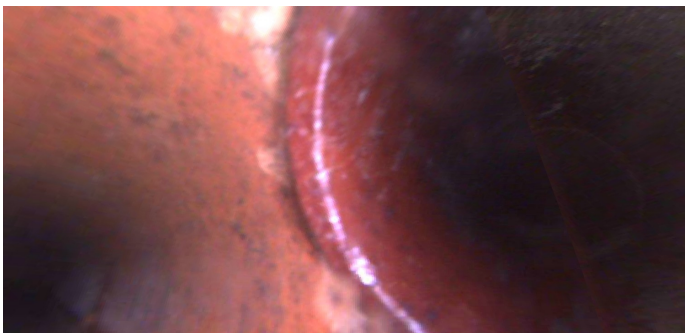
Code: **TBI**
Description: **Tap Break-in Intruding**

Distance (ft): **154.5**
Structural Grade: **0**
O&M Grade: **2**
Clock Start/From: **2**
Clock To:
1st Value: **4.000**
2nd Value: **1.000**
Value Percent:
Continuous Index:
Within 8" of Joint:
Remarks:

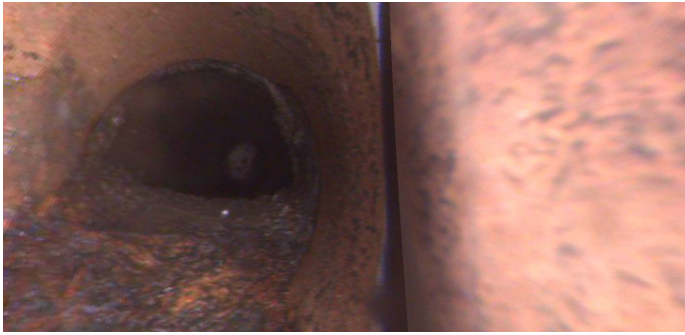
Code: **TFD**
Description: **Tap Factory Defective**

Distance (ft): **166.1**
Structural Grade: **0**
O&M Grade: **2**
Clock Start/From: **10**
Clock To:
1st Value: **4.000**
2nd Value:
Value Percent:
Continuous Index:
Within 8" of Joint: **YES**
Remarks: **partially blocked by deposits**

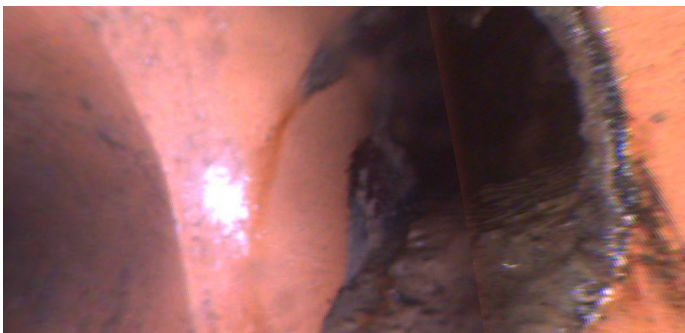
Code: **TFD**
Description: **Tap Factory Defective**

Distance (ft): **168.6**
Structural Grade: **0**
O&M Grade: **2**
Clock Start/From: **2**
Clock To:
1st Value: **4.000**
2nd Value:
Value Percent:
Continuous Index:
Within 8" of Joint: **YES**
Remarks: **partially blocked**

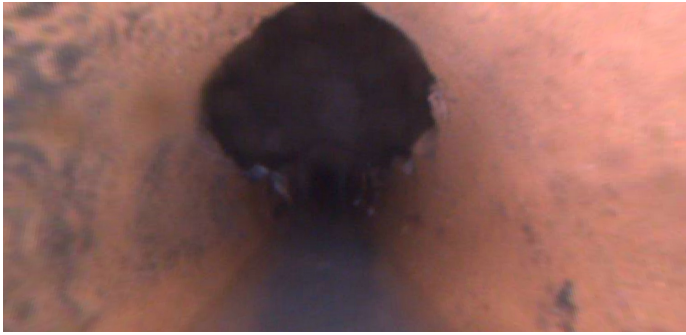
Code: **DAE**
Description: **Deposits Attached Encrustation**

Distance (ft): **174.7**
Structural Grade: **0**
O&M Grade: **2**
Clock Start/From: **7**
Clock To: **5**
1st Value:
2nd Value:
Value Percent: **5.000**
Continuous Index: **F05**
Within 8" of Joint: **YES**
Remarks: **wandering**

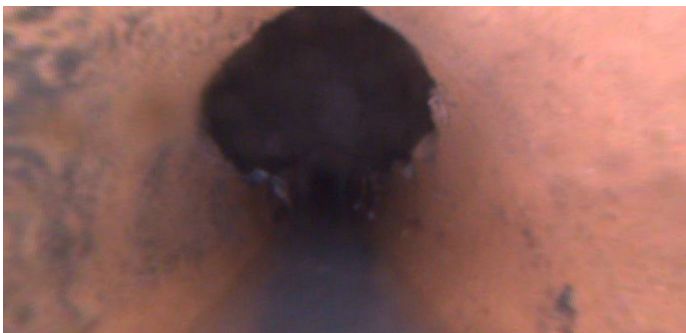
Code: **IS**
Description: **Infil Stain**

Distance (ft): **174.7**
Structural Grade: **0**
O&M Grade: **0**
Clock Start/From: **8**
Clock To: **4**
1st Value:
2nd Value:
Value Percent:
Continuous Index: **F03**
Within 8" of Joint: **YES**
Remarks: **wandering**

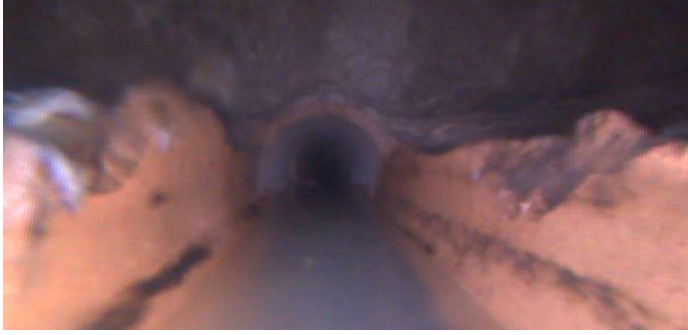
Code:	AMH
Description:	Manhole
Distance (ft):	177.0
Structural Grade:	0
O&M Grade:	0
Clock Start/From:	
Clock To:	
1st Value:	
2nd Value:	
Value Percent:	
Continuous Index:	
Within 8" of Joint:	NO
Remarks:	M-902-041
