Profile/Photo Observation Report

| Street: | ALLEY BETWEEN E 34TH AVE & E 34T | Flow Control: | Not Controlled |
| City: | Hobart, IN | Year Renewed: | |

| US MH: | M-902-043 | DS MH: | M-902-042 |

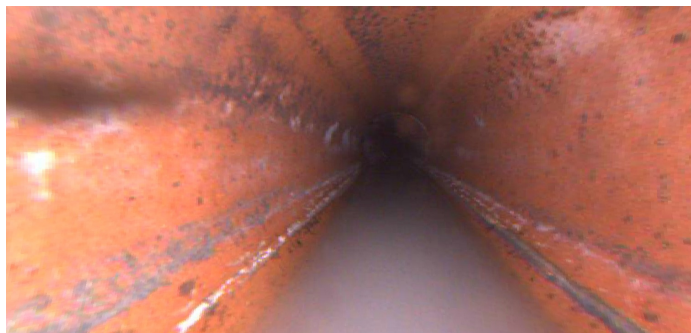
Code: **AMH**
Description: **Manhole**

Distance (ft): **.0**
Structural Grade: **0**
O&M Grade: **0**
Clock Start/From:
Clock To:
1st Value:
2nd Value:
Value Percent:
Continuous Index:
Within 8" of Joint: **NO**
Remarks: **M-902-042**

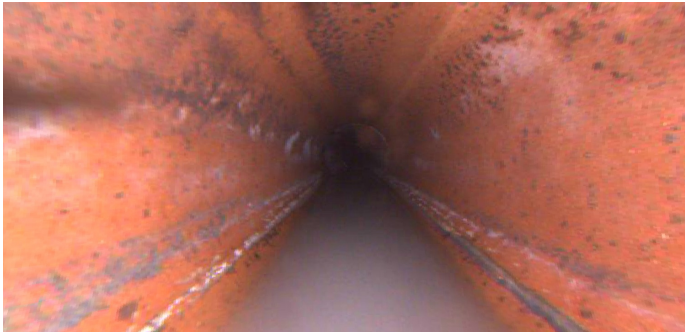
| Code: | MWL |
| Description: | Water Level |

| Value Percent: | 5.000 |

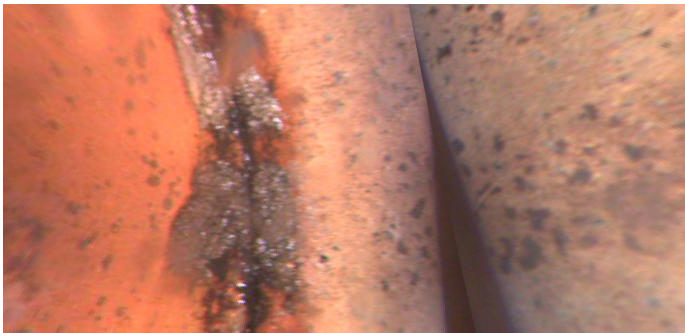
| Code: | DAZ |
| Description: | Deposits Attached Other |

| O&M Grade: | 2 |

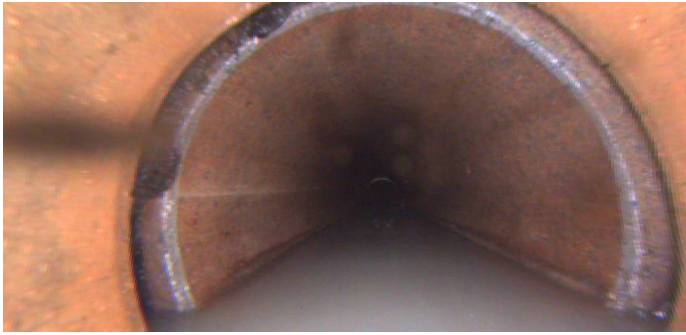
Code: **JSM**
Description: **Joint Separated Medium**

Distance (ft): **22.0**
Structural Grade: **1**
O&M Grade: **0**
Clock Start/From:
Clock To:
1st Value:
2nd Value:
Value Percent:
Continuous Index:
Within 8" of Joint: **NO**
Remarks:

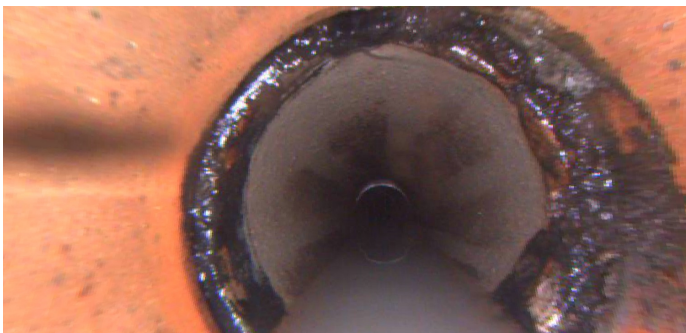
Code: **DAE**
Description: **Deposits Attached Encrustation**

Distance (ft): **25.0**
Structural Grade: **0**
O&M Grade: **2**
Clock Start/From: **7**
Clock To: **5**
1st Value:
2nd Value:
Value Percent: **5.000**
Continuous Index:
Within 8" of Joint: **YES**
Remarks:

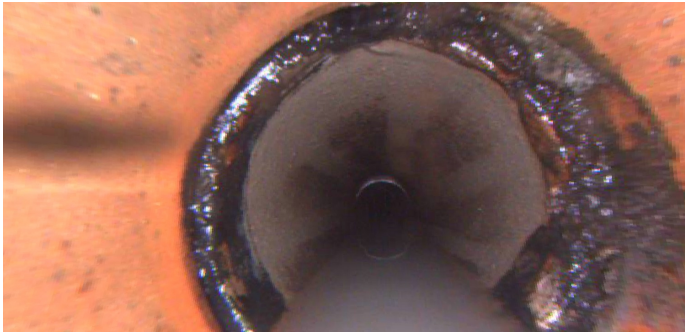
Code: **IS**
Description: **Infil Stain**

Distance (ft): **25.0**
Structural Grade: **0**
O&M Grade: **0**
Clock Start/From: **7**
Clock To: **5**
1st Value:
2nd Value:
Value Percent:
Continuous Index:
Within 8" of Joint: **YES**
Remarks:

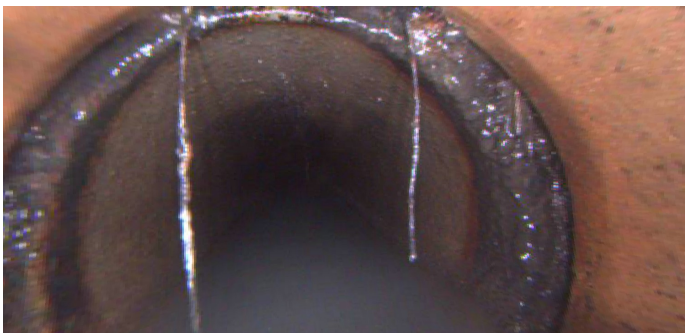
Code: **IW**
Description: **Infil Weeper**

Distance (ft): **31.4**
Structural Grade: **0**
O&M Grade: **2**
Clock Start/From: **7**
Clock To: **5**
1st Value:
2nd Value:
Value Percent:
Continuous Index:
Within 8" of Joint: **YES**
Remarks:

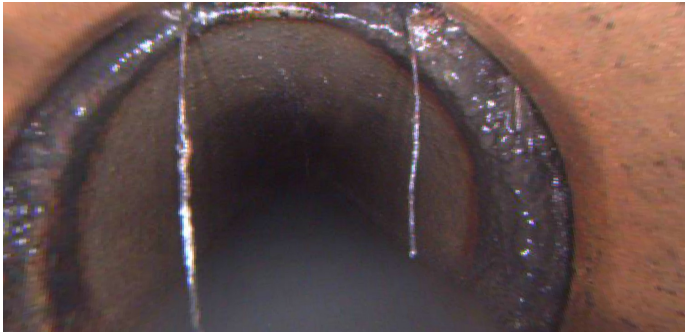
Code: **RFJ**
Description: **Roots Fine Joint**

Distance (ft): **31.4**
Structural Grade: **0**
O&M Grade: **1**
Clock Start/From: **11**
Clock To: **1**
1st Value:
2nd Value:
Value Percent:
Continuous Index:
Within 8" of Joint: **YES**
Remarks:

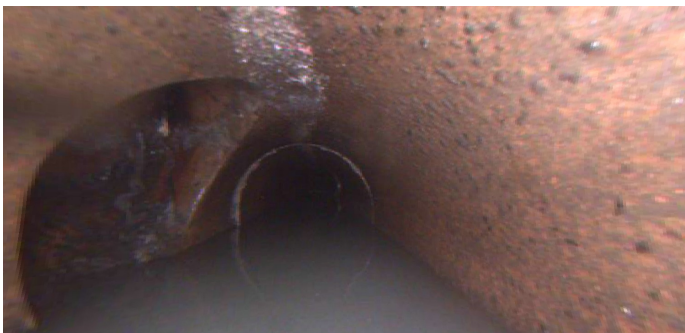
Code: **TF**
Description: **Tap Factory**

Distance (ft): **39.7**
Structural Grade: **0**
O&M Grade: **0**
Clock Start/From: **10**
Clock To:
1st Value: **4.000**
2nd Value:
Value Percent:
Continuous Index:
Within 8" of Joint: **YES**
Remarks:

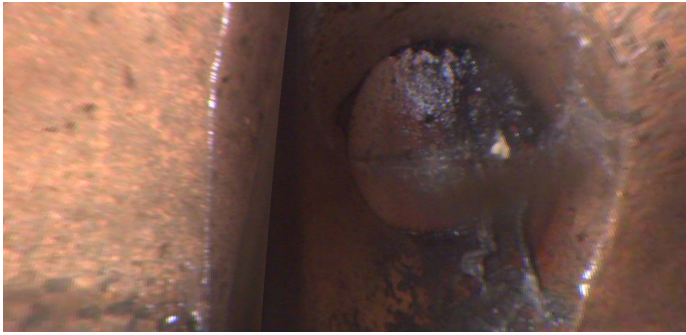
Code: **TFC**
Description: **Tap Factory Capped**

Distance (ft): **40.2**
Structural Grade: **0**
O&M Grade: **0**
Clock Start/From: **10**
Clock To:
1st Value: **4.000**
2nd Value:
Value Percent:
Continuous Index:
Within 8" of Joint:
Remarks:

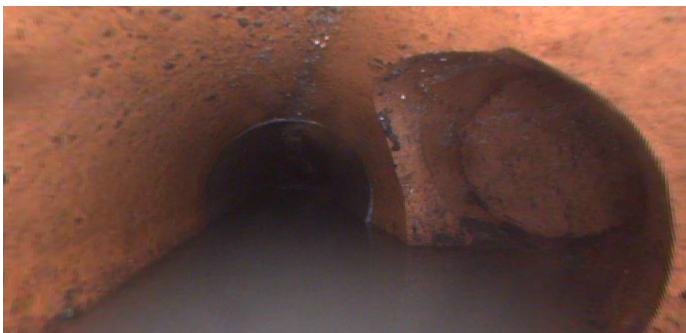
Code: **TFC**
Description: **Tap Factory Capped**

Distance (ft): **43.0**
Structural Grade: **0**
O&M Grade: **0**
Clock Start/From: **2**
Clock To:
1st Value: **4.000**
2nd Value:
Value Percent:
Continuous Index:
Within 8" of Joint: **YES**
Remarks:

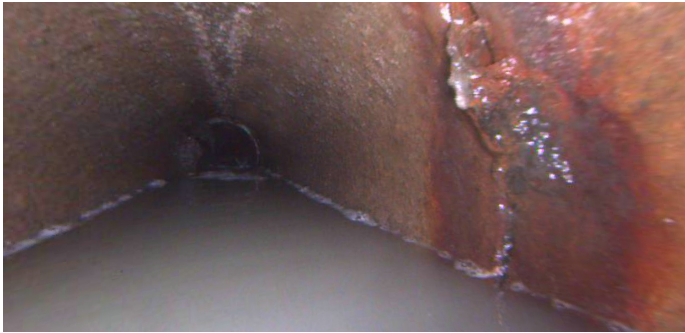
Code: **IW**
Description: **Infil Weeper**

Distance (ft): **47.1**
Structural Grade: **0**
O&M Grade: **2**
Clock Start/From: **1**
Clock To: **4**
1st Value:
2nd Value:
Value Percent:
Continuous Index:
Within 8" of Joint: **YES**
Remarks:

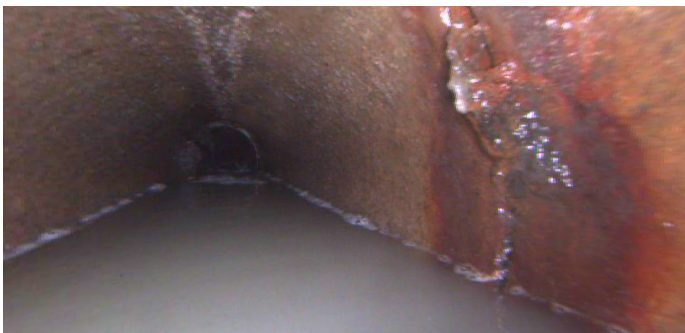
Code: **DAE**
Description: **Deposits Attached Encrustation**

Distance (ft): **47.1**
Structural Grade: **0**
O&M Grade: **2**
Clock Start/From: **3**
Clock To:
1st Value:
2nd Value:
Value Percent: **5.000**
Continuous Index:
Within 8" of Joint: **YES**
Remarks:

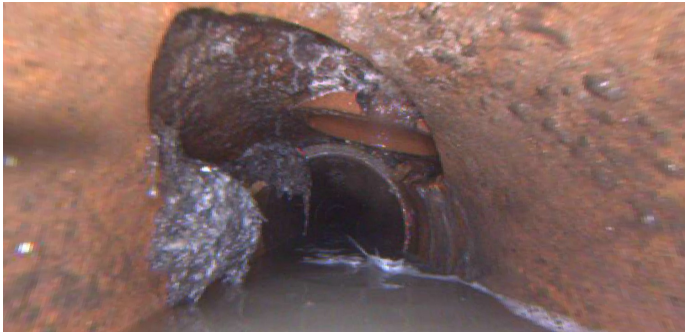
Code: **RPP**
Description: **Repair Patch**

Distance (ft): **49.2**
Structural Grade: **0**
O&M Grade: **0**
Clock Start/From: **10**
Clock To: **2**
1st Value:
2nd Value:
Value Percent:
Continuous Index:
Within 8" of Joint: **NO**
Remarks: **UNKNOWN REPAIR MATERIAL
PATCH; RF COMING FROM PATCH**

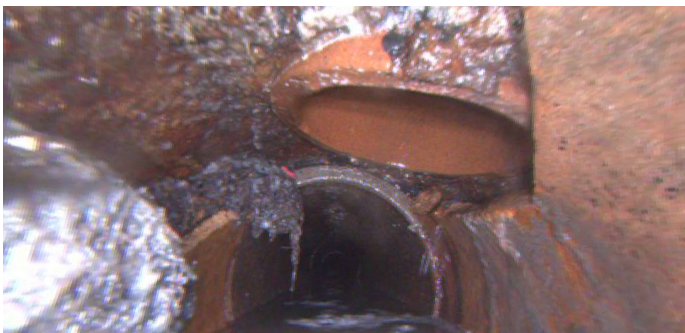
Code: **TB**
Description: **Tap Break-in**

Distance (ft): **49.5**
Structural Grade: **0**
O&M Grade: **0**
Clock Start/From: **1**
Clock To:
1st Value: **4.000**
2nd Value:
Value Percent:
Continuous Index:
Within 8" of Joint:
Remarks:

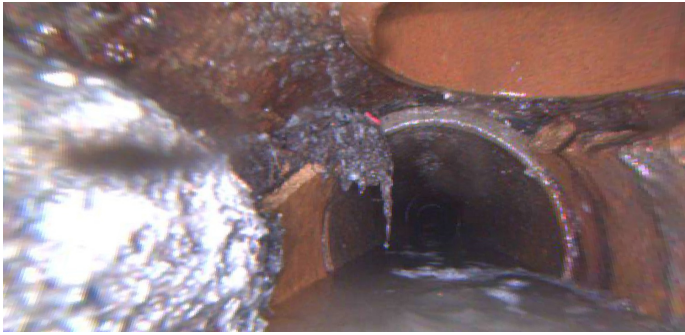
Code: **RMB**
Description: **Roots Medium Barrel**

Distance (ft): **49.6**
Structural Grade: **0**
O&M Grade: **4**
Clock Start/From: **8**
Clock To: **11**
1st Value:
2nd Value:
Value Percent: **10.000**
Continuous Index:
Within 8" of Joint: **NO**
Remarks:

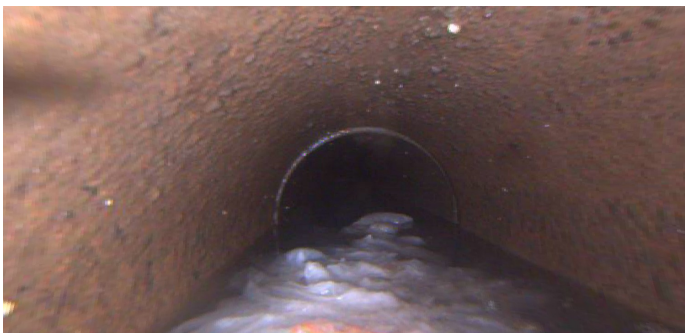
Code: **DSZ**
Description: **Deposits Settled Other**

Distance (ft): **58.7**
Structural Grade: **0**
O&M Grade: **2**
Clock Start/From: **6**
Clock To:
1st Value:
2nd Value:
Value Percent: **5.000**
Continuous Index:
Within 8" of Joint: **NO**
Remarks: **tissue**

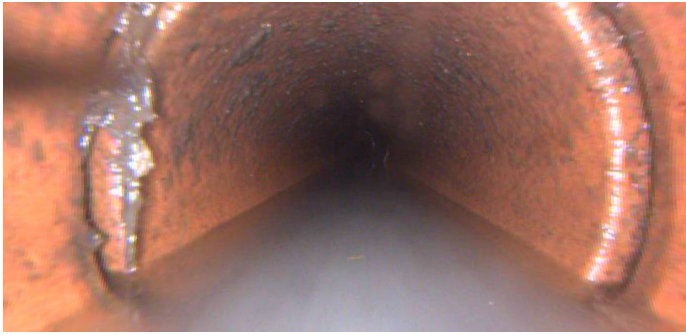
Code: **RFJ**
Description: **Roots Fine Joint**

Distance (ft): **84.3**
Structural Grade: **0**
O&M Grade: **1**
Clock Start/From: **9**
Clock To:
1st Value:
2nd Value:
Value Percent:
Continuous Index:
Within 8" of Joint: **YES**
Remarks:

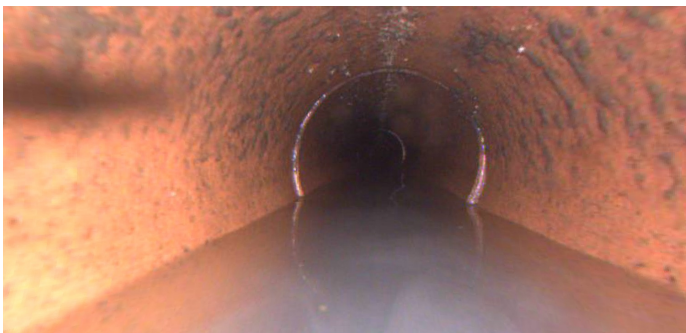
Code: **MGP**
Description: **General Photo**

Distance (ft): **86.7**
Structural Grade: **0**
O&M Grade: **0**
Clock Start/From:
Clock To:
1st Value:
2nd Value:
Value Percent:
Continuous Index:
Within 8" of Joint: **NO**
Remarks:

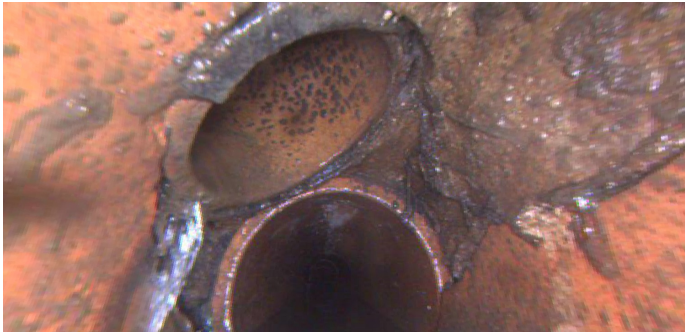
Code: **TBA**
Description: **Tap Break-in Active**

Distance (ft): **96.1**
Structural Grade: **0**
O&M Grade: **0**
Clock Start/From: **11**
Clock To:
1st Value: **4.000**
2nd Value:
Value Percent:
Continuous Index:
Within 8" of Joint:
Remarks:

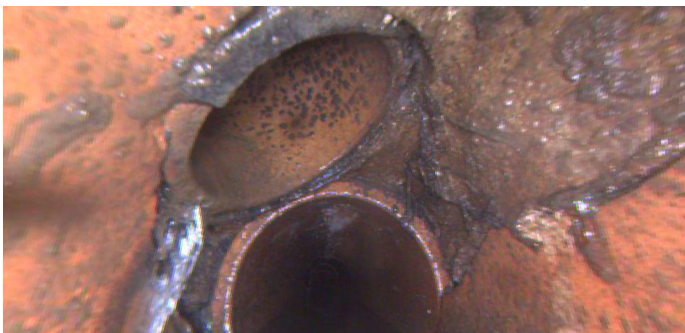
Code: **RPP**
Description: **Repair Patch**

Distance (ft): **96.1**
Structural Grade: **0**
O&M Grade: **0**
Clock Start/From: **12**
Clock To: **2**
1st Value:
2nd Value:
Value Percent:
Continuous Index:
Within 8" of Joint: **NO**
Remarks: **UNKNOWN PATCH MATERIAL**

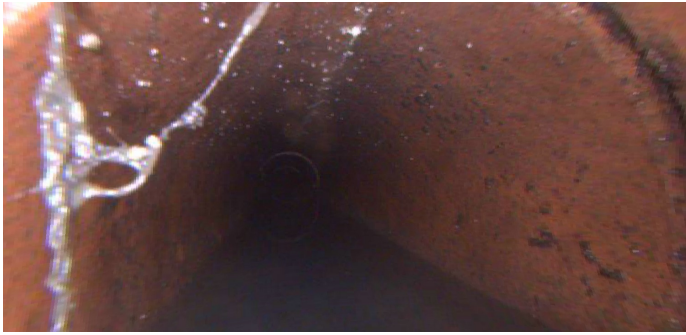
Code: **RFJ**
Description: **Roots Fine Joint**

Distance (ft): **100.1**
Structural Grade: **0**
O&M Grade: **1**
Clock Start/From: **10**
Clock To: **12**
1st Value:
2nd Value:
Value Percent:
Continuous Index: **S01**
Within 8" of Joint: **YES**
Remarks:

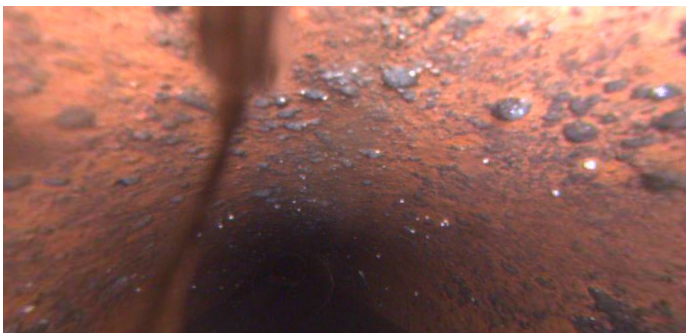
Code: **RFJ**
Description: **Roots Fine Joint**

Distance (ft): **107.6**
Structural Grade: **0**
O&M Grade: **1**
Clock Start/From: **10**
Clock To: **12**
1st Value:
2nd Value:
Value Percent:
Continuous Index: **F01**
Within 8" of Joint: **YES**
Remarks:

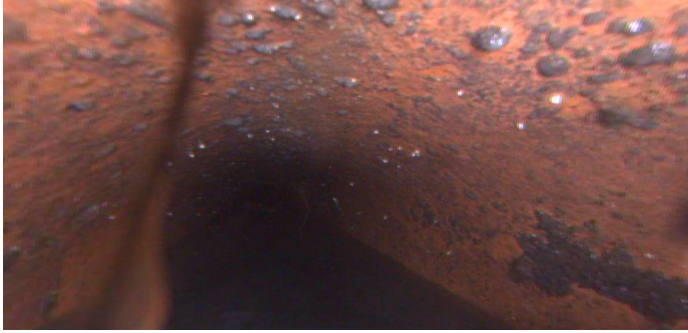
| Code: | MSA |
| Description: | Abandoned Survey |
| Remarks: | stuck on wall |
