Profile/Photo Observation Report

Street:	e 34th st	Flow Control:	Not Controlled
City:	Hobart, IN	Year Renewed:	
Location:	Other	Tape/Media #:	
Purpose:	Not Known	Dia/Height:	10"
Use:	Sanitary	Material:	VCP
Drain Area:	NA	Lining:	
Category:	NA		
Comment:

Location Details:		Direction of Survey:	Upstream
US MH:	M-902-043	DS MH:	M-902-042
		Total Length Surveyed (ft):	107.6

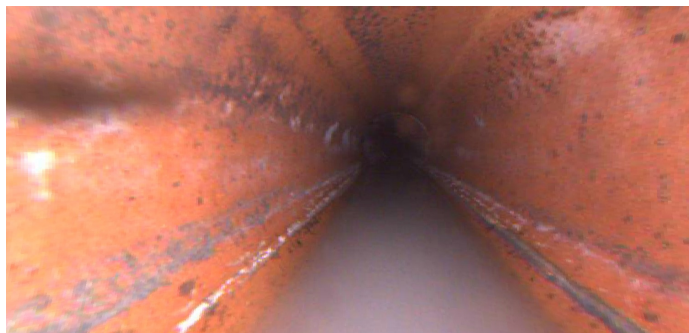
Code: **AMH**
Description: **Manhole**

Distance (ft): **.0**
Structural Grade: **0**
O&M Grade: **0**
Clock Start/From:
Clock To:
1st Value:
2nd Value:
Value Percent:
Continuous Index:
Within 8" of Joint: **NO**
Remarks: **M-902-042**

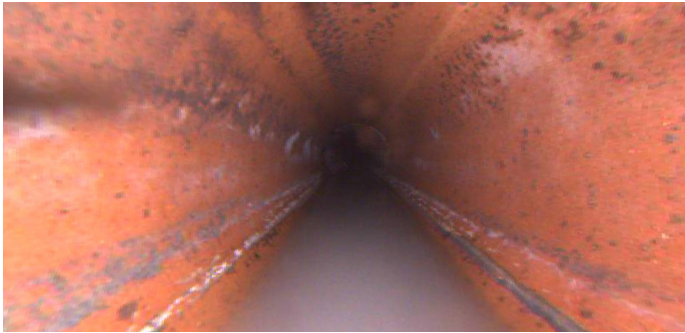
Code:	MWL
Description:	Water Level

Distance (ft):	.0
Structural Grade:	0
O&M Grade:	0
Clock Start/From:	
Clock To:	
1st Value:	
2nd Value:	
Value Percent:	5.000
Continuous Index:	
Within 8" of Joint:	NO
Remarks:

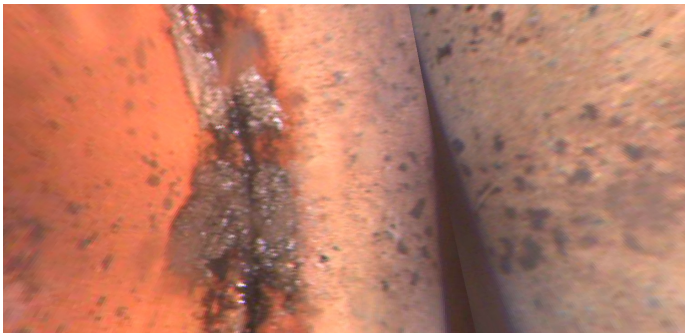
Code:	DAZ
Description:	Deposits Attached Other

Distance (ft):	4.1
Structural Grade:	0
O&M Grade:	2
Clock Start/From:	7
Clock To:	5
1st Value:	
2nd Value:	
Value Percent:	5.000
Continuous Index:	
Within 8" of Joint:	YES
Remarks:

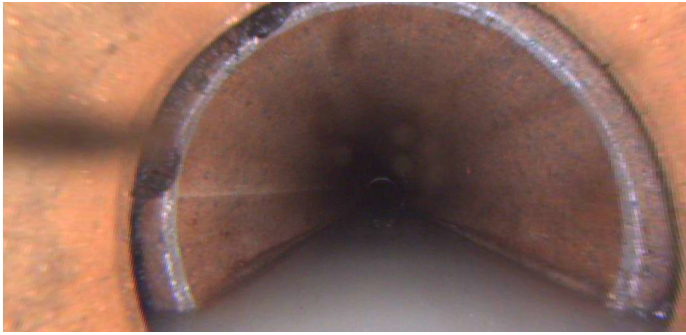
Code: **JSM**
Description: **Joint Separated Medium**

Distance (ft): **22.0**
Structural Grade: **1**
O&M Grade: **0**
Clock Start/From:
Clock To:
1st Value:
2nd Value:
Value Percent:
Continuous Index:
Within 8" of Joint: **NO**
Remarks:

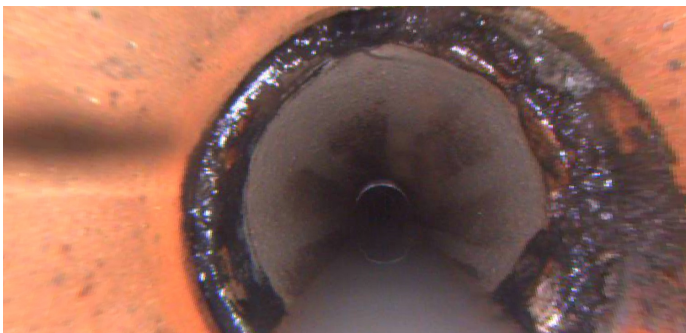
Code: **DAE**
Description: **Deposits Attached Encrustation**

Distance (ft): **25.0**
Structural Grade: **0**
O&M Grade: **2**
Clock Start/From: **7**
Clock To: **5**
1st Value:
2nd Value:
Value Percent: **5.000**
Continuous Index:
Within 8" of Joint: **YES**
Remarks:

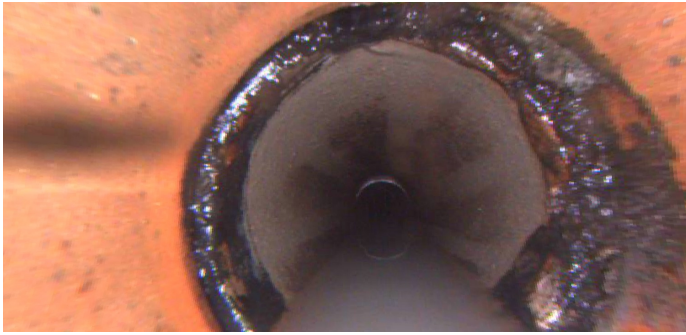
Code: **IS**
Description: **Infil Stain**

Distance (ft): **25.0**
Structural Grade: **0**
O&M Grade: **0**
Clock Start/From: **7**
Clock To: **5**
1st Value:
2nd Value:
Value Percent:
Continuous Index:
Within 8" of Joint: **YES**
Remarks:

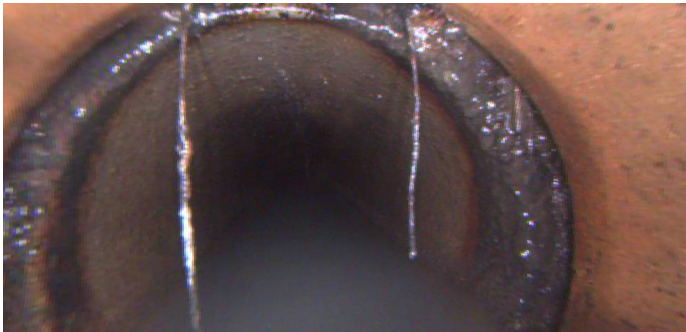
Code: **IW**
Description: **Infil Weeper**

Distance (ft): **31.4**
Structural Grade: **0**
O&M Grade: **2**
Clock Start/From: **7**
Clock To: **5**
1st Value:
2nd Value:
Value Percent:
Continuous Index:
Within 8" of Joint: **YES**
Remarks:

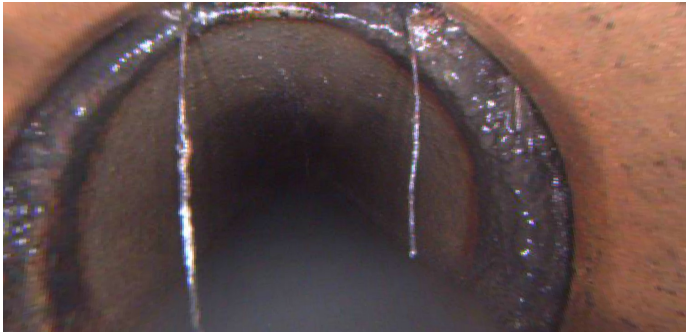
Code: **RFJ**
Description: **Roots Fine Joint**

Distance (ft): **31.4**
Structural Grade: **0**
O&M Grade: **1**
Clock Start/From: **11**
Clock To: **1**
1st Value:
2nd Value:
Value Percent:
Continuous Index:
Within 8" of Joint: **YES**
Remarks:

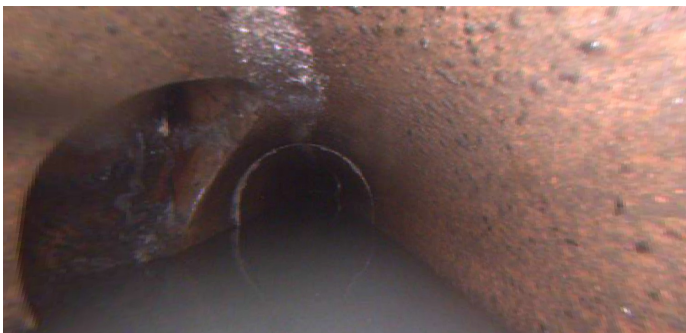
Code: **TF**
Description: **Tap Factory**

Distance (ft): **39.7**
Structural Grade: **0**
O&M Grade: **0**
Clock Start/From: **10**
Clock To:
1st Value: **4.000**
2nd Value:
Value Percent:
Continuous Index:
Within 8" of Joint: **YES**
Remarks:

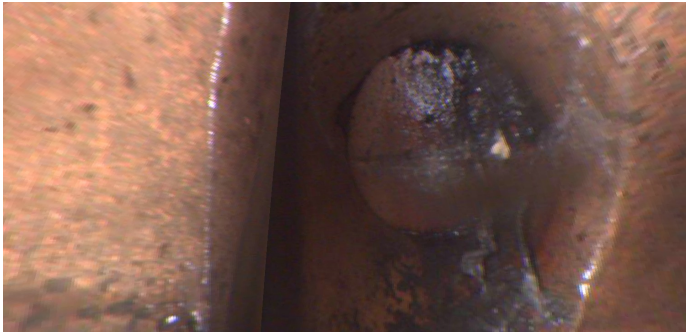
Code: **TFC**
Description: **Tap Factory Capped**

Distance (ft): **40.2**
Structural Grade: **0**
O&M Grade: **0**
Clock Start/From: **10**
Clock To:
1st Value: **4.000**
2nd Value:
Value Percent:
Continuous Index:
Within 8" of Joint:
Remarks:

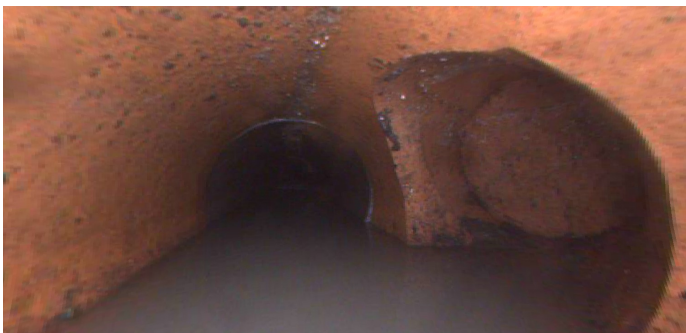
Code: **TFC**
Description: **Tap Factory Capped**

Distance (ft): **43.0**
Structural Grade: **0**
O&M Grade: **0**
Clock Start/From: **2**
Clock To:
1st Value: **4.000**
2nd Value:
Value Percent:
Continuous Index:
Within 8" of Joint: **YES**
Remarks:

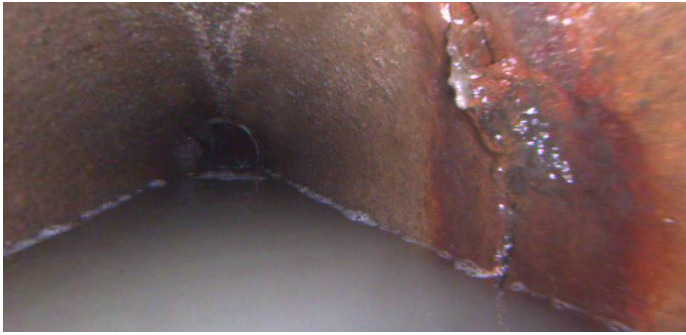
Code: **IW**
Description: **Infil Weeper**

Distance (ft): **47.1**
Structural Grade: **0**
O&M Grade: **2**
Clock Start/From: **1**
Clock To: **4**
1st Value:
2nd Value:
Value Percent:
Continuous Index:
Within 8" of Joint: **YES**
Remarks:

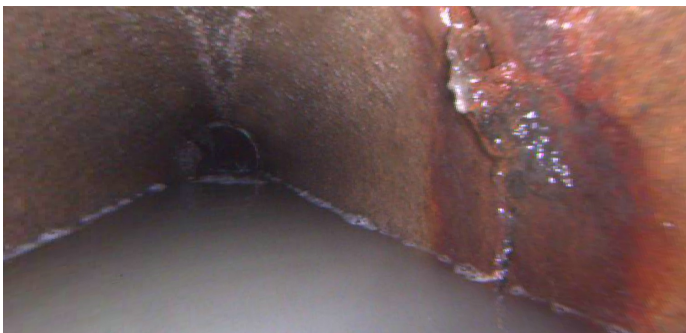
Code: **DAE**
Description: **Deposits Attached Encrustation**

Distance (ft): **47.1**
Structural Grade: **0**
O&M Grade: **2**
Clock Start/From: **3**
Clock To:
1st Value:
2nd Value:
Value Percent: **5.000**
Continuous Index:
Within 8" of Joint: **YES**
Remarks:

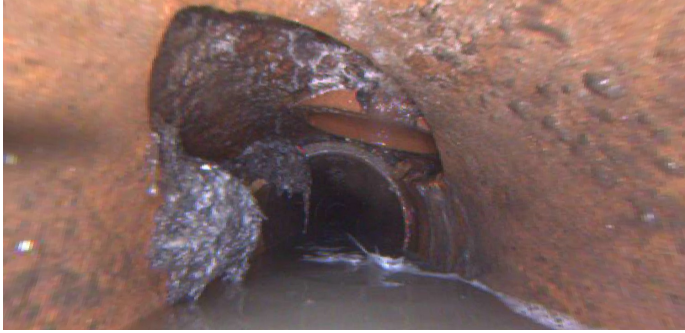
Code: **RPP**
Description: **Repair Patch**

Distance (ft): **49.2**
Structural Grade: **0**
O&M Grade: **0**
Clock Start/From: **10**
Clock To: **2**
1st Value:
2nd Value:
Value Percent:
Continuous Index:
Within 8" of Joint: **NO**
Remarks: **UNKNOWN REPAIR MATERIAL
PATCH; RF COMING FROM PATCH**

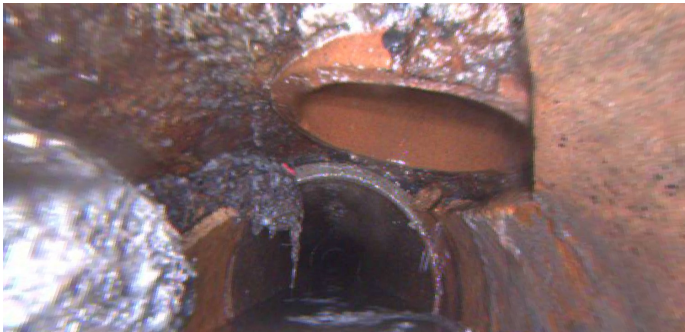
Code: **TB**
Description: **Tap Break-in**

Distance (ft): **49.5**
Structural Grade: **0**
O&M Grade: **0**
Clock Start/From: **1**
Clock To:
1st Value: **4.000**
2nd Value:
Value Percent:
Continuous Index:
Within 8" of Joint:
Remarks:

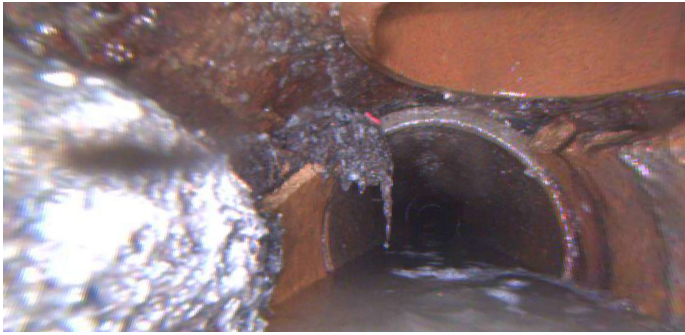
Code: **RMB**
Description: **Roots Medium Barrel**

Distance (ft): **49.6**
Structural Grade: **0**
O&M Grade: **4**
Clock Start/From: **8**
Clock To: **11**
1st Value:
2nd Value:
Value Percent: **10.000**
Continuous Index:
Within 8" of Joint: **NO**
Remarks:

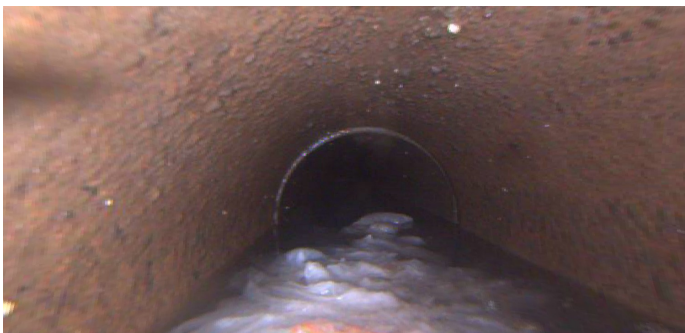
Code: **DSZ**
Description: **Deposits Settled Other**

Distance (ft): **58.7**
Structural Grade: **0**
O&M Grade: **2**
Clock Start/From: **6**
Clock To:
1st Value:
2nd Value:
Value Percent: **5.000**
Continuous Index:
Within 8" of Joint: **NO**
Remarks: **tissue**

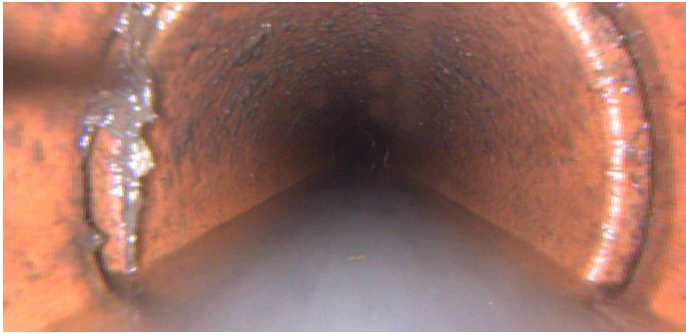
Code: **RFJ**
Description: **Roots Fine Joint**

Distance (ft): **84.3**
Structural Grade: **0**
O&M Grade: **1**
Clock Start/From: **9**
Clock To:
1st Value:
2nd Value:
Value Percent:
Continuous Index:
Within 8" of Joint: **YES**
Remarks:

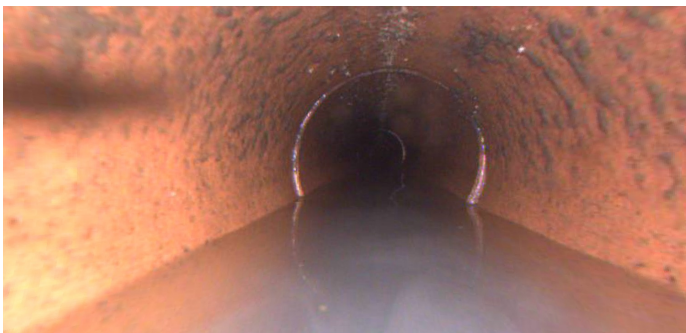
Code: **MGP**
Description: **General Photo**

Distance (ft): **86.7**
Structural Grade: **0**
O&M Grade: **0**
Clock Start/From:
Clock To:
1st Value:
2nd Value:
Value Percent:
Continuous Index:
Within 8" of Joint: **NO**
Remarks:

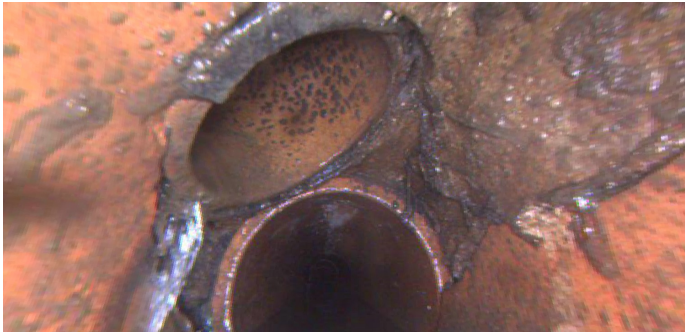
Code: **TBA**
Description: **Tap Break-in Active**

Distance (ft): **96.1**
Structural Grade: **0**
O&M Grade: **0**
Clock Start/From: **11**
Clock To:
1st Value: **4.000**
2nd Value:
Value Percent:
Continuous Index:
Within 8" of Joint:
Remarks:

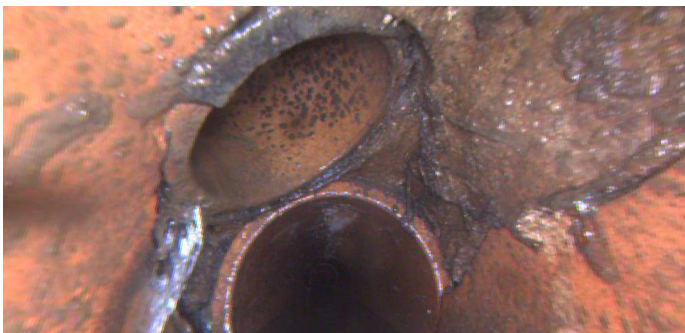
Code: **RPP**
Description: **Repair Patch**

Distance (ft): **96.1**
Structural Grade: **0**
O&M Grade: **0**
Clock Start/From: **12**
Clock To: **2**
1st Value:
2nd Value:
Value Percent:
Continuous Index:
Within 8" of Joint: **NO**
Remarks: **UNKNOWN PATCH MATERIAL**

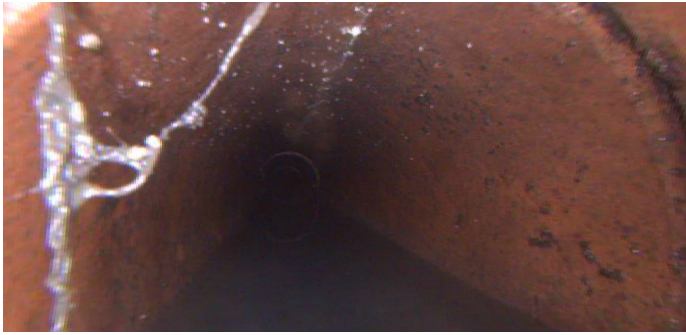
Code: **RFJ**
Description: **Roots Fine Joint**

Distance (ft): **100.1**
Structural Grade: **0**
O&M Grade: **1**
Clock Start/From: **10**
Clock To: **12**
1st Value:
2nd Value:
Value Percent:
Continuous Index: **S01**
Within 8" of Joint: **YES**
Remarks:

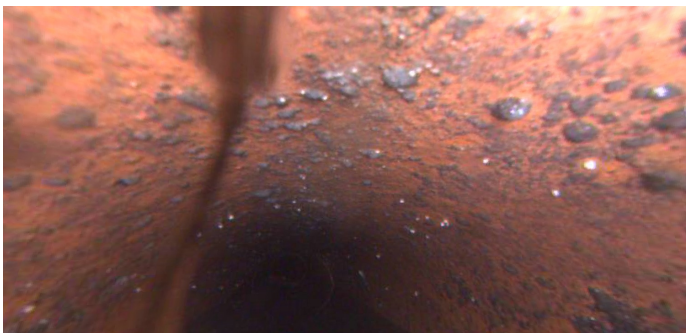
Code: **RFJ**
Description: **Roots Fine Joint**

Distance (ft): **107.6**
Structural Grade: **0**
O&M Grade: **1**
Clock Start/From: **10**
Clock To: **12**
1st Value:
2nd Value:
Value Percent:
Continuous Index: **F01**
Within 8" of Joint: **YES**
Remarks:

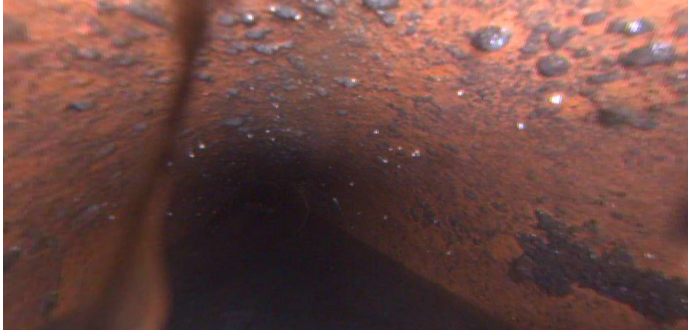
Code:	MSA
Description:	Abandoned Survey
Distance (ft):	107.6
Structural Grade:	0
O&M Grade:	0
Clock Start/From:	
Clock To:	
1st Value:	
2nd Value:	
Value Percent:	
Continuous Index:	
Within 8" of Joint:	NO
Remarks:	stuck on wall
