Profile/Photo Observation Report

Street:	randolph pl	Flow Control:	Not Controlled
City:	Hobart, IN	Year Renewed:	
Location:	Other	Tape/Media #:	
Purpose:	Not Known	Dia/Height:	10"
Use:	Sanitary	Material:	VCP
Drain Area:	NA	Lining:	
Category:	NA		
Comment:	null-cnl

Location Details:		Direction of Survey:	Downstream
US MH:	M-902-044	DS MH:	M-902-038
		Total Length Surveyed (ft):	2.2

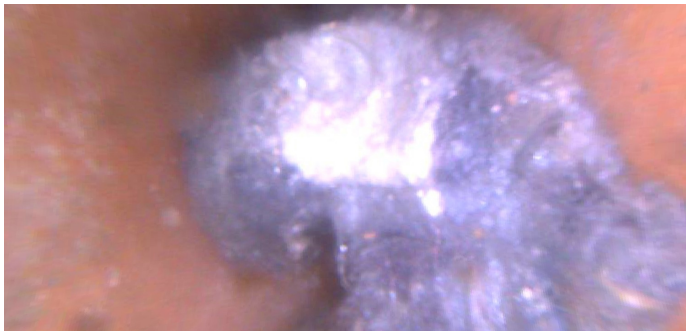
Code: **AMH**
Description: **Manhole**

Distance (ft): **.0**
Structural Grade: **0**
O&M Grade: **0**
Clock Start/From:
Clock To:
1st Value:
2nd Value:
Value Percent:
Continuous Index:
Within 8" of Joint: **NO**
Remarks: **M-902-044**

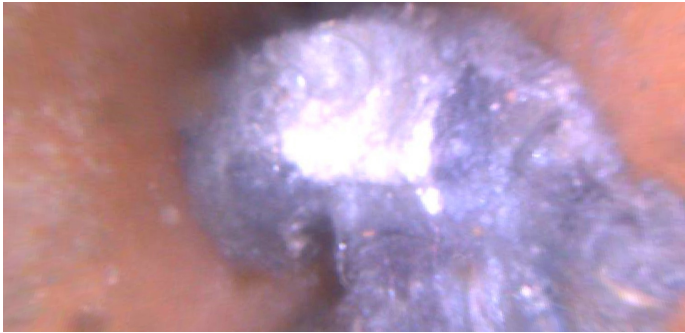
Code:	MWL
Description:	Water Level

Distance (ft):	.0
Structural Grade:	0
O&M Grade:	0
Clock Start/From:	
Clock To:	
1st Value:	
2nd Value:	
Value Percent:	0.000
Continuous Index:	
Within 8" of Joint:	NO
Remarks:

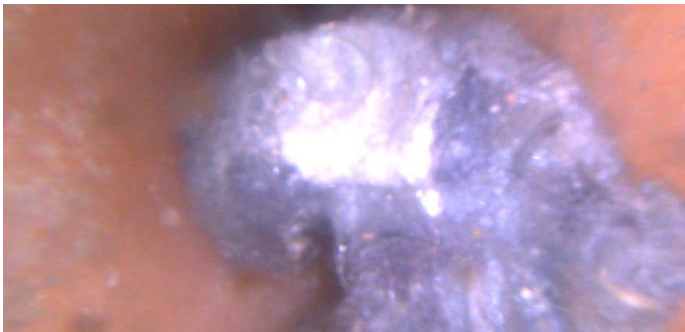
Code:	RBB
Description:	Roots Ball Barrel

Distance (ft):	.0
Structural Grade:	0
O&M Grade:	5
Clock Start/From:	12
Clock To:	12
1st Value:	
2nd Value:	
Value Percent:	80.000
Continuous Index:	
Within 8" of Joint:	NO
Remarks:
