## Profile/Photo Observation Report

Street:	<b>SAINT JOSEPH PL</b>	Flow Control:	<b>Not Controlled</b>
City:	<b>Hobart, IN</b>	Year Renewed:	
Location:	<b>Other</b>	Tape/Media #:	
Purpose:	<b>Not Known</b>	Dia/Height:	<b>10"</b>
Use:	<b>Sanitary</b>	Material:	<b>PVC</b>
Drain Area:	<b>NA</b>	Lining:	
Category:	<b>NA</b>		
Comment:

Location Details:		Direction of Survey:	<b>Upstream</b>
US MH:	<b>M-902-045</b>	DS MH:	<b>M-902-078</b>
		Total Length Surveyed (ft):	<b>82.7</b>

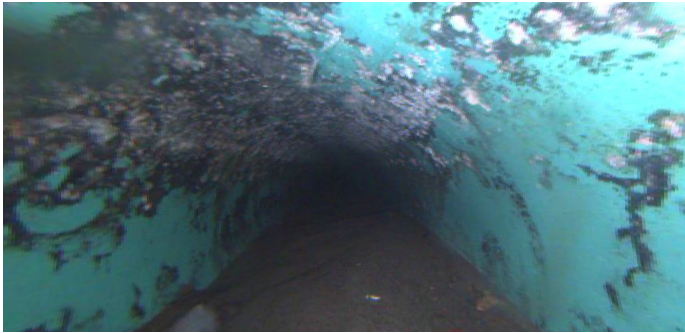
Code:	<b>AMH</b>
Description:	<b>Manhole</b>

Distance (ft):	<b>.0</b>
Structural Grade:	<b>0</b>
O&M Grade:	<b>0</b>
Clock Start/From:	
Clock To:	
1st Value:	
2nd Value:	
Value Percent:	
Continuous Index:	
Within 8" of Joint:	<b>NO</b>
Remarks:	<b>M-902-078</b>

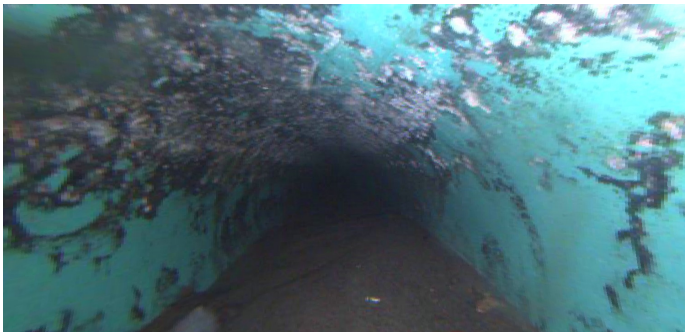
Code:	<b>MWL</b>
Description:	<b>Water Level</b>

Distance (ft):	<b>.0</b>
Structural Grade:	<b>0</b>
O&M Grade:	<b>0</b>
Clock Start/From:	
Clock To:	
1st Value:	
2nd Value:	
Value Percent:	<b>0.000</b>
Continuous Index:	
Within 8" of Joint:	<b>NO</b>
Remarks:

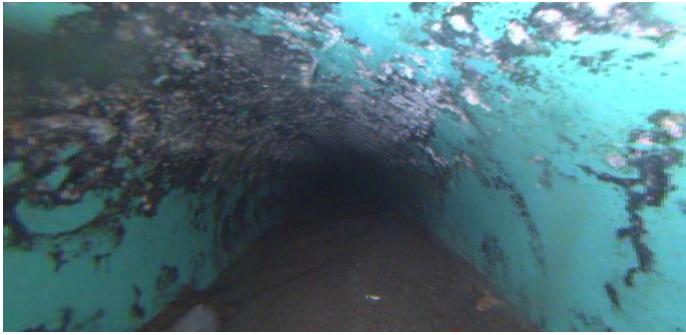
Code: **DAGS**  
Description: **Deposits Attached Grease**

Distance (ft): **.0**  
Structural Grade: **0**  
O&M Grade: **2**  
Clock Start/From: **7**  
Clock To: **5**  
1st Value:  
2nd Value:  
Value Percent: **5.000**  
Continuous Index: **S01**  
Within 8" of Joint: **NO**  
Remarks:

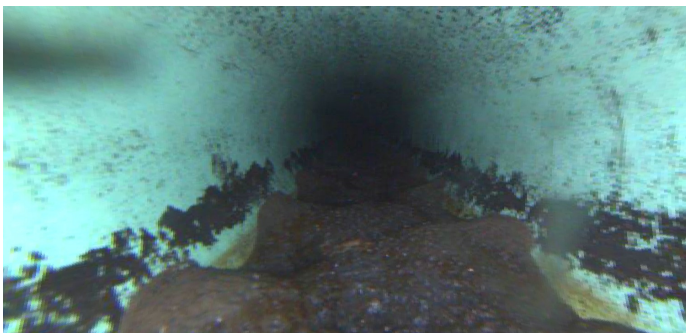
Code: **DAGS**  
Description: **Deposits Attached Grease**

Distance (ft): **30.5**  
Structural Grade: **0**  
O&M Grade: **2**  
Clock Start/From: **7**  
Clock To: **5**  
1st Value:  
2nd Value:  
Value Percent: **5.000**  
Continuous Index: **F01**  
Within 8" of Joint: **NO**  
Remarks:

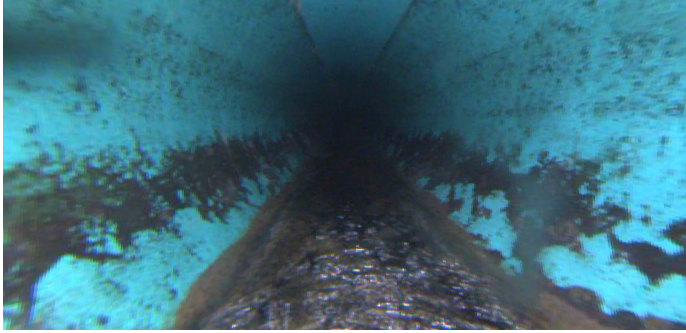
Code: **MWL**  
Description: **Water Level**

Distance (ft): **42.9**  
Structural Grade: **0**  
O&M Grade: **0**  
Clock Start/From:  
Clock To:  
1st Value:  
2nd Value:  
Value Percent: **5.000**  
Continuous Index:  
Within 8" of Joint: **NO**  
Remarks:

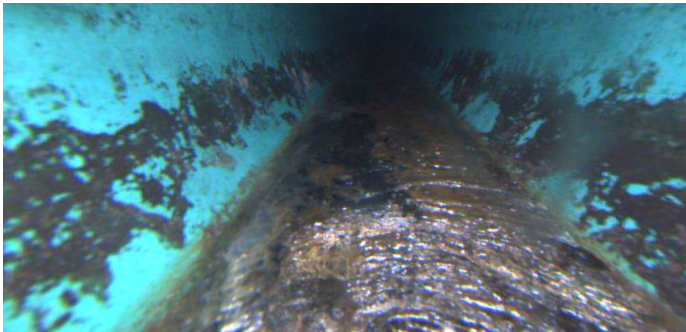
Code: **DSF**  
Description: **Deposits Settled Fine**

Distance (ft): **44.3**  
Structural Grade: **0**  
O&M Grade: **3**  
Clock Start/From: **4**  
Clock To: **8**  
1st Value:  
2nd Value:  
Value Percent: **20.000**  
Continuous Index: **F02**  
Within 8" of Joint: **NO**  
Remarks:

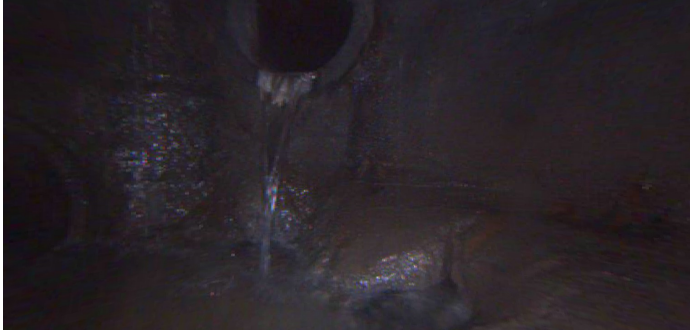
Code:	AMH
Description:	Manhole
Distance (ft):	82.7
Structural Grade:	0
O&M Grade:	0
Clock Start/From:	
Clock To:	
1st Value:	
2nd Value:	
Value Percent:	
Continuous Index:	
Within 8" of Joint:	NO
Remarks:	M-902-045
