Profile/Photo Observation Report

Date:	03/20/2018	Weather:		Coding:	PACP 6.0
Pipe Length (ft):	247.0	Owner:	NA	Pre Clean:	Not Known
P.O.#:		Surveyor:	John Kuglmaier	PSR:	P-902-056-046
Customer:		Clean Date:	01/01/1900	Shape:	C

Street:	N Hobart Rd	Flow Control:	Not Controlled
City:	Hobart, IN	Year Renewed:	
Location:	Main Highway - Suburban/Rural	Tape/Media #:	
Purpose:	Resurvey	Dia/Height:	12"
Use:	Sanitary	Material:	VCP
Drain Area:	NA	Lining:	
Category:	NA		
Comment:

Location Details:		Direction of Survey:	Upstream
US MH:	M-902-046	DS MH:	M-902-056
		Total Length Surveyed (ft):	55.2

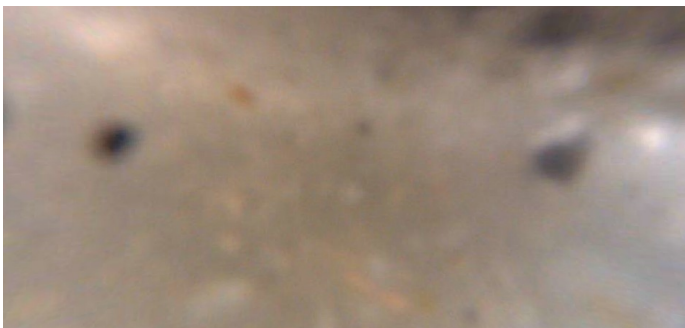
Code: **AMH**
Description: **Manhole**

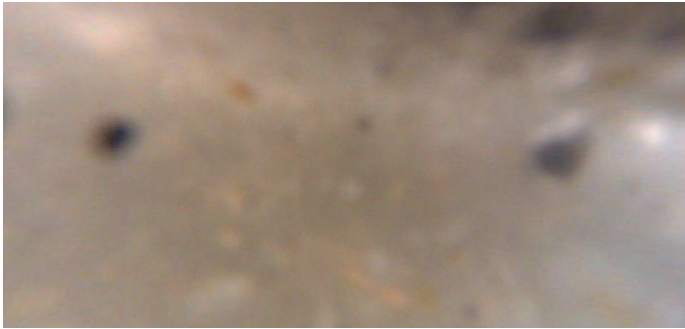
Code:	MWL
Description:	Water Level

Distance (ft):	.0
Structural Grade:	0
O&M Grade:	0
Clock Start/From:	
Clock To:	
1st Value:	
2nd Value:	
Value Percent:	50.000
Continuous Index:	
Within 8" of Joint:	NO
Remarks:

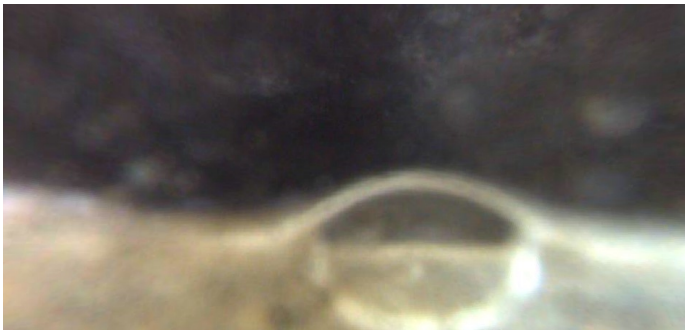
Code:	MGO
Description:	General Observation

Distance (ft):	2.2
Structural Grade:	0
O&M Grade:	0
Clock Start/From:	
Clock To:	
1st Value:	
2nd Value:	
Value Percent:	
Continuous Index:	
Within 8" of Joint:	NO
Remarks:	Switching to rear camera

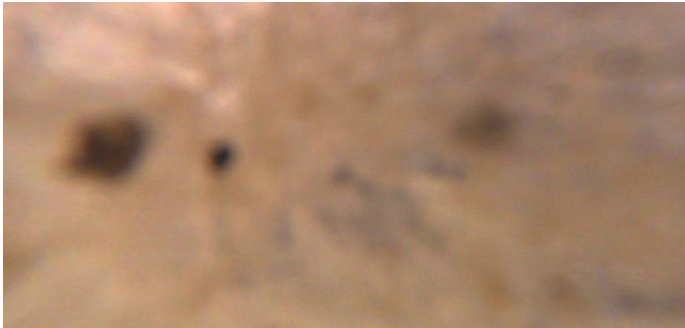
Code: **MGO**
Description: **General Observation**

Distance (ft): **3.2**
Structural Grade: **0**
O&M Grade: **0**
Clock Start/From:
Clock To:
1st Value:
2nd Value:
Value Percent:
Continuous Index:
Within 8" of Joint: **NO**
Remarks: **Switching to front camera**

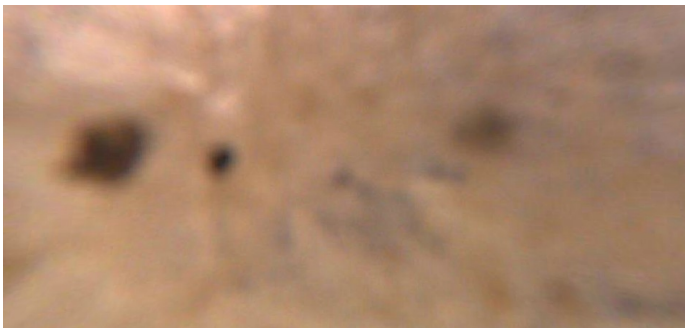
Code: **MCU**
Description: **Camera Underwater**

Distance (ft): **3.2**
Structural Grade: **0**
O&M Grade: **4**
Clock Start/From:
Clock To:
1st Value:
2nd Value:
Value Percent:
Continuous Index: **S01**
Within 8" of Joint: **NO**
Remarks:
