Profile/Photo Observation Report

Street:	N Hobart Rd	Flow Control:	Not Controlled
City:	Hobart, IN	Year Renewed:	
Location:	Main Highway - Suburban/Rural	Tape/Media #:	
Purpose:	Resurvey	Dia/Height:	12"
Use:	Sanitary	Material:	PVC
Drain Area:	NA	Lining:	
Category:	NA		
Comment:

Location Details:		Direction of Survey:	Downstream
US MH:	M-902-046	DS MH:	M-902-056
		Total Length Surveyed (ft):	8.6

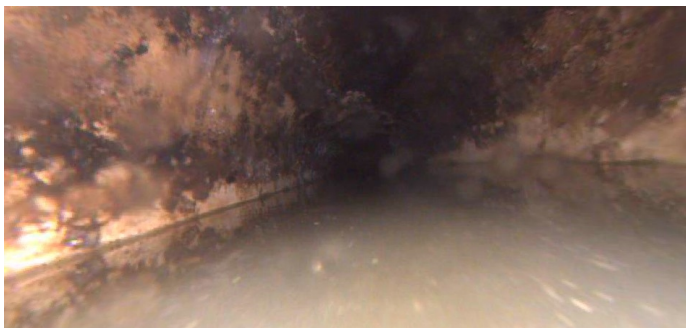
Code: **AMH**
Description: **Manhole**

Distance (ft): **.0**
Structural Grade: **0**
O&M Grade: **0**
Clock Start/From:
Clock To:
1st Value:
2nd Value:
Value Percent:
Continuous Index:
Within 8" of Joint: **NO**
Remarks: **M-902-046**

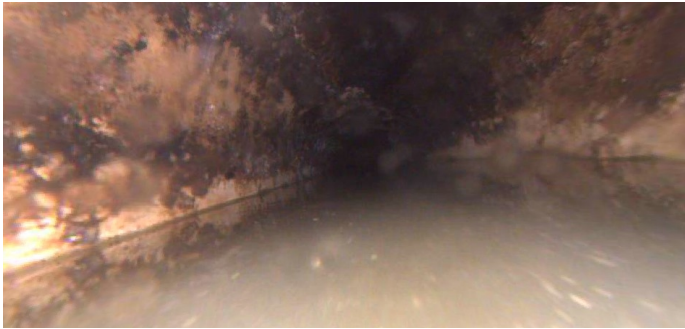
Code:	MWL
Description:	Water Level

Distance (ft):	.0
Structural Grade:	0
O&M Grade:	0
Clock Start/From:	
Clock To:	
1st Value:	
2nd Value:	
Value Percent:	30.000
Continuous Index:	
Within 8" of Joint:	NO
Remarks:

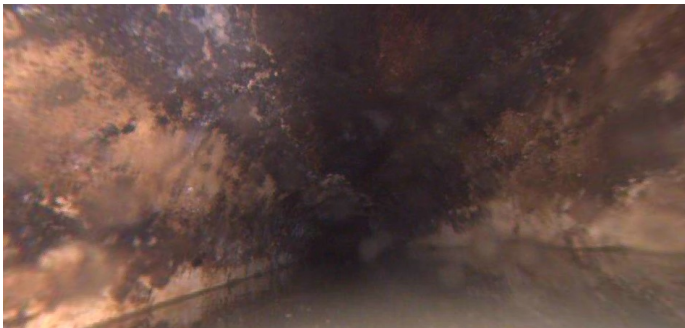
Code:	DAZ
Description:	Deposits Attached Other

Distance (ft):	.0
Structural Grade:	0
O&M Grade:	2
Clock Start/From:	9
Clock To:	3
1st Value:	
2nd Value:	
Value Percent:	5.000
Continuous Index:	S01
Within 8" of Joint:	NO
Remarks:	Mixed materials

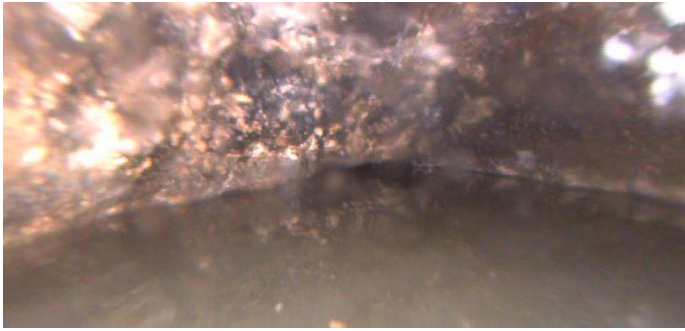
Code: **MWL**
Description: **Water Level**

Distance (ft): **7.2**
Structural Grade: **0**
O&M Grade: **0**
Clock Start/From:
Clock To:
1st Value:
2nd Value:
Value Percent: **70.000**
Continuous Index:
Within 8" of Joint: **NO**
Remarks:

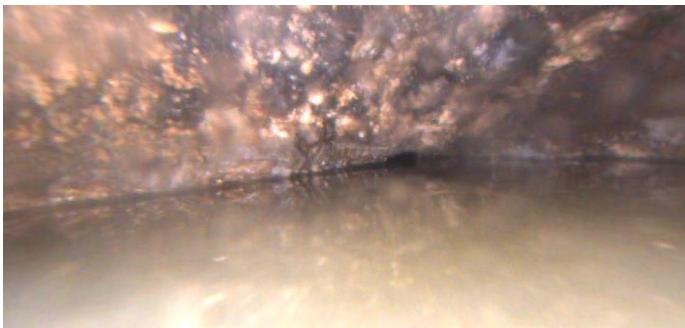
Code: **DAZ**
Description: **Deposits Attached Other**

Distance (ft): **7.4**
Structural Grade: **0**
O&M Grade: **2**
Clock Start/From: **9**
Clock To: **3**
1st Value:
2nd Value:
Value Percent: **5.000**
Continuous Index: **F01**
Within 8" of Joint: **NO**
Remarks: **Mixed materials / Clock positions vary**
