Profile/Photo Observation Report

Street:	E 36TH AVE	Flow Control:	Not Controlled
City:	Hobart, IN	Year Renewed:	
Location:	Other	Tape/Media #:	
Purpose:	Not Known	Dia/Height:	10"
Use:	Sanitary	Material:	VCP
Drain Area:	NA	Lining:	Cured in Place
Category:	NA		
Comment:	6 inch.

Location Details:		Direction of Survey:	Upstream
US MH:	M-902-052	DS MH:	M-902-053
		Total Length Surveyed (ft):	85.3

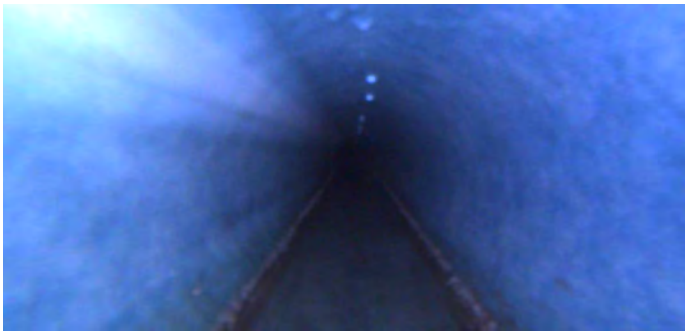
Code: **AMH**
Description: **Manhole**

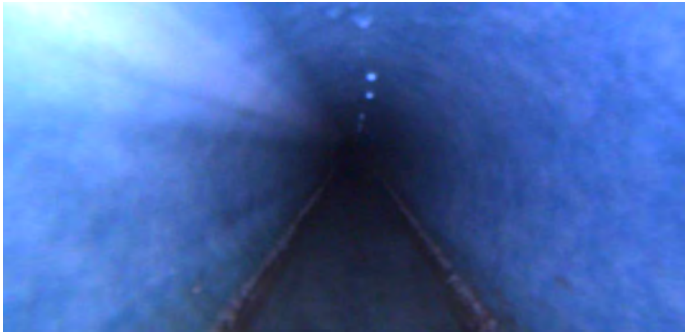
Code:	MWL
Description:	Water Level

Distance (ft):	.0
Structural Grade:	0
O&M Grade:	0
Clock Start/From:	
Clock To:	
1st Value:	
2nd Value:	
Value Percent:	5.000
Continuous Index:	
Within 8" of Joint:	NO
Remarks:

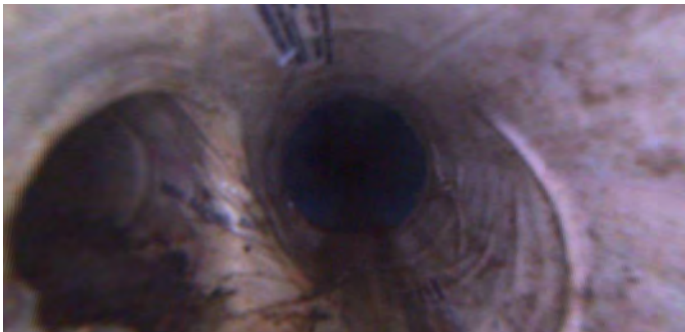
Code:	TF
Description:	Tap Factory

Distance (ft):	25.9
Structural Grade:	0
O&M Grade:	0
Clock Start/From:	9
Clock To:	
1st Value:	4.000
2nd Value:	
Value Percent:	
Continuous Index:	
Within 8" of Joint:	
Remarks:

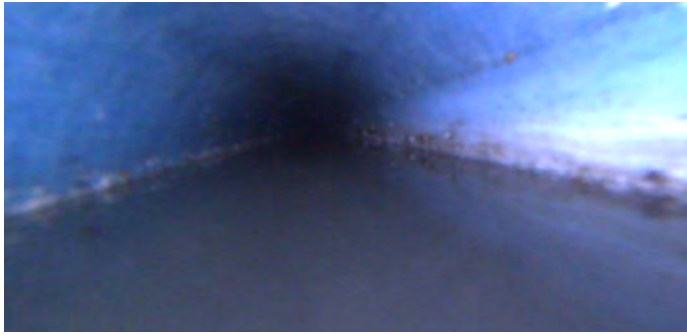
Code:	MWL
Description:	Water Level
Distance (ft):	60.3
Structural Grade:	0
O&M Grade:	0
Clock Start/From:	
Clock To:	
1st Value:	
2nd Value:	
Value Percent:	40.000
Continuous Index:	
Within 8" of Joint:	NO
Remarks:

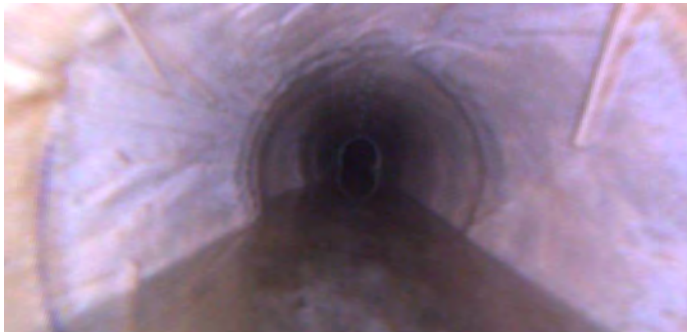
Code:	LFW
Description:	Lining Failure Wrinkled
Distance (ft):	81.3
Structural Grade:	3
O&M Grade:	0
Clock Start/From:	7
Clock To:	5
1st Value:	
2nd Value:	
Value Percent:	
Continuous Index:	S01
Within 8" of Joint:	NO
Remarks:

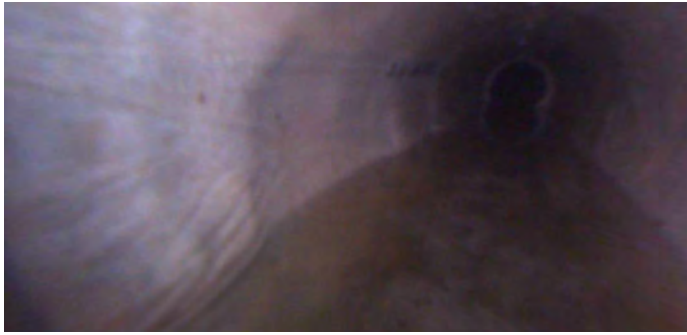
Code:	LFAC
Description:	Lining Failure Abandoned Connection
Distance (ft):	81.8
Structural Grade:	0
O&M Grade:	0
Clock Start/From:	9
Clock To:	
1st Value:	
2nd Value:	
Value Percent:	
Continuous Index:	
Within 8" of Joint:	NO
Remarks:

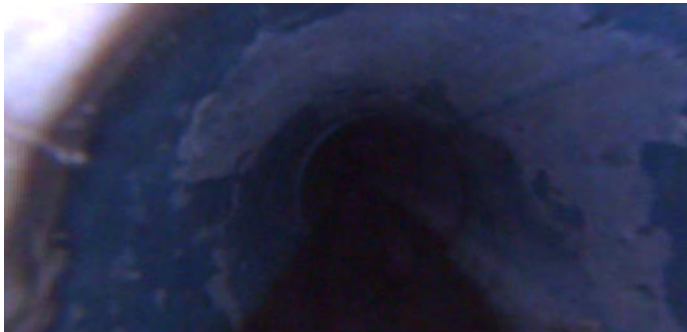
Code:	LFW
Description:	Lining Failure Wrinkled
Distance (ft):	85.3
Structural Grade:	3
O&M Grade:	0
Clock Start/From:	7
Clock To:	5
1st Value:	
2nd Value:	
Value Percent:	
Continuous Index:	F01
Within 8" of Joint:	NO
Remarks:

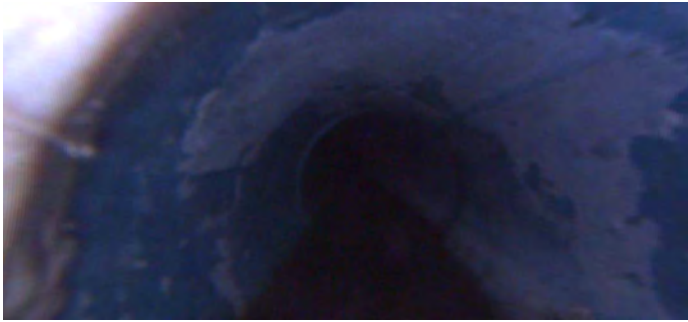
Code:	MSA
Description:	Abandoned Survey
Distance (ft):	85.3
Structural Grade:	0
O&M Grade:	0
Clock Start/From:	
Clock To:	
1st Value:	
2nd Value:	
Value Percent:	
Continuous Index:	
Within 8" of Joint:	NO
Remarks:	camera stopped
