Profile/Photo Observation Report

Date:	03/21/2018	Weather:		Coding:	PACP 6.0
Pipe Length (ft):	126.7	Owner:	NA	Pre Clean:	Not Known
P.O.#:		Surveyor:	Selasie Honu	PSR:	P-902-052-053
Customer:		Clean Date:	01/01/1900	Shape:	C

Street:	38th pl	Flow Control:	Not Controlled
City:	Hobart, IN	Year Renewed:	
Location:	Other	Tape/Media #:	
Purpose:	Not Known	Dia/Height:	10"
Use:	Sanitary	Material:	VCP
Drain Area:	NA	Lining:	Cured in Place
Category:	NA		
Comment:	6 inch.

Location Details:		Direction of Survey:	Upstream
US MH:	M-902-052	DS MH:	M-902-053
		Total Length Surveyed (ft):	85.3

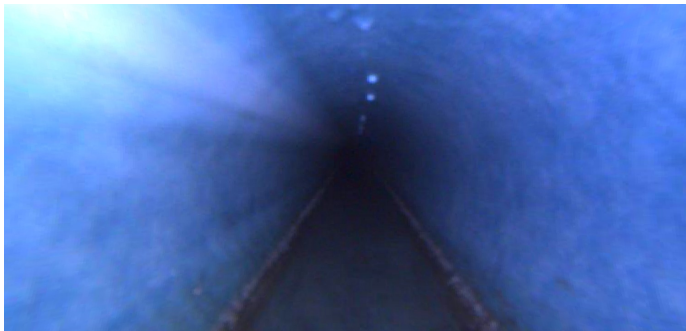
Code: **AMH**
Description: **Manhole**

Distance (ft): **.0**
Structural Grade: **0**
O&M Grade: **0**
Clock Start/From:
Clock To:
1st Value:
2nd Value:
Value Percent:
Continuous Index:
Within 8" of Joint: **NO**
Remarks: **M-902-053**

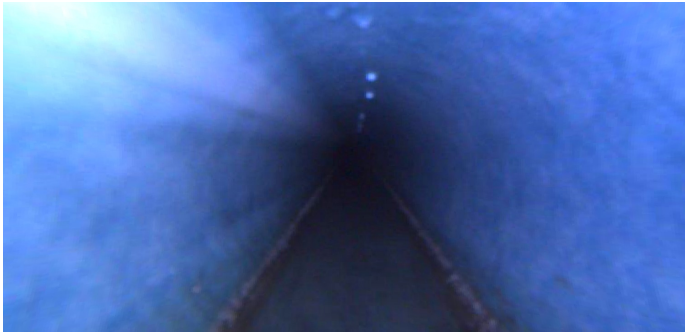
Code:	MWL
Description:	Water Level

Distance (ft):	.0
Structural Grade:	0
O&M Grade:	0
Clock Start/From:	
Clock To:	
1st Value:	
2nd Value:	
Value Percent:	5.000
Continuous Index:	
Within 8" of Joint:	NO
Remarks:

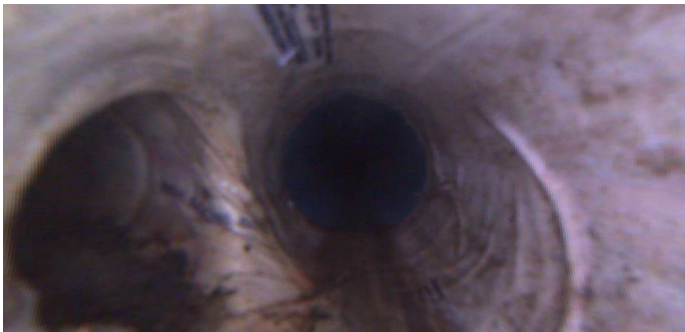
Code:	TF
Description:	Tap Factory

Distance (ft):	25.9
Structural Grade:	0
O&M Grade:	0
Clock Start/From:	9
Clock To:	
1st Value:	4.000
2nd Value:	
Value Percent:	
Continuous Index:	
Within 8" of Joint:	
Remarks:

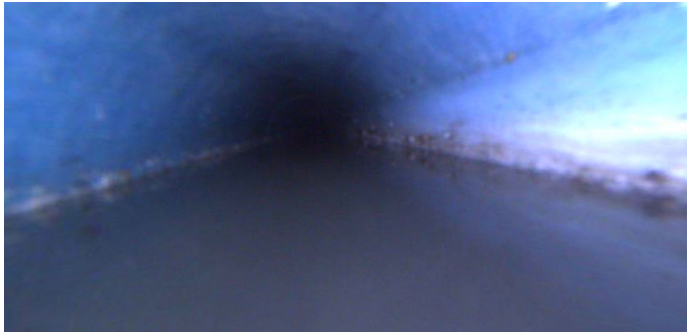
Code:	MWL
Description:	Water Level
Distance (ft):	60.3
Structural Grade:	0
O&M Grade:	0
Clock Start/From:	
Clock To:	
1st Value:	
2nd Value:	
Value Percent:	40.000
Continuous Index:	
Within 8" of Joint:	NO
Remarks:

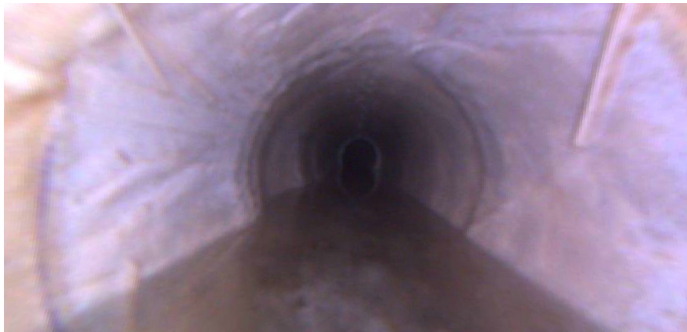
Code:	LFW
Description:	Lining Failure Wrinkled
Distance (ft):	81.3
Structural Grade:	3
O&M Grade:	0
Clock Start/From:	7
Clock To:	5
1st Value:	
2nd Value:	
Value Percent:	
Continuous Index:	S01
Within 8" of Joint:	NO
Remarks:

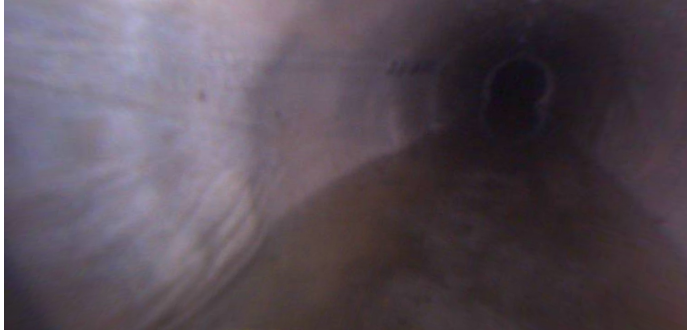
Code:	LFAC
Description:	Lining Failure Abandoned Connection
Distance (ft):	81.8
Structural Grade:	0
O&M Grade:	0
Clock Start/From:	9
Clock To:	
1st Value:	
2nd Value:	
Value Percent:	
Continuous Index:	
Within 8" of Joint:	NO
Remarks:

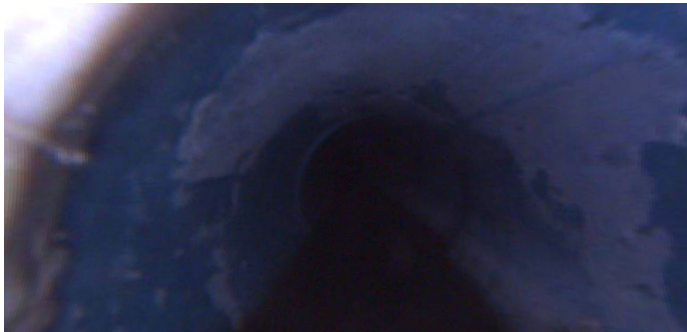
Code:	LFW
Description:	Lining Failure Wrinkled
Distance (ft):	85.3
Structural Grade:	3
O&M Grade:	0
Clock Start/From:	7
Clock To:	5
1st Value:	
2nd Value:	
Value Percent:	
Continuous Index:	F01
Within 8" of Joint:	NO
Remarks:

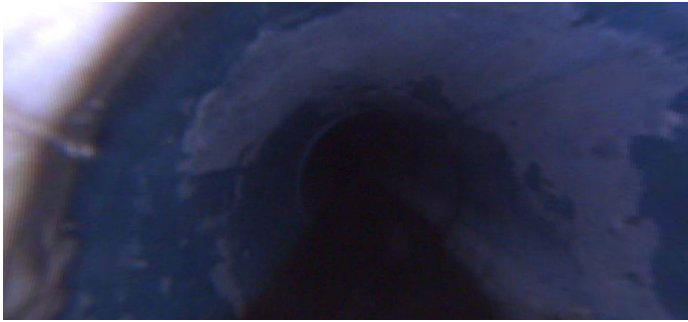
Code:	MSA
Description:	Abandoned Survey
Distance (ft):	85.3
Structural Grade:	0
O&M Grade:	0
Clock Start/From:	
Clock To:	
1st Value:	
2nd Value:	
Value Percent:	
Continuous Index:	
Within 8" of Joint:	NO
Remarks:	camera stopped
