Profile/Photo Observation Report

Street:	E 36TH AVE	Flow Control:	Not Controlled
City:	Hobart, IN	Year Renewed:	
Location:	Other	Tape/Media #:	
Purpose:	Not Known	Dia/Height:	8"
Use:	Sanitary	Material:	VCP
Drain Area:	NA	Lining:	Cured in Place
Category:	NA		
Comment:	6 inch.

Location Details:		Direction of Survey:	Downstream
US MH:	M-902-052	DS MH:	M-902-053
		Total Length Surveyed (ft):	32.1

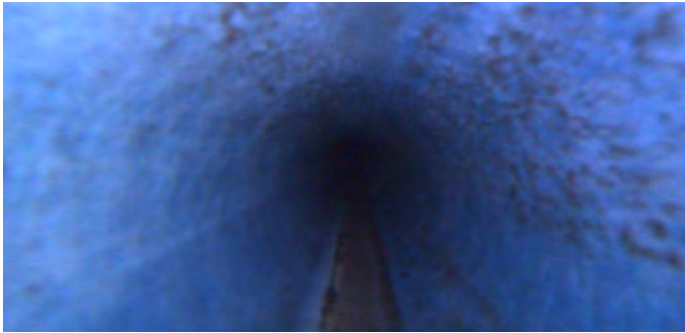
Code:	MWL
Description:	Water Level

Distance (ft):	.0
Structural Grade:	0
O&M Grade:	0
Clock Start/From:	
Clock To:	
1st Value:	
2nd Value:	
Value Percent:	5.000
Continuous Index:	
Within 8" of Joint:	NO
Remarks:

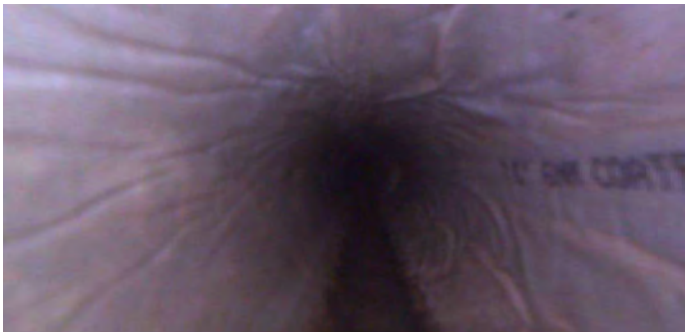
Code:	LFW
Description:	Lining Failure Wrinkled

Distance (ft):	32.1
Structural Grade:	3
O&M Grade:	0
Clock Start/From:	7
Clock To:	5
1st Value:	
2nd Value:	
Value Percent:	
Continuous Index:	
Within 8" of Joint:	NO
Remarks:

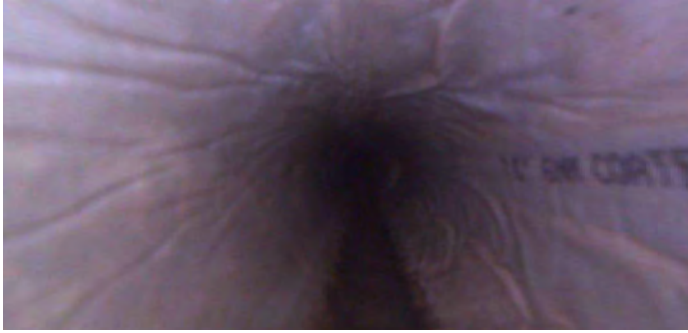
Code:	MSA
Description:	Abandoned Survey
Distance (ft):	32.1
Structural Grade:	0
O&M Grade:	0
Clock Start/From:	
Clock To:	
1st Value:	
2nd Value:	
Value Percent:	
Continuous Index:	
Within 8" of Joint:	NO
Remarks:	camera stopped
