## Profile/Photo Observation Report

Date:	<b>03/21/2018</b>	Weather:		Coding:	<b>PACP 6.0</b>
Pipe Length (ft):	<b>126.7</b>	Owner:	<b>NA</b>	Pre Clean:	<b>Not Known</b>
P.O.#:		Surveyor:	<b>Selasie Honu</b>	PSR:	<b>P-902-052-053</b>
Customer:		Clean Date:	<b>01/01/1900</b>	Shape:	<b>C</b>

Street:	<b>38th pl</b>	Flow Control:	<b>Not Controlled</b>
City:	<b>Hobart, IN</b>	Year Renewed:	
Location:	<b>Other</b>	Tape/Media #:	
Purpose:	<b>Not Known</b>	Dia/Height:	<b>8"</b>
Use:	<b>Sanitary</b>	Material:	<b>VCP</b>
Drain Area:	<b>NA</b>	Lining:	<b>Cured in Place</b>
Category:	<b>NA</b>		
Comment:	<b>6 inch.</b>

Location Details:		Direction of Survey:	<b>Downstream</b>
US MH:	<b>M-902-052</b>	DS MH:	<b>M-902-053</b>
		Total Length Surveyed (ft):	<b>32.1</b>

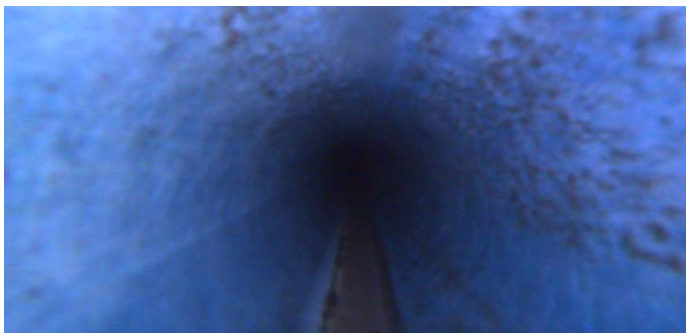
Code: **AMH**  
Description: **Manhole**

Distance (ft): **.0**  
Structural Grade: **0**  
O&M Grade: **0**  
Clock Start/From:  
Clock To:  
1st Value:  
2nd Value:  
Value Percent:  
Continuous Index:  
Within 8" of Joint: **NO**  
Remarks: **M-902-052**

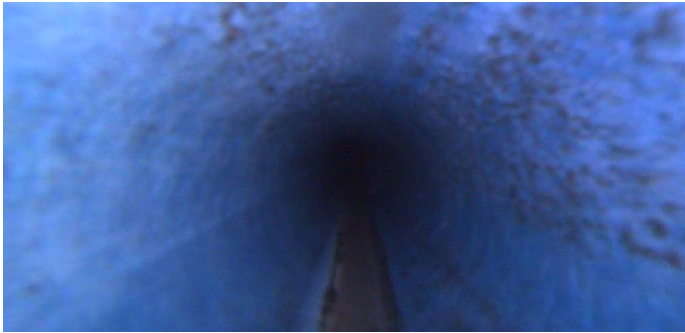
Code:	<b>MWL</b>
Description:	<b>Water Level</b>

Distance (ft):	<b>.0</b>
Structural Grade:	<b>0</b>
O&M Grade:	<b>0</b>
Clock Start/From:	
Clock To:	
1st Value:	
2nd Value:	
Value Percent:	<b>5.000</b>
Continuous Index:	
Within 8" of Joint:	<b>NO</b>
Remarks:

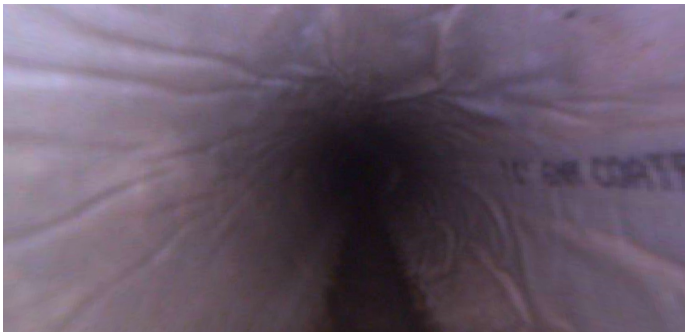
Code:	<b>LFW</b>
Description:	<b>Lining Failure Wrinkled</b>

Distance (ft):	<b>32.1</b>
Structural Grade:	<b>3</b>
O&M Grade:	<b>0</b>
Clock Start/From:	<b>7</b>
Clock To:	<b>5</b>
1st Value:	
2nd Value:	
Value Percent:	
Continuous Index:	
Within 8" of Joint:	<b>NO</b>
Remarks:

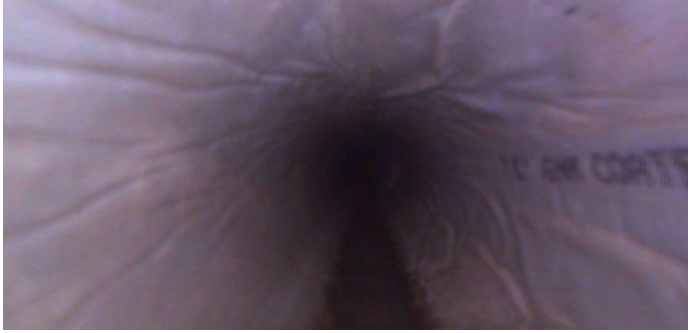
Code:	<b>MSA</b>
Description:	<b>Abandoned Survey</b>
Distance (ft):	<b>32.1</b>
Structural Grade:	<b>0</b>
O&M Grade:	<b>0</b>
Clock Start/From:	
Clock To:	
1st Value:	
2nd Value:	
Value Percent:	
Continuous Index:	
Within 8" of Joint:	<b>NO</b>
Remarks:	<b>camera stopped</b>
