Profile/Photo Observation Report

Date:	03/21/2018	Weather:		Coding:	PACP 6.0
Pipe Length (ft):	227.9	Owner:	NA	Pre Clean:	Not Known
P.O.#:		Surveyor:	Selasie Honu	PSR:	P-902-053-059
Customer:		Clean Date:	01/01/1900	Shape:	C

Street:	38th pl	Flow Control:	Not Controlled
City:	Hobart, IN	Year Renewed:	
Location:	Other	Tape/Media #:	
Purpose:	Not Known	Dia/Height:	10"
Use:	Sanitary	Material:	PVC
Drain Area:	NA	Lining:	Cured in Place
Category:	NA		
Comment:

Location Details:		Direction of Survey:	Upstream
US MH:	M-902-053	DS MH:	M-902-059
		Total Length Surveyed (ft):	220.9

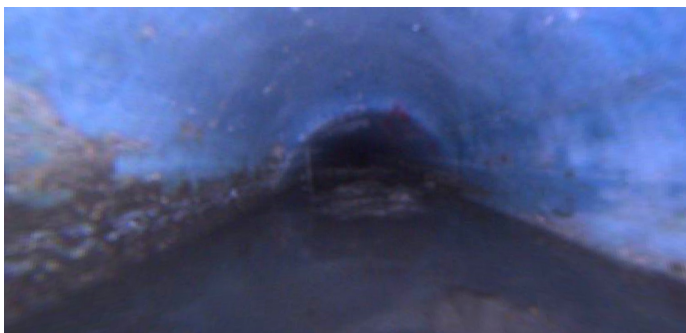
Code: **AMH**
Description: **Manhole**

Distance (ft): **.0**
Structural Grade: **0**
O&M Grade: **0**
Clock Start/From:
Clock To:
1st Value:
2nd Value:
Value Percent:
Continuous Index:
Within 8" of Joint: **NO**
Remarks: **M-902-059**

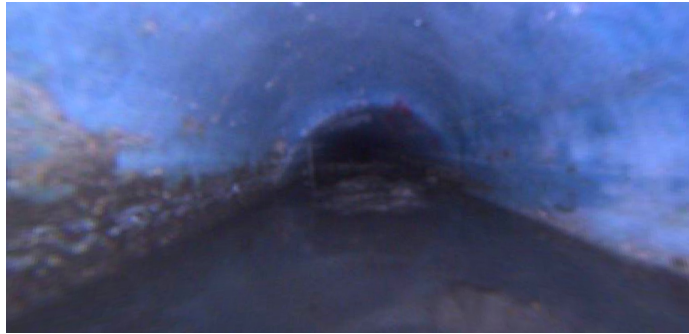
Code: **MWL**
Description: **Water Level**

Distance (ft): **.0**
Structural Grade: **0**
O&M Grade: **0**
Clock Start/From:
Clock To:
1st Value:
2nd Value:
Value Percent: **5.000**
Continuous Index:
Within 8" of Joint: **NO**
Remarks:

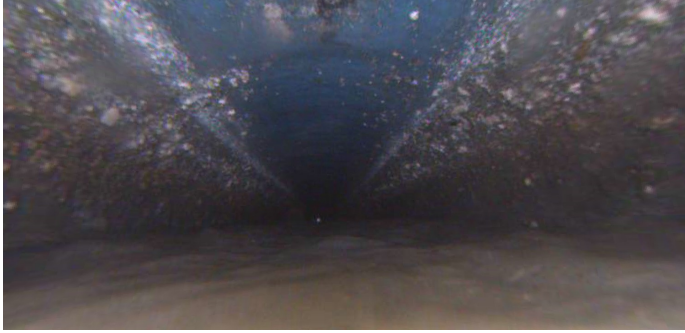
Code: **DAGS**
Description: **Deposits Attached Grease**

Distance (ft): **8.1**
Structural Grade: **0**
O&M Grade: **2**
Clock Start/From: **8**
Clock To: **4**
1st Value:
2nd Value:
Value Percent: **5.000**
Continuous Index: **S02**
Within 8" of Joint: **NO**
Remarks:

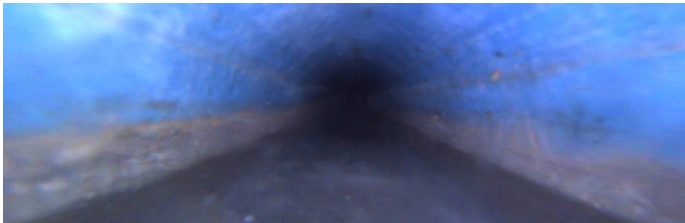
Code: **MWLS**
Description: **Water Level Sag**

Distance (ft): **42.5**
Structural Grade: **2**
O&M Grade: **3**
Clock Start/From:
Clock To:
1st Value:
2nd Value:
Value Percent: **10.000**
Continuous Index: **F01**
Within 8" of Joint: **NO**
Remarks:

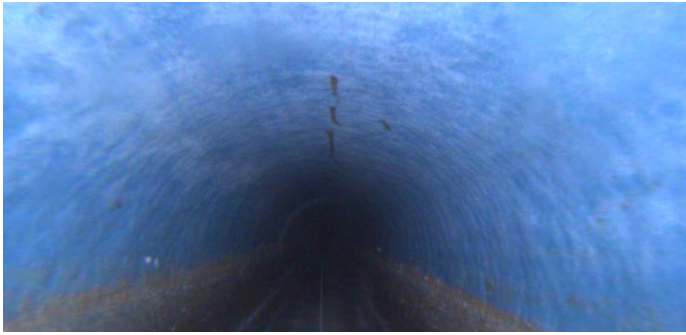
Code: **DAGS**
Description: **Deposits Attached Grease**

Distance (ft): **47.4**
Structural Grade: **0**
O&M Grade: **2**
Clock Start/From: **8**
Clock To: **4**
1st Value:
2nd Value:
Value Percent: **5.000**
Continuous Index: **F02**
Within 8" of Joint: **NO**
Remarks:

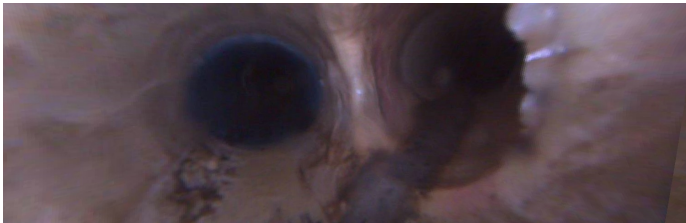
Code: **TF**
Description: **Tap Factory**

Distance (ft): **126.7**
Structural Grade: **0**
O&M Grade: **0**
Clock Start/From: **3**
Clock To:
1st Value: **4.000**
2nd Value:
Value Percent:
Continuous Index:
Within 8" of Joint:
Remarks:

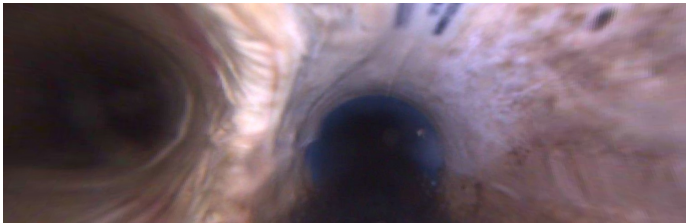
Code: **TF**
Description: **Tap Factory**

Distance (ft): **130.0**
Structural Grade: **0**
O&M Grade: **0**
Clock Start/From: **10**
Clock To:
1st Value: **4.000**
2nd Value:
Value Percent:
Continuous Index:
Within 8" of Joint:
Remarks:

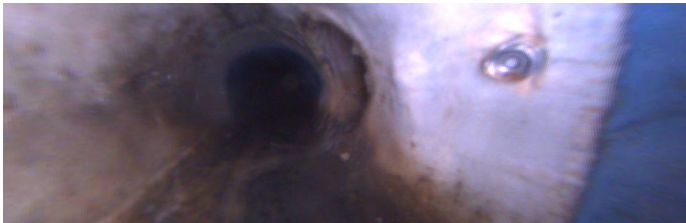
Code: **TF**
Description: **Tap Factory**

Distance (ft): **185.0**
Structural Grade: **0**
O&M Grade: **0**
Clock Start/From: **3**
Clock To:
1st Value: **4.000**
2nd Value:
Value Percent:
Continuous Index:
Within 8" of Joint:
Remarks:

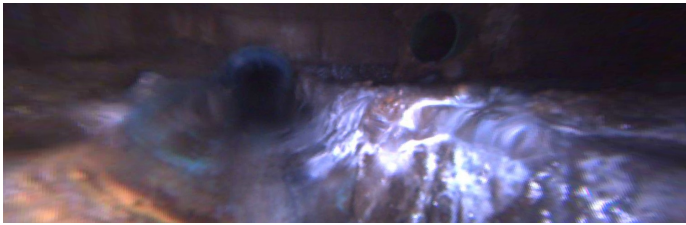
Code: **AMH**
Description: **Manhole**

Distance (ft): **220.9**
Structural Grade: **0**
O&M Grade: **0**
Clock Start/From:
Clock To:
1st Value:
2nd Value:
Value Percent:
Continuous Index:
Within 8" of Joint: **NO**
Remarks: **M-902-053**
