Profile/Photo Observation Report

| Street: | RUSH PL | Flow Control: | Not Controlled |
| City: | Hobart, IN | Year Renewed: | |

| US MH: | M-902-056 | DS MH: | M-902-031 |

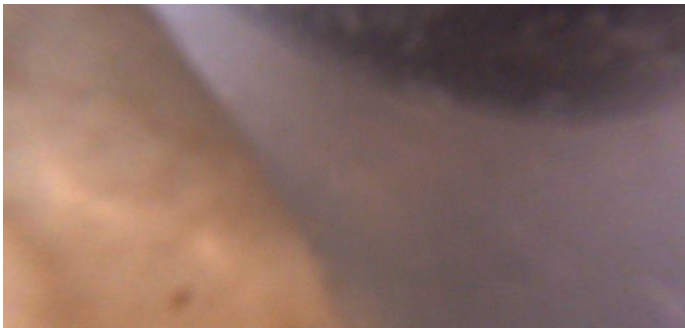
| Code: | MCU |
| Description: | Camera Underwater |

| Distance (ft): | .9 |
| O&M Grade: | 4 |

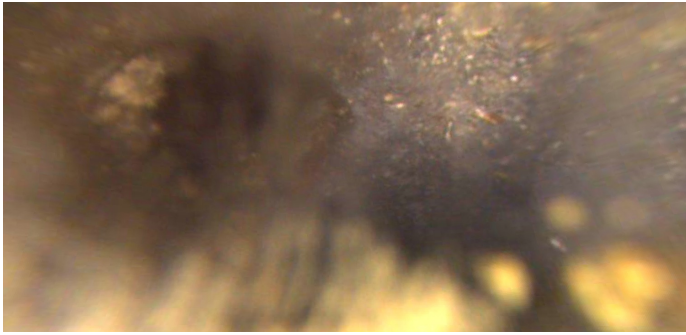
Code: **TF**
Description: **Tap Factory**

Distance (ft): **3.2**
Structural Grade: **0**
O&M Grade: **0**
Clock Start/From: **2**
Clock To:
1st Value: **4.000**
2nd Value:
Value Percent:
Continuous Index:
Within 8" of Joint:
Remarks:

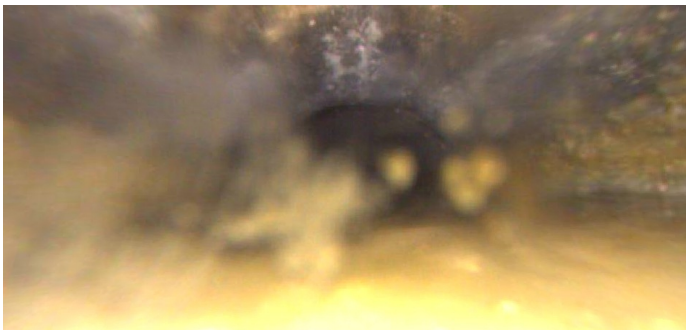
Code: **MGO**
Description: **General Observation**

Distance (ft): **4.3**
Structural Grade: **0**
O&M Grade: **0**
Clock Start/From:
Clock To:
1st Value:
2nd Value:
Value Percent:
Continuous Index:
Within 8" of Joint: **NO**
Remarks: **Switching to rear camera**

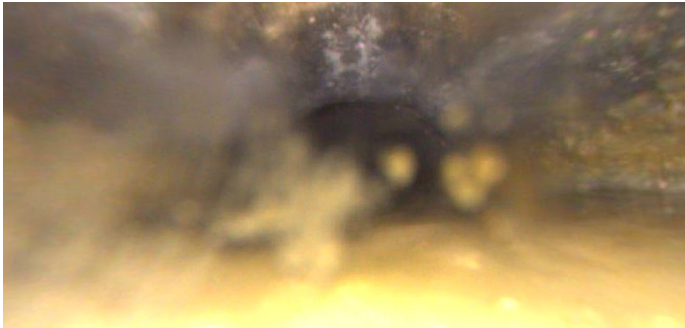
Code: **DAZ**
Description: **Deposits Attached Other**

Distance (ft): **4.3**
Structural Grade: **0**
O&M Grade: **2**
Clock Start/From: **9**
Clock To: **3**
1st Value:
2nd Value:
Value Percent: **10.000**
Continuous Index: **S01**
Within 8" of Joint: **NO**
Remarks: **Mixed materials**

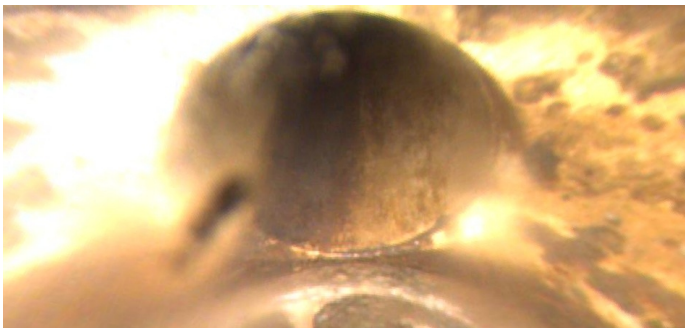
Code: **TF**
Description: **Tap Factory**

Distance (ft): **77.3**
Structural Grade: **0**
O&M Grade: **0**
Clock Start/From: **12**
Clock To:
1st Value: **4.000**
2nd Value:
Value Percent:
Continuous Index:
Within 8" of Joint:
Remarks:

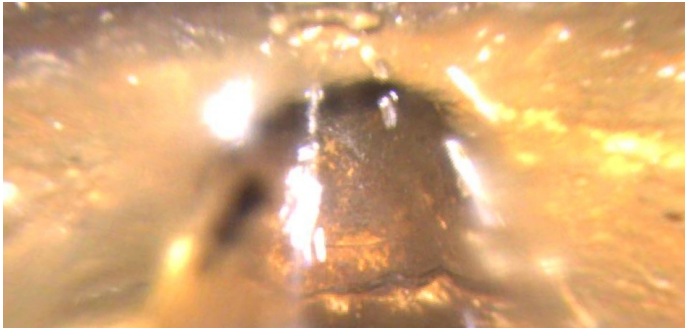
Code: **TFA**
Description: **Tap Factory Active**

Distance (ft): **154.0**
Structural Grade: **0**
O&M Grade: **0**
Clock Start/From: **12**
Clock To:
1st Value: **4.000**
2nd Value:
Value Percent:
Continuous Index:
Within 8" of Joint:
Remarks:

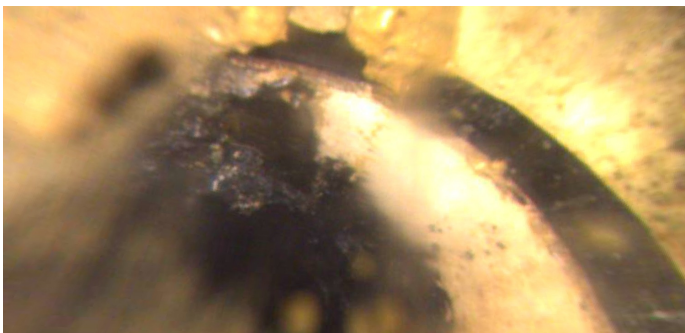
Code: **JSM**
Description: **Joint Separated Medium**

Distance (ft): **193.2**
Structural Grade: **1**
O&M Grade: **0**
Clock Start/From:
Clock To:
1st Value:
2nd Value:
Value Percent:
Continuous Index:
Within 8" of Joint: **NO**
Remarks:

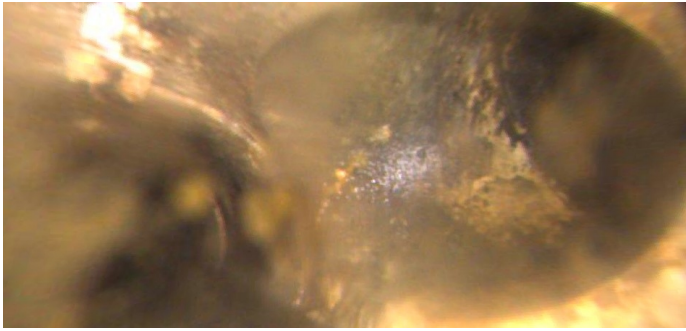
Code: **TF**
Description: **Tap Factory**

Distance (ft): **194.4**
Structural Grade: **0**
O&M Grade: **0**
Clock Start/From: **10**
Clock To:
1st Value: **4.000**
2nd Value:
Value Percent:
Continuous Index:
Within 8" of Joint:
Remarks:

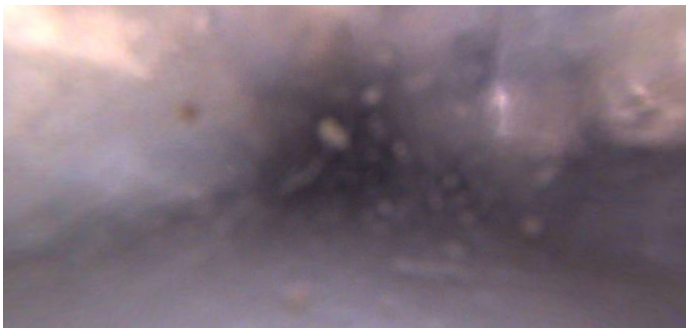
Code: **MGO**
Description: **General Observation**

Distance (ft): **263.5**
Structural Grade: **0**
O&M Grade: **0**
Clock Start/From:
Clock To:
1st Value:
2nd Value:
Value Percent:
Continuous Index:
Within 8" of Joint: **NO**
Remarks: **Switching to front camera**

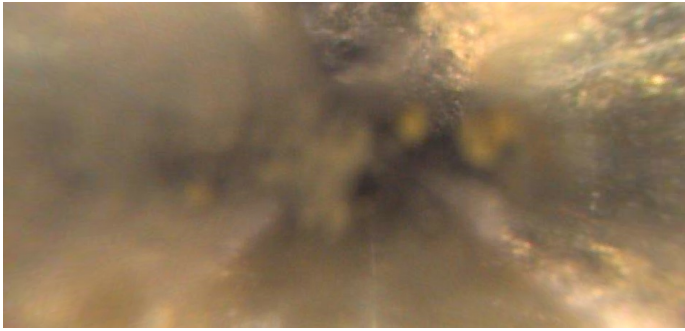
Code: **DAZ**
Description: **Deposits Attached Other**

Distance (ft): **263.5**
Structural Grade: **0**
O&M Grade: **2**
Clock Start/From: **9**
Clock To: **3**
1st Value:
2nd Value:
Value Percent: **10.000**
Continuous Index: **F01**
Within 8" of Joint: **NO**
Remarks: **Mixed materials / Clock positions vary**

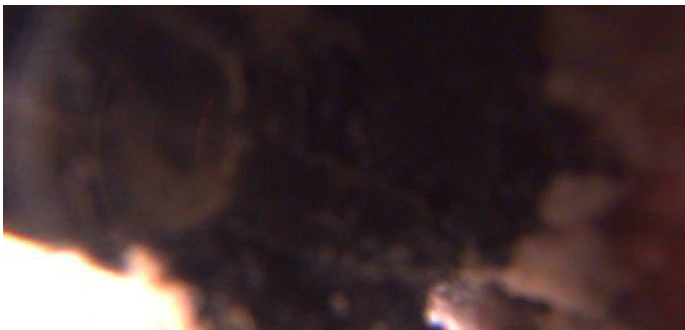
Code: **MSA**
Description: **Abandoned Survey**

Distance (ft): **277.3**
Structural Grade: **0**
O&M Grade: **0**
Clock Start/From:
Clock To:
1st Value:
2nd Value:
Value Percent:
Continuous Index:
Within 8" of Joint: **NO**
Remarks: **Unknown**
