Profile/Photo Observation Report

Date:	03/20/2018	Weather:		Coding:	PACP 6.0
Pipe Length (ft):	296.1	Owner:	NA	Pre Clean:	Not Known
P.O.#:		Surveyor:	John Kuglmaier	PSR:	P-902-031-056
Customer:		Clean Date:	01/01/1900	Shape:	O

Street:	N Hobart Rd	Flow Control:	Not Controlled
City:	Hobart, IN	Year Renewed:	
Location:	Main Highway - Suburban/Rural	Tape/Media #:	
Purpose:	Resurvey	Dia/Height:	12"
Use:	Sanitary	Material:	PVC
Drain Area:	NA	Lining:	
Category:	NA		
Comment:

Location Details:		Direction of Survey:	Downstream
US MH:	M-902-056	DS MH:	M-902-031
		Total Length Surveyed (ft):	277.3

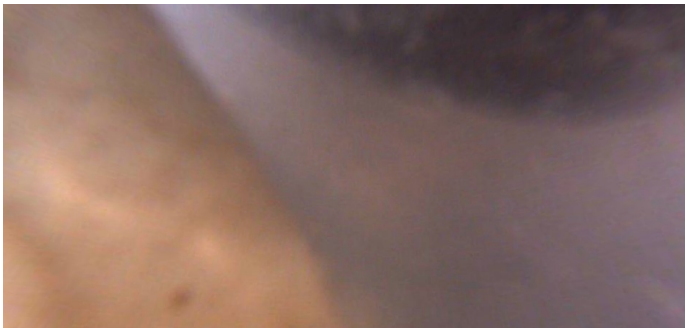
Code:	MCU
Description:	Camera Underwater

Distance (ft):	.9
Structural Grade:	0
O&M Grade:	4
Clock Start/From:	
Clock To:	
1st Value:	
2nd Value:	
Value Percent:	
Continuous Index:	
Within 8" of Joint:	NO
Remarks:

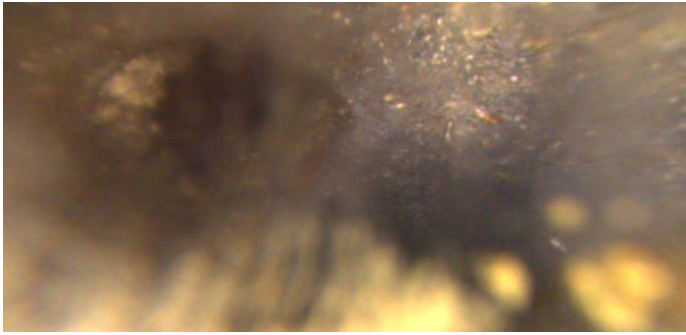
Code: **TF**
Description: **Tap Factory**

Distance (ft): **3.2**
Structural Grade: **0**
O&M Grade: **0**
Clock Start/From: **2**
Clock To:
1st Value: **4.000**
2nd Value:
Value Percent:
Continuous Index:
Within 8" of Joint:
Remarks:

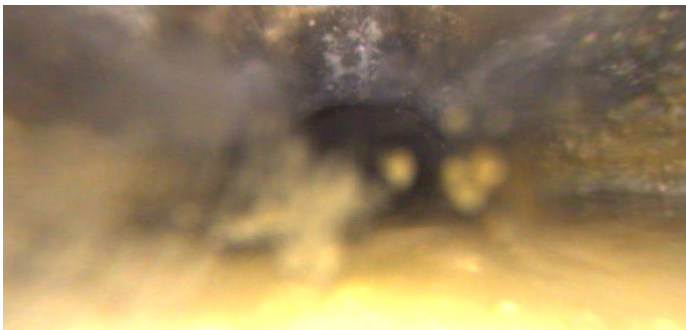
Code: **MGO**
Description: **General Observation**

Distance (ft): **4.3**
Structural Grade: **0**
O&M Grade: **0**
Clock Start/From:
Clock To:
1st Value:
2nd Value:
Value Percent:
Continuous Index:
Within 8" of Joint: **NO**
Remarks: **Switching to rear camera**

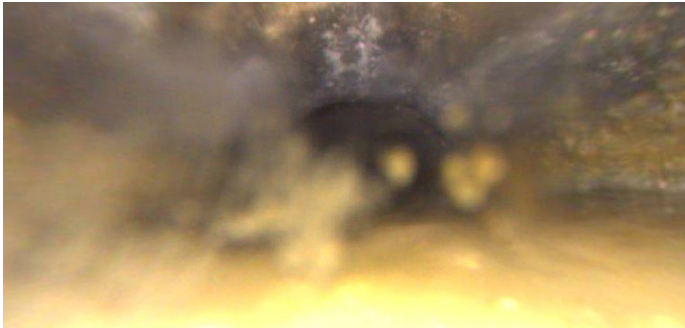
Code: **DAZ**
Description: **Deposits Attached Other**

Distance (ft): **4.3**
Structural Grade: **0**
O&M Grade: **2**
Clock Start/From: **9**
Clock To: **3**
1st Value:
2nd Value:
Value Percent: **10.000**
Continuous Index: **S01**
Within 8" of Joint: **NO**
Remarks: **Mixed materials**

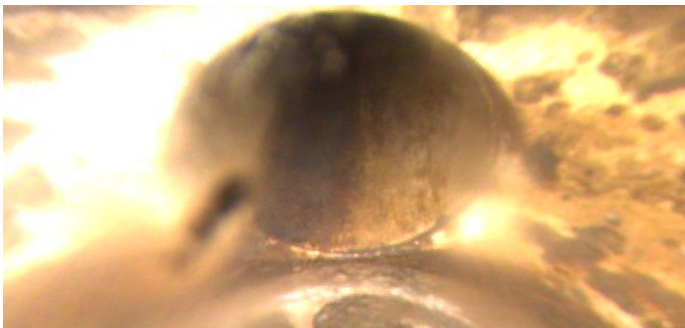
Code: **TF**
Description: **Tap Factory**

Distance (ft): **77.3**
Structural Grade: **0**
O&M Grade: **0**
Clock Start/From: **12**
Clock To:
1st Value: **4.000**
2nd Value:
Value Percent:
Continuous Index:
Within 8" of Joint:
Remarks:

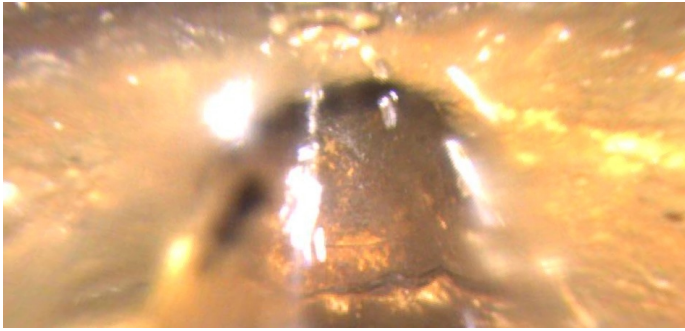
Code: **TFA**
Description: **Tap Factory Active**

Distance (ft): **154.0**
Structural Grade: **0**
O&M Grade: **0**
Clock Start/From: **12**
Clock To:
1st Value: **4.000**
2nd Value:
Value Percent:
Continuous Index:
Within 8" of Joint:
Remarks:

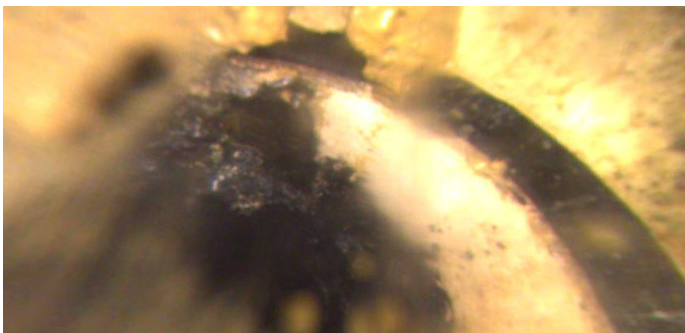
Code: **JSM**
Description: **Joint Separated Medium**

Distance (ft): **193.2**
Structural Grade: **1**
O&M Grade: **0**
Clock Start/From:
Clock To:
1st Value:
2nd Value:
Value Percent:
Continuous Index:
Within 8" of Joint: **NO**
Remarks:

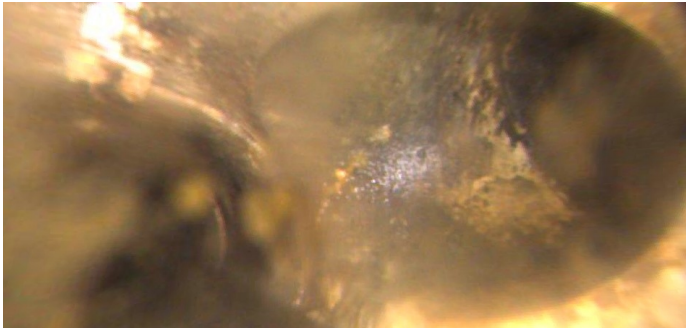
Code: **TF**
Description: **Tap Factory**

Distance (ft): **194.4**
Structural Grade: **0**
O&M Grade: **0**
Clock Start/From: **10**
Clock To:
1st Value: **4.000**
2nd Value:
Value Percent:
Continuous Index:
Within 8" of Joint:
Remarks:

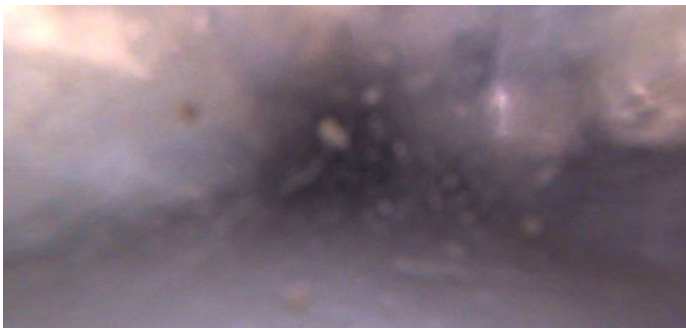
Code: **MGO**
Description: **General Observation**

Distance (ft): **263.5**
Structural Grade: **0**
O&M Grade: **0**
Clock Start/From:
Clock To:
1st Value:
2nd Value:
Value Percent:
Continuous Index:
Within 8" of Joint: **NO**
Remarks: **Switching to front camera**

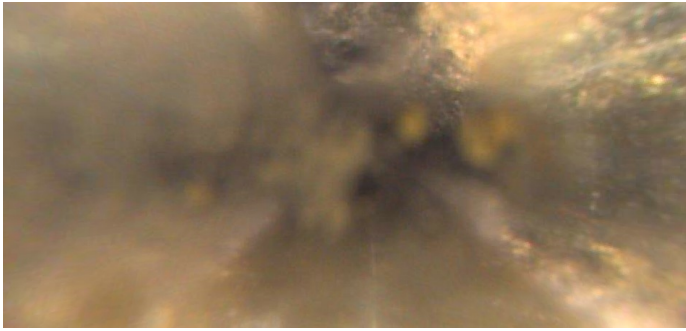
Code: **DAZ**
Description: **Deposits Attached Other**

Distance (ft): **263.5**
Structural Grade: **0**
O&M Grade: **2**
Clock Start/From: **9**
Clock To: **3**
1st Value:
2nd Value:
Value Percent: **10.000**
Continuous Index: **F01**
Within 8" of Joint: **NO**
Remarks: **Mixed materials / Clock positions vary**

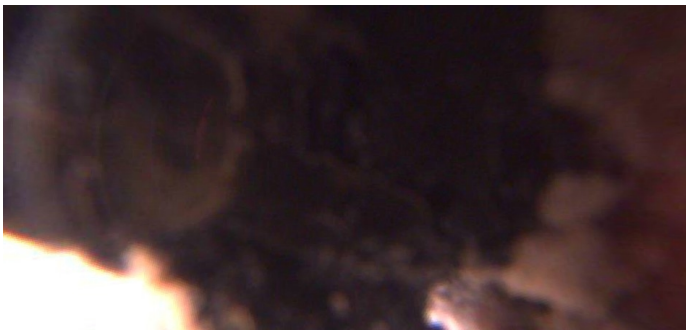
Code: **MSA**
Description: **Abandoned Survey**

Distance (ft): **277.3**
Structural Grade: **0**
O&M Grade: **0**
Clock Start/From:
Clock To:
1st Value:
2nd Value:
Value Percent:
Continuous Index:
Within 8" of Joint: **NO**
Remarks: **Unknown**
