Date:	03/21/2018	Weather:			Coding:	PACP 6.0
Pipe Length (ft)		Owner:	NA		Pre Clean:	Not Known
P.O.#:		Surveyor:	Selasie Honu	I	PSR:	P-902-057-056
Customer:		Clean Date:	01/01/1900		Shape:	С
Street:	RUSH PL		Flow Control:		Not Controlled	
City:	Hobart, IN		Year Renewed	:		
Location:	Other		Tape/Media #	:		
Purpose:	Not Known		Dia/Height:		10"	
Use:	Sanitary		Material:		VCP	
Drain Area:	NA		Lining:		Cured in Place	
Category:	NA					
Comment:	Pipe is surcharged					
Location Detail	s:		Direction of Su	irvey:	Upstream	
US MH:	M-902-056	DS MH:	M-902-057	Tot	al Length Surveyed (ft):	60.7
D&M Index:	0.00	O&M Quick:	0	000	O&M Rating:	0.00
Structural Index:	0.00	 Structural Qu	uick: 0	000	Structural Rating:	0.00
Overall Index:	0.00	Overall Quick		000	Overall Rating:	0.00

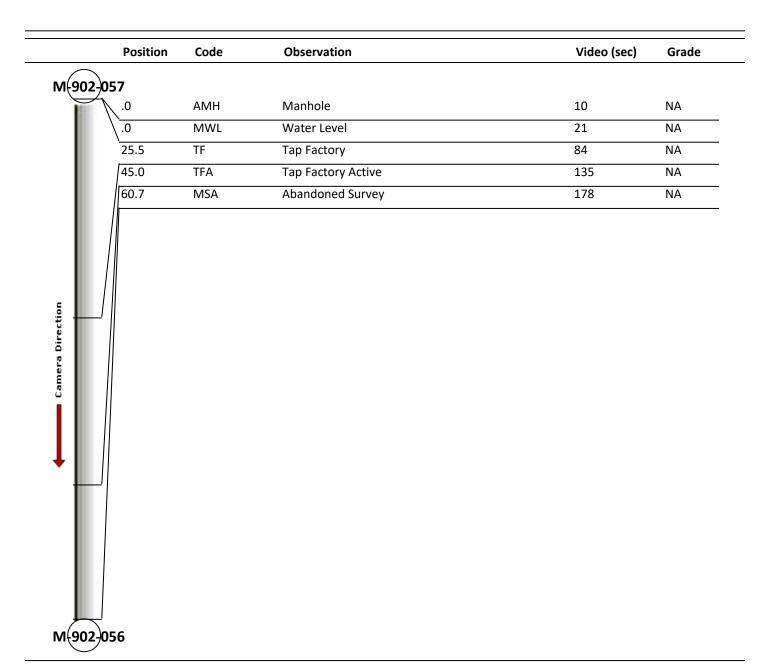
Code: Description:	AMH Manhole
Distance (ft):	.0
Structural Grade:	0
O&M Grade:	0
Clock Start/From:	
Clock To:	
1st Value:	
2nd Value:	
Value Percent:	
Continuous Index:	
Within 8" of Joint:	NO
Remarks:	M-902-057
