Profile/Photo Observation Report

Street:	37th ave	Flow Control:	Not Controlled
City:	Hobart, IN	Year Renewed:	
Location:	Other	Tape/Media #:	
Purpose:	Not Known	Dia/Height:	10"
Use:	Sanitary	Material:	VCP
Drain Area:	NA	Lining:	Cured in Place
Category:	NA		
Comment:	Pipe is surcharged

Location Details:		Direction of Survey:	Upstream
US MH:	M-902-056	DS MH:	M-902-057
		Total Length Surveyed (ft):	60.7

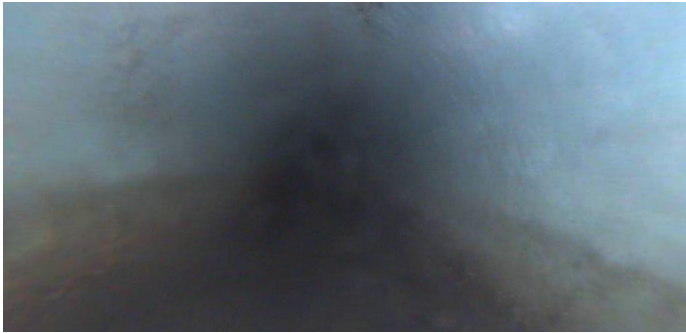
Code:	MWL
Description:	Water Level

Distance (ft):	.0
Structural Grade:	0
O&M Grade:	0
Clock Start/From:	
Clock To:	
1st Value:	
2nd Value:	
Value Percent:	5.000
Continuous Index:	
Within 8" of Joint:	NO
Remarks:

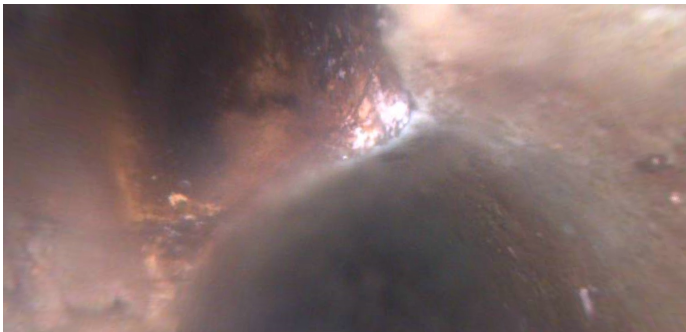
Code:	TF
Description:	Tap Factory

Distance (ft):	25.5
Structural Grade:	0
O&M Grade:	0
Clock Start/From:	11
Clock To:	
1st Value:	4.000
2nd Value:	
Value Percent:	
Continuous Index:	
Within 8" of Joint:	
Remarks:

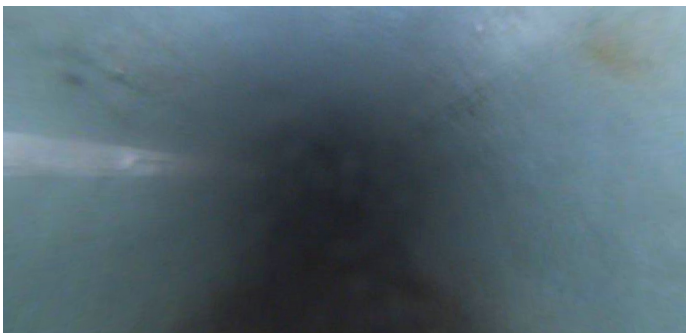
Code: **MSA**
Description: **Abandoned Survey**

Distance (ft): **60.7**
Structural Grade: **0**
O&M Grade: **0**
Clock Start/From:
Clock To:
1st Value:
2nd Value:
Value Percent:
Continuous Index:
Within 8" of Joint: **NO**
Remarks: **debris**
