Profile/Photo Observation Report

Date:	03/21/2018	Weather:		Coding:	PACP 6.0
Pipe Length (ft):	181.7	Owner:	NA	Pre Clean:	Not Known
P.O.#:		Surveyor:	Selasie Honu	PSR:	P-902-058-057
Customer:		Clean Date:	01/01/1900	Shape:	C

Street:	RUSH PL	Flow Control:	Not Controlled
City:	Hobart, IN	Year Renewed:	
Location:	Other	Tape/Media #:	
Purpose:	Not Known	Dia/Height:	10"
Use:	Sanitary	Material:	VCP
Drain Area:	NA	Lining:	Cured in Place
Category:	NA		
Comment:

Location Details:		Direction of Survey:	Downstream
US MH:	M-902-057	DS MH:	M-902-058
		Total Length Surveyed (ft):	28.2

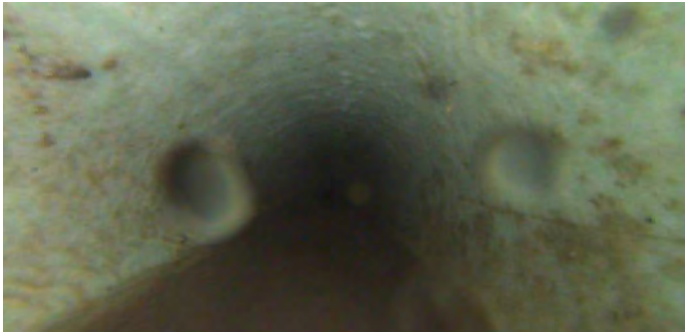
Code:	MWL
Description:	Water Level

Distance (ft):	.0
Structural Grade:	0
O&M Grade:	0
Clock Start/From:	
Clock To:	
1st Value:	
2nd Value:	
Value Percent:	5.000
Continuous Index:	
Within 8" of Joint:	NO
Remarks:

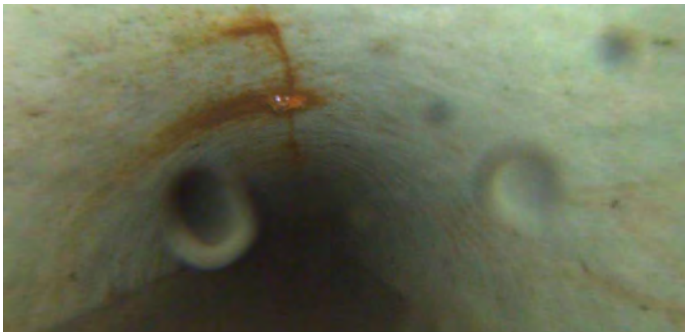
Code:	FL
Description:	Fracture Longitudinal

Distance (ft):	13.0
Structural Grade:	3
O&M Grade:	0
Clock Start/From:	12
Clock To:	
1st Value:	
2nd Value:	
Value Percent:	
Continuous Index:	
Within 8" of Joint:	
Remarks:

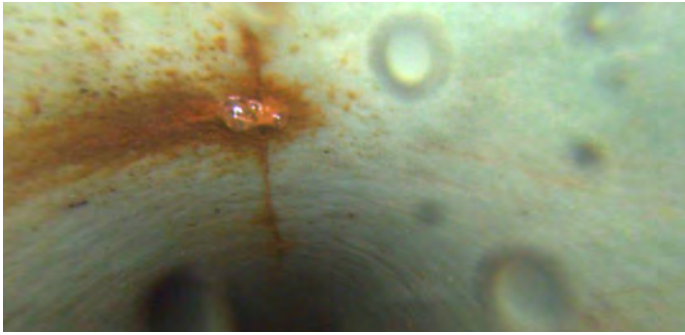
Code: **ID**
Description: **Infil Dripper**

Distance (ft): **13.2**
Structural Grade: **0**
O&M Grade: **3**
Clock Start/From: **12**
Clock To:
1st Value:
2nd Value:
Value Percent:
Continuous Index:
Within 8" of Joint:
Remarks:

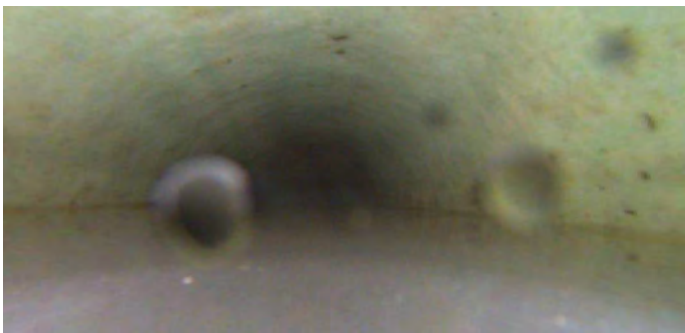
Code: **MWLS**
Description: **Water Level Sag**

Distance (ft): **17.4**
Structural Grade: **2**
O&M Grade: **3**
Clock Start/From:
Clock To:
1st Value:
2nd Value:
Value Percent: **10.000**
Continuous Index: **S01**
Within 8" of Joint: **NO**
Remarks:
