## Profile/Photo Observation Report

Date:	<b>03/21/2018</b>	Weather:		Coding:	<b>PACP 6.0</b>
Pipe Length (ft):	<b>181.7</b>	Owner:	<b>NA</b>	Pre Clean:	<b>Not Known</b>
P.O.#:		Surveyor:	<b>Selasie Honu</b>	PSR:	<b>P-902-058-057</b>
Customer:		Clean Date:	<b>01/01/1900</b>	Shape:	<b>C</b>

Street:	<b>37th ave</b>	Flow Control:	<b>Not Controlled</b>
City:	<b>Hobart, IN</b>	Year Renewed:	
Location:	<b>Other</b>	Tape/Media #:	
Purpose:	<b>Not Known</b>	Dia/Height:	<b>10"</b>
Use:	<b>Sanitary</b>	Material:	<b>VCP</b>
Drain Area:	<b>NA</b>	Lining:	<b>Cured in Place</b>
Category:	<b>NA</b>		
Comment:

Location Details:		Direction of Survey:	<b>Downstream</b>
US MH:	<b>M-902-057</b>	DS MH:	<b>M-902-058</b>
		Total Length Surveyed (ft):	<b>28.2</b>

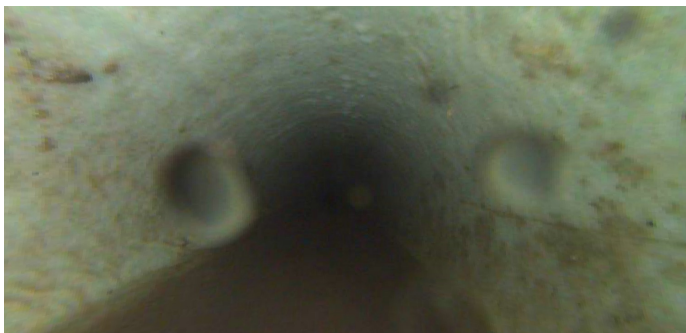
Code: **AMH**  
Description: **Manhole**

Distance (ft): **.0**  
Structural Grade: **0**  
O&M Grade: **0**  
Clock Start/From:  
Clock To:  
1st Value:  
2nd Value:  
Value Percent:  
Continuous Index:  
Within 8" of Joint: **NO**  
Remarks: **M-902-057**

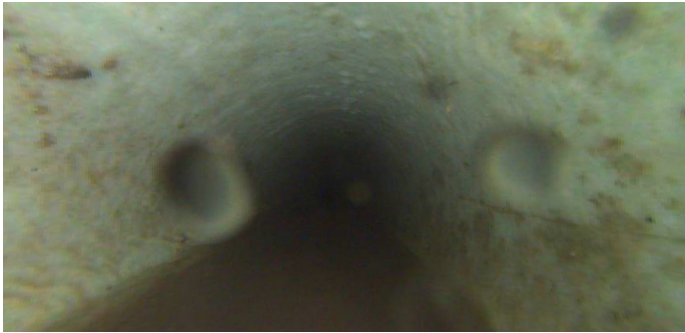
Code:	<b>MWL</b>
Description:	<b>Water Level</b>

Distance (ft):	<b>.0</b>
Structural Grade:	<b>0</b>
O&M Grade:	<b>0</b>
Clock Start/From:	
Clock To:	
1st Value:	
2nd Value:	
Value Percent:	<b>5.000</b>
Continuous Index:	
Within 8" of Joint:	<b>NO</b>
Remarks:

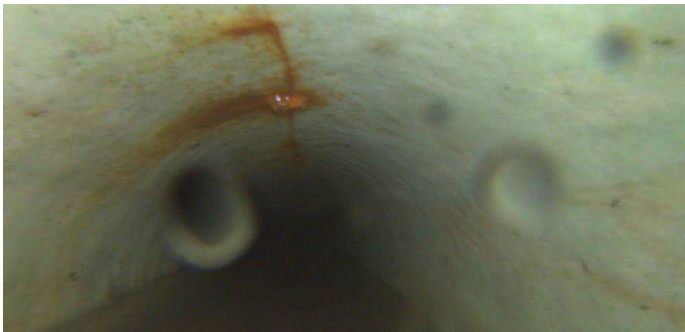
Code:	<b>FL</b>
Description:	<b>Fracture Longitudinal</b>

Distance (ft):	<b>13.0</b>
Structural Grade:	<b>3</b>
O&M Grade:	<b>0</b>
Clock Start/From:	<b>12</b>
Clock To:	
1st Value:	
2nd Value:	
Value Percent:	
Continuous Index:	
Within 8" of Joint:	
Remarks:

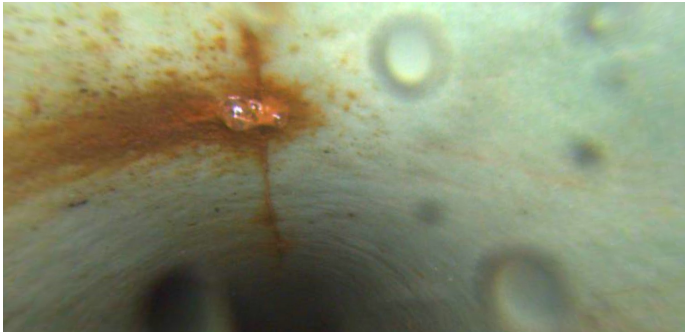
Code: **ID**  
Description: **Infil Dripper**

Distance (ft): **13.2**  
Structural Grade: **0**  
O&M Grade: **3**  
Clock Start/From: **12**  
Clock To:  
1st Value:  
2nd Value:  
Value Percent:  
Continuous Index:  
Within 8" of Joint:  
Remarks:

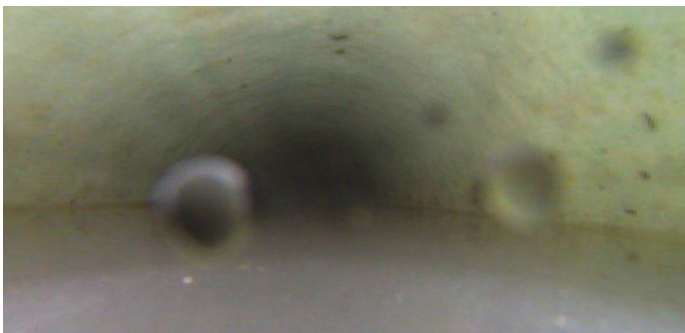
Code: **MWLS**  
Description: **Water Level Sag**

Distance (ft): **17.4**  
Structural Grade: **2**  
O&M Grade: **3**  
Clock Start/From:  
Clock To:  
1st Value:  
2nd Value:  
Value Percent: **10.000**  
Continuous Index: **S01**  
Within 8" of Joint: **NO**  
Remarks:

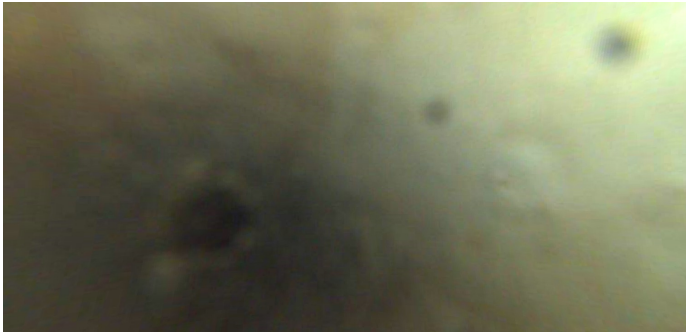
Code: **MWLS**  
Description: **Water Level Sag**

Distance (ft): **28.2**  
Structural Grade: **2**  
O&M Grade: **3**  
Clock Start/From:  
Clock To:  
1st Value:  
2nd Value:  
Value Percent: **10.000**  
Continuous Index: **F01**  
Within 8" of Joint: **NO**  
Remarks:

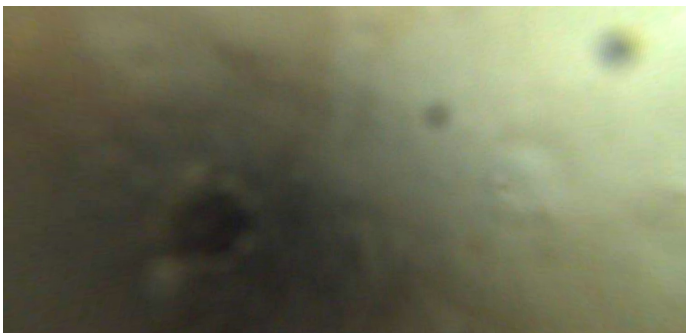
Code: **MSA**  
Description: **Abandoned Survey**

Distance (ft): **28.2**  
Structural Grade: **0**  
O&M Grade: **0**  
Clock Start/From:  
Clock To:  
1st Value:  
2nd Value:  
Value Percent:  
Continuous Index:  
Within 8" of Joint: **NO**  
Remarks: **mcu**
