## Profile/Photo Observation Report

Street:	<b>37th ave</b>	Flow Control:	<b>Not Controlled</b>
City:	<b>Hobart, IN</b>	Year Renewed:	
Location:	<b>Other</b>	Tape/Media #:	
Purpose:	<b>Not Known</b>	Dia/Height:	<b>10"</b>
Use:	<b>Sanitary</b>	Material:	<b>VCP</b>
Drain Area:	<b>NA</b>	Lining:	<b>Cured in Place</b>
Category:	<b>NA</b>		
Comment:

Location Details:		Direction of Survey:	<b>Upstream</b>
US MH:	<b>M-902-057</b>	DS MH:	<b>M-902-058</b>
		Total Length Surveyed (ft):	<b>72.3</b>

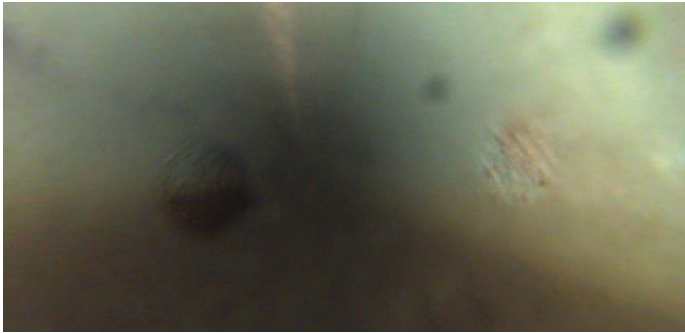
Code:	<b>MWL</b>
Description:	<b>Water Level</b>

Distance (ft):	<b>.0</b>
Structural Grade:	<b>0</b>
O&M Grade:	<b>0</b>
Clock Start/From:	
Clock To:	
1st Value:	
2nd Value:	
Value Percent:	<b>5.000</b>
Continuous Index:	
Within 8" of Joint:	<b>NO</b>
Remarks:

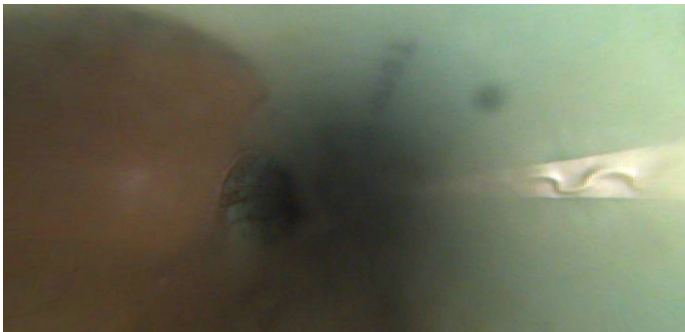
Code:	<b>TF</b>
Description:	<b>Tap Factory</b>

Distance (ft):	<b>31.3</b>
Structural Grade:	<b>0</b>
O&M Grade:	<b>0</b>
Clock Start/From:	<b>9</b>
Clock To:	
1st Value:	<b>4.000</b>
2nd Value:	
Value Percent:	
Continuous Index:	
Within 8" of Joint:	
Remarks:

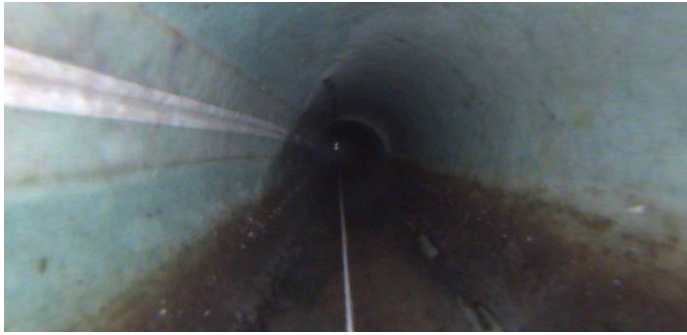
Code:	<b>LFAC</b>
Description:	<b>Lining Failure Abandoned Connection</b>
Distance (ft):	<b>39.2</b>
Structural Grade:	<b>0</b>
O&M Grade:	<b>0</b>
Clock Start/From:	<b>3</b>
Clock To:	
1st Value:	
2nd Value:	
Value Percent:	
Continuous Index:	
Within 8" of Joint:	<b>NO</b>
Remarks:

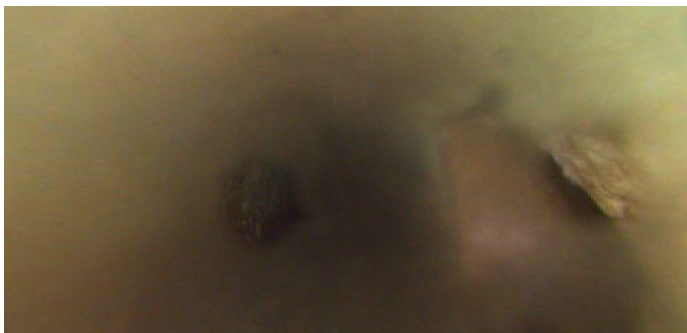
Code:	<b>TF</b>
Description:	<b>Tap Factory</b>
Distance (ft):	<b>66.5</b>
Structural Grade:	<b>0</b>
O&M Grade:	<b>0</b>
Clock Start/From:	<b>3</b>
Clock To:	
1st Value:	<b>4.000</b>
2nd Value:	
Value Percent:	
Continuous Index:	
Within 8" of Joint:	
Remarks:

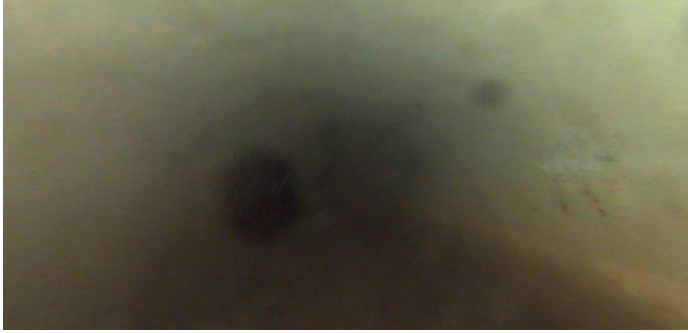
Code:	<b>MSA</b>
Description:	<b>Abandoned Survey</b>
Distance (ft):	<b>72.3</b>
Structural Grade:	<b>0</b>
O&M Grade:	<b>0</b>
Clock Start/From:	
Clock To:	
1st Value:	
2nd Value:	
Value Percent:	
Continuous Index:	
Within 8" of Joint:	<b>NO</b>
Remarks:	<b>debris</b>
