## Profile/Photo Observation Report

| Street: | <b>37th ave</b> | Flow Control: | <b>Not Controlled</b> |
| City: | <b>Hobart, IN</b> | Year Renewed: | |

| US MH: | <b>M-902-057</b> | DS MH: | <b>M-902-058</b> |

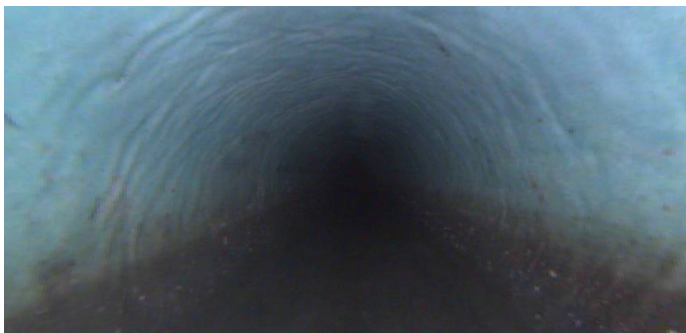
Code: **AMH**  
Description: **Manhole**

Distance (ft): **.0**  
Structural Grade: **0**  
O&M Grade: **0**  
Clock Start/From:  
Clock To:  
1st Value:  
2nd Value:  
Value Percent:  
Continuous Index:  
Within 8" of Joint: **NO**  
Remarks: **M-902-058**

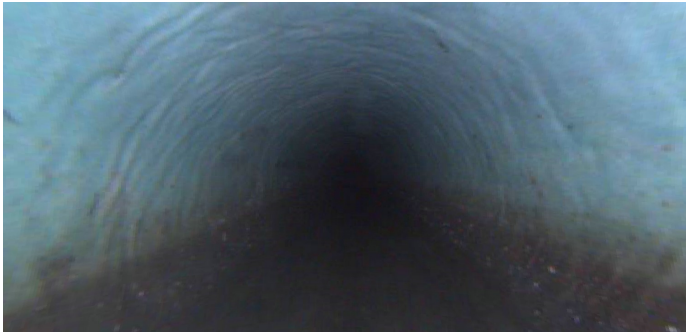
| Code: | <b>MWL</b> |
| Description: | <b>Water Level</b> |

| Value Percent: | <b>5.000</b> |

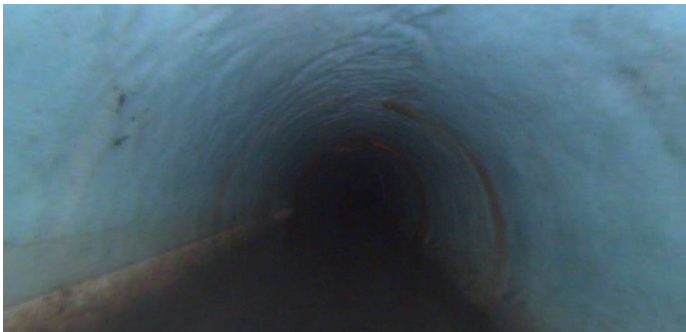
| Code: | <b>MSA</b> |
| Description: | <b>Abandoned Survey</b> |

| Distance (ft): | <b>30.6</b> |
| Remarks: | <b>camera stopped</b> |
