Profile/Photo Observation Report

Date:	03/21/2018	Weather:		Coding:	PACP 6.0
Pipe Length (ft):	174.2	Owner:	NA	Pre Clean:	Not Known
P.O.#:		Surveyor:	Selasie Honu	PSR:	P-902-059-058
Customer:		Clean Date:	01/01/1900	Shape:	C

Street:	E 36TH ST & RUSH PL	Flow Control:	Not Controlled
City:	Hobart, IN	Year Renewed:	
Location:	Other	Tape/Media #:	
Purpose:	Not Known	Dia/Height:	10"
Use:	Sanitary	Material:	PVC
Drain Area:	NA	Lining:	Cured in Place
Category:	NA		
Comment:

Location Details:		Direction of Survey:	Upstream
US MH:	M-902-058	DS MH:	M-902-059
		Total Length Surveyed (ft):	79.4

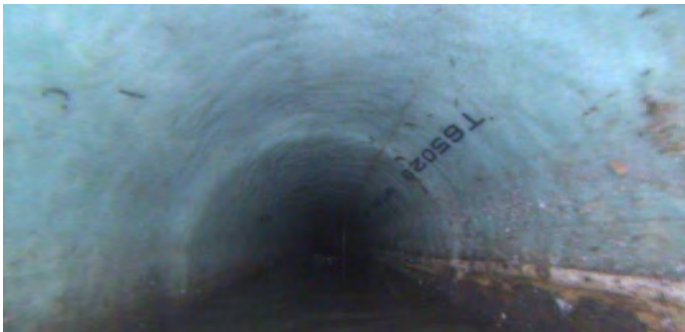
Code:	FL
Description:	Fracture Longitudinal

Distance (ft):	.0
Structural Grade:	3
O&M Grade:	0
Clock Start/From:	1
Clock To:	
1st Value:	
2nd Value:	
Value Percent:	
Continuous Index:	S01
Within 8" of Joint:	
Remarks:

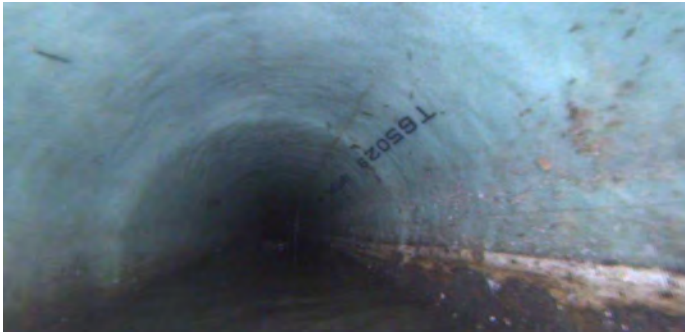
Code: **FL**
Description: **Fracture Longitudinal**

Distance (ft): **.0**
Structural Grade: **3**
O&M Grade: **0**
Clock Start/From: **3**
Clock To:
1st Value:
2nd Value:
Value Percent:
Continuous Index: **S03**
Within 8" of Joint:
Remarks:

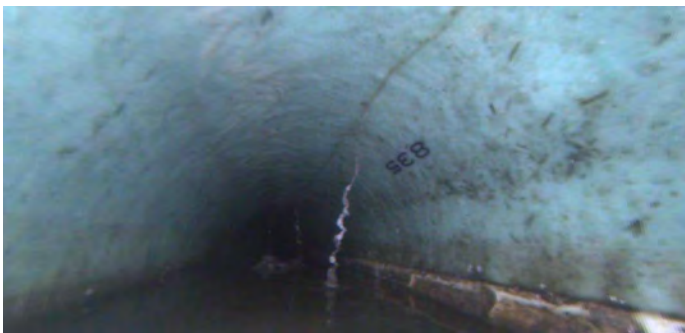
Code: **RFB**
Description: **Roots Fine Barrel**

Distance (ft): **2.8**
Structural Grade: **0**
O&M Grade: **2**
Clock Start/From: **1**
Clock To:
1st Value:
2nd Value:
Value Percent:
Continuous Index:
Within 8" of Joint: **NO**
Remarks:

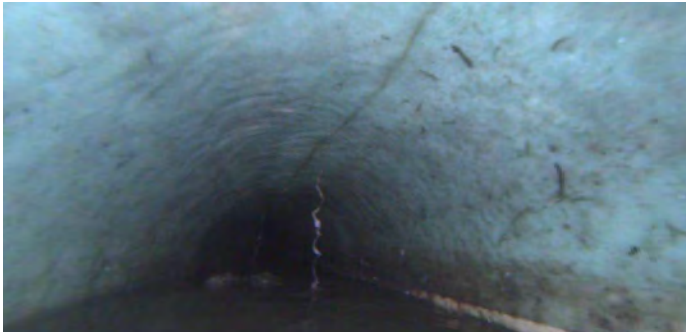
Code: **RFB**
Description: **Roots Fine Barrel**

Distance (ft): **3.6**
Structural Grade: **0**
O&M Grade: **2**
Clock Start/From: **1**
Clock To:
1st Value:
2nd Value:
Value Percent:
Continuous Index:
Within 8" of Joint: **NO**
Remarks:

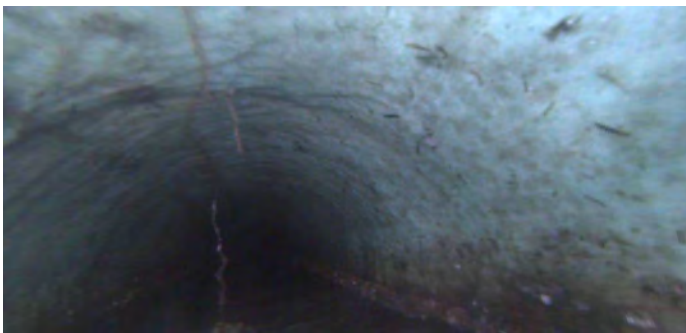
Code: **RFB**
Description: **Roots Fine Barrel**

Distance (ft): **4.4**
Structural Grade: **0**
O&M Grade: **2**
Clock Start/From: **12**
Clock To:
1st Value:
2nd Value:
Value Percent:
Continuous Index:
Within 8" of Joint: **NO**
Remarks:

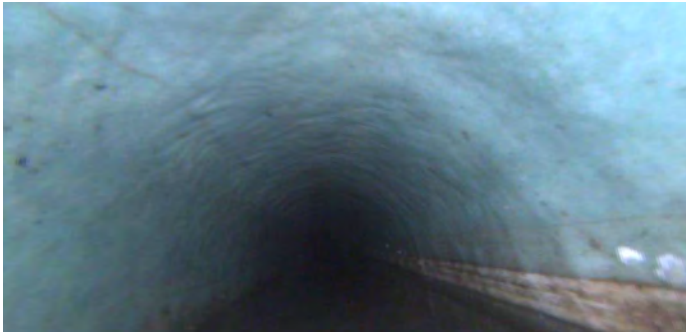
Code: **FL**
Description: **Fracture Longitudinal**

Distance (ft): **10.4**
Structural Grade: **3**
O&M Grade: **0**
Clock Start/From: **1**
Clock To:
1st Value:
2nd Value:
Value Percent:
Continuous Index: **F01**
Within 8" of Joint:
Remarks:

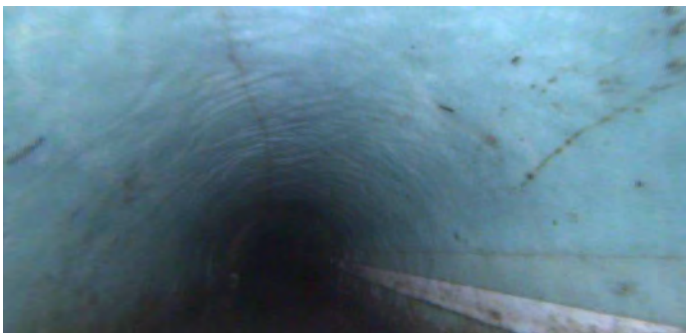
Code: **FL**
Description: **Fracture Longitudinal**

Distance (ft): **15.1**
Structural Grade: **3**
O&M Grade: **0**
Clock Start/From: **12**
Clock To:
1st Value:
2nd Value:
Value Percent:
Continuous Index: **S02**
Within 8" of Joint:
Remarks:

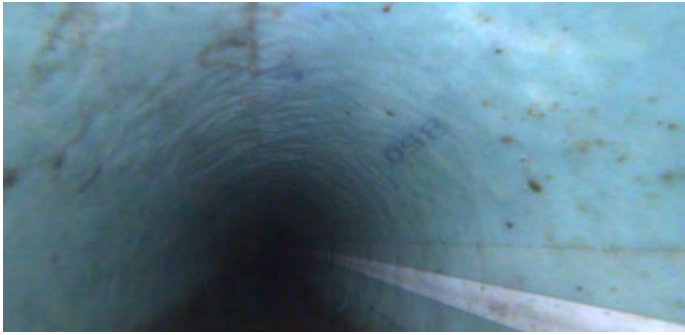
Code: **FL**
Description: **Fracture Longitudinal**

Distance (ft): **18.1**
Structural Grade: **3**
O&M Grade: **0**
Clock Start/From: **12**
Clock To:
1st Value:
2nd Value:
Value Percent:
Continuous Index: **F02**
Within 8" of Joint:
Remarks:

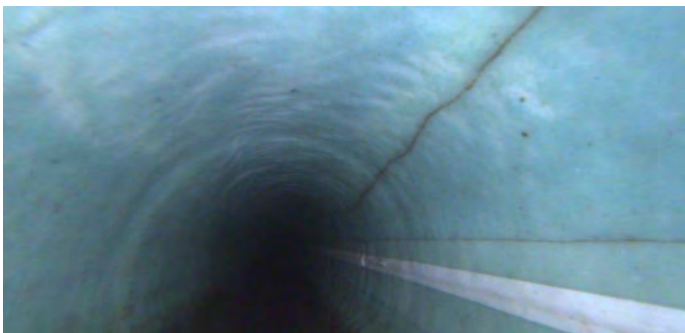
Code: **FL**
Description: **Fracture Longitudinal**

Distance (ft): **30.8**
Structural Grade: **3**
O&M Grade: **0**
Clock Start/From: **1**
Clock To:
1st Value:
2nd Value:
Value Percent:
Continuous Index:
Within 8" of Joint:
Remarks:

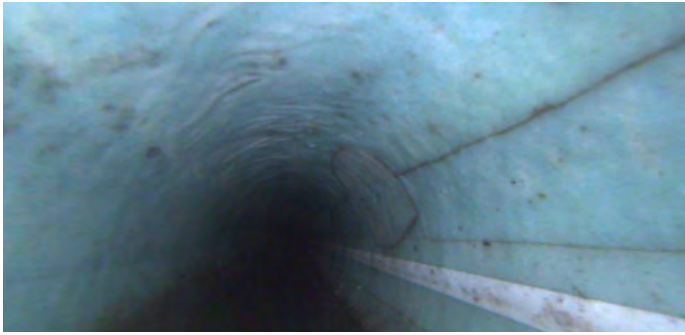
Code: **FL**
Description: **Fracture Longitudinal**

Distance (ft): **35.8**
Structural Grade: **3**
O&M Grade: **0**
Clock Start/From: **1**
Clock To:
1st Value:
2nd Value:
Value Percent:
Continuous Index:
Within 8" of Joint:
Remarks:

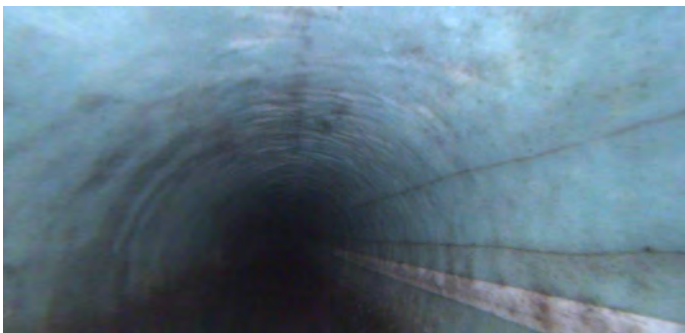
Code: **FL**
Description: **Fracture Longitudinal**

Distance (ft): **39.0**
Structural Grade: **3**
O&M Grade: **0**
Clock Start/From: **1**
Clock To:
1st Value:
2nd Value:
Value Percent:
Continuous Index:
Within 8" of Joint:
Remarks:

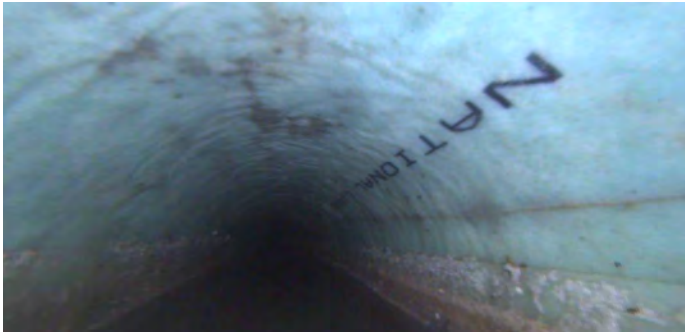
Code: **FL**
Description: **Fracture Longitudinal**

Distance (ft): **47.8**
Structural Grade: **3**
O&M Grade: **0**
Clock Start/From: **3**
Clock To:
1st Value:
2nd Value:
Value Percent:
Continuous Index: **F03**
Within 8" of Joint:
Remarks:

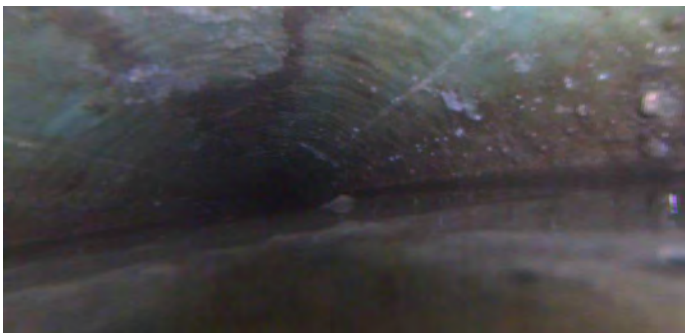
Code: **MWLS**
Description: **Water Level Sag**

Distance (ft): **56.3**
Structural Grade: **2**
O&M Grade: **3**
Clock Start/From:
Clock To:
1st Value:
2nd Value:
Value Percent: **5.000**
Continuous Index: **S04**
Within 8" of Joint: **NO**
Remarks:

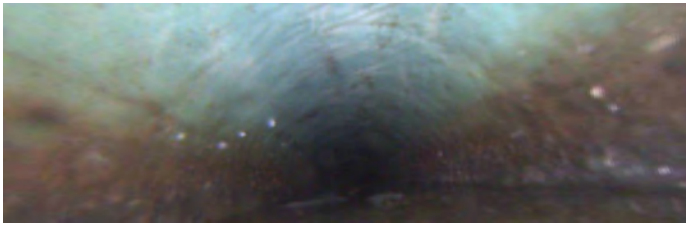
Code: **FL**
Description: **Fracture Longitudinal**

Distance (ft): **60.2**
Structural Grade: **3**
O&M Grade: **0**
Clock Start/From: **10**
Clock To:
1st Value:
2nd Value:
Value Percent:
Continuous Index: **S05**
Within 8" of Joint: **NO**
Remarks:

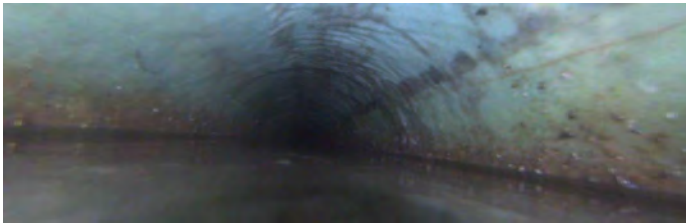
Code: **MWLS**
Description: **Water Level Sag**

Distance (ft): **63.2**
Structural Grade: **2**
O&M Grade: **3**
Clock Start/From:
Clock To:
1st Value:
2nd Value:
Value Percent: **5.000**
Continuous Index: **F04**
Within 8" of Joint: **NO**
Remarks:

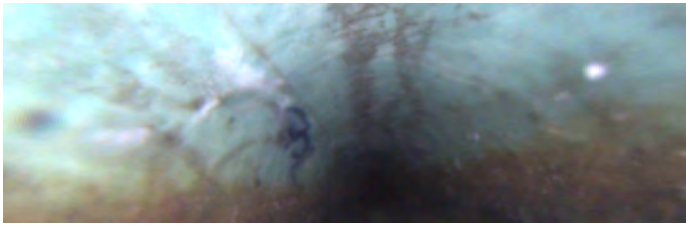
Code: **FL**
Description: **Fracture Longitudinal**

Distance (ft): **66.7**
Structural Grade: **3**
O&M Grade: **0**
Clock Start/From: **10**
Clock To:
1st Value:
2nd Value:
Value Percent:
Continuous Index: **F05**
Within 8" of Joint: **NO**
Remarks:

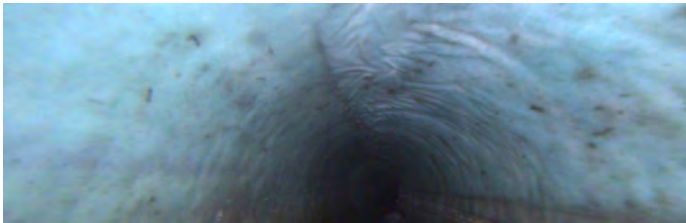
Code: **FL**
Description: **Fracture Longitudinal**

Distance (ft): **76.3**
Structural Grade: **3**
O&M Grade: **0**
Clock Start/From: **12**
Clock To:
1st Value:
2nd Value:
Value Percent:
Continuous Index:
Within 8" of Joint:
Remarks:

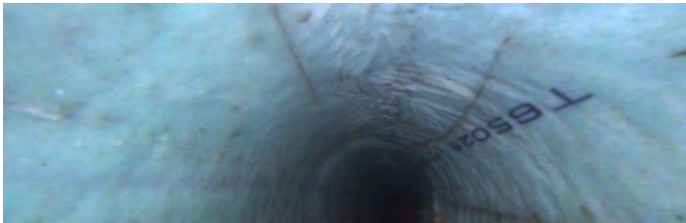
Code: **FL**
Description: **Fracture Longitudinal**

Distance (ft): **77.8**
Structural Grade: **3**
O&M Grade: **0**
Clock Start/From: **1**
Clock To:
1st Value:
2nd Value:
Value Percent:
Continuous Index:
Within 8" of Joint:
Remarks:

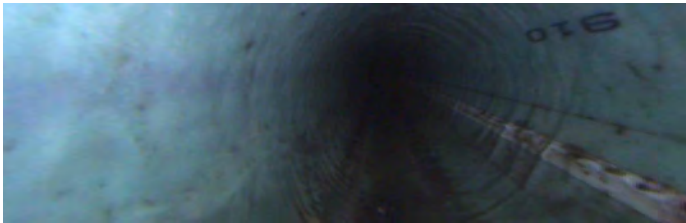
Code: **MSA**
Description: **Abandoned Survey**

Distance (ft): **79.4**
Structural Grade: **0**
O&M Grade: **0**
Clock Start/From:
Clock To:
1st Value:
2nd Value:
Value Percent:
Continuous Index:
Within 8" of Joint: **NO**
Remarks: **camera stopped**
