Profile/Photo Observation Report

Date:	03/21/2018	Weather:		Coding:	PACP 6.0
Pipe Length (ft):	174.2	Owner:	NA	Pre Clean:	Not Known
P.O.#:		Surveyor:	Selasie Honu	PSR:	P-902-059-058
Customer:		Clean Date:	01/01/1900	Shape:	C

Street:	38th pl	Flow Control:	Not Controlled
City:	Hobart, IN	Year Renewed:	
Location:	Other	Tape/Media #:	
Purpose:	Not Known	Dia/Height:	10"
Use:	Sanitary	Material:	PVC
Drain Area:	NA	Lining:	Cured in Place
Category:	NA		
Comment:

Location Details:		Direction of Survey:	Upstream
US MH:	M-902-058	DS MH:	M-902-059
		Total Length Surveyed (ft):	79.4

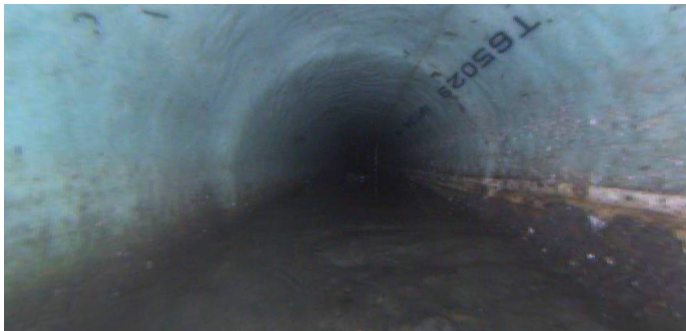
Code: **AMH**
Description: **Manhole**

Distance (ft): **.0**
Structural Grade: **0**
O&M Grade: **0**
Clock Start/From:
Clock To:
1st Value:
2nd Value:
Value Percent:
Continuous Index:
Within 8" of Joint: **NO**
Remarks: **M-902-059**

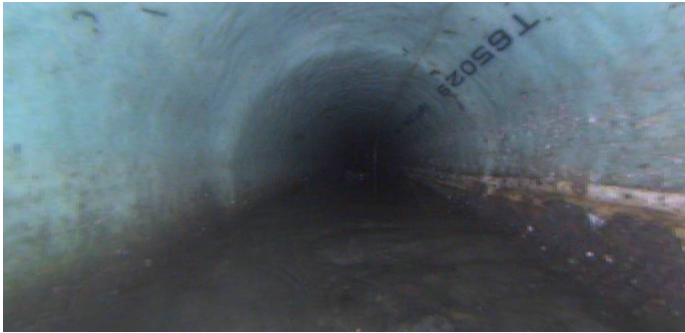
Code:	MWL
Description:	Water Level

Distance (ft):	.0
Structural Grade:	0
O&M Grade:	0
Clock Start/From:	
Clock To:	
1st Value:	
2nd Value:	
Value Percent:	5.000
Continuous Index:	
Within 8" of Joint:	NO
Remarks:

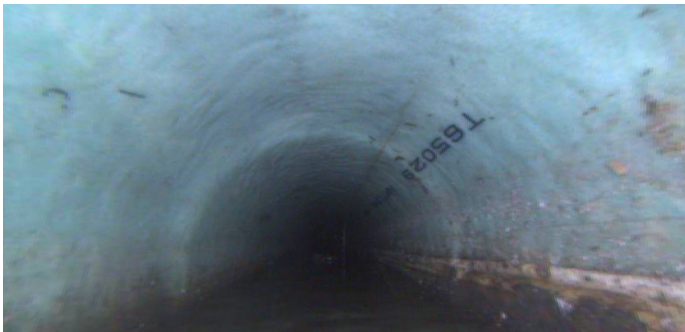
Code:	FL
Description:	Fracture Longitudinal

Distance (ft):	.0
Structural Grade:	3
O&M Grade:	0
Clock Start/From:	1
Clock To:	
1st Value:	
2nd Value:	
Value Percent:	
Continuous Index:	S01
Within 8" of Joint:	
Remarks:

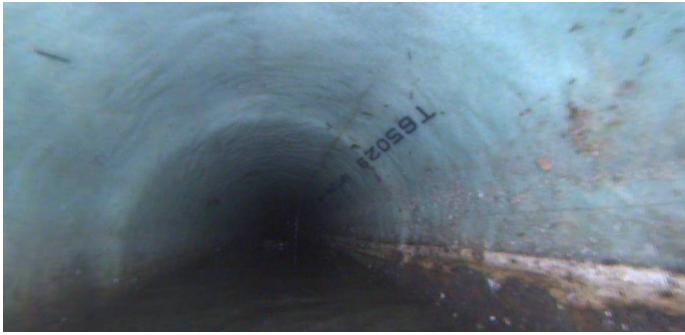
Code: **FL**
Description: **Fracture Longitudinal**

Distance (ft): **.0**
Structural Grade: **3**
O&M Grade: **0**
Clock Start/From: **3**
Clock To:
1st Value:
2nd Value:
Value Percent:
Continuous Index: **S03**
Within 8" of Joint:
Remarks:

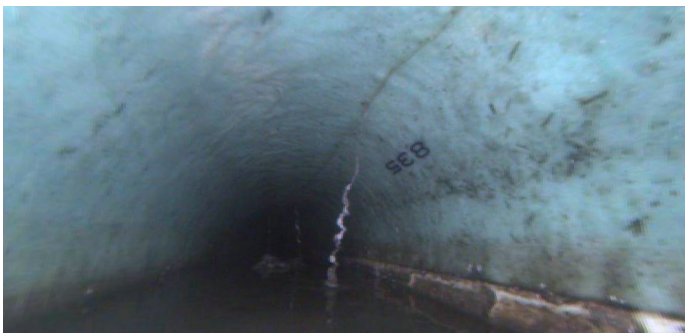
Code: **RFB**
Description: **Roots Fine Barrel**

Distance (ft): **2.8**
Structural Grade: **0**
O&M Grade: **2**
Clock Start/From: **1**
Clock To:
1st Value:
2nd Value:
Value Percent:
Continuous Index:
Within 8" of Joint: **NO**
Remarks:

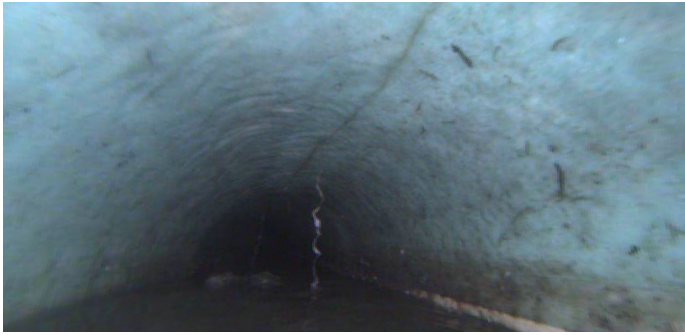
Code: **RFB**
Description: **Roots Fine Barrel**

Distance (ft): **3.6**
Structural Grade: **0**
O&M Grade: **2**
Clock Start/From: **1**
Clock To:
1st Value:
2nd Value:
Value Percent:
Continuous Index:
Within 8" of Joint: **NO**
Remarks:

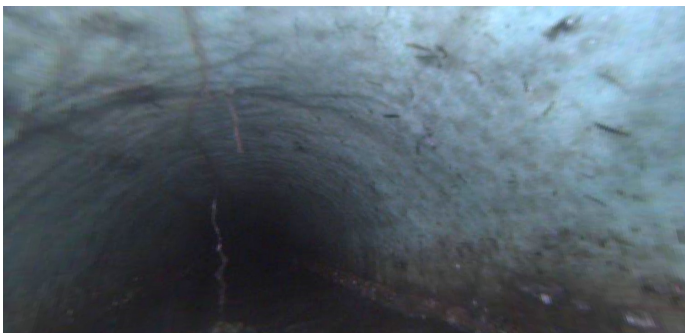
Code: **RFB**
Description: **Roots Fine Barrel**

Distance (ft): **4.4**
Structural Grade: **0**
O&M Grade: **2**
Clock Start/From: **12**
Clock To:
1st Value:
2nd Value:
Value Percent:
Continuous Index:
Within 8" of Joint: **NO**
Remarks:

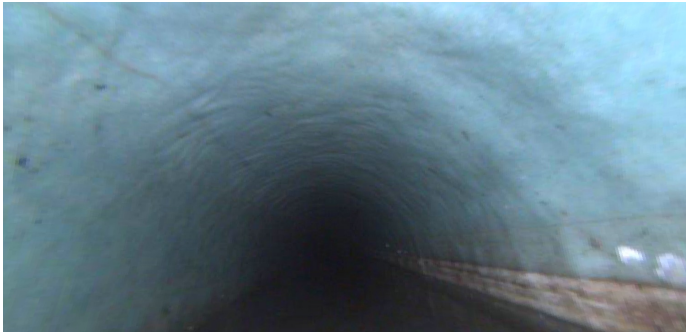
Code: **FL**
Description: **Fracture Longitudinal**

Distance (ft): **10.4**
Structural Grade: **3**
O&M Grade: **0**
Clock Start/From: **1**
Clock To:
1st Value:
2nd Value:
Value Percent:
Continuous Index: **F01**
Within 8" of Joint:
Remarks:

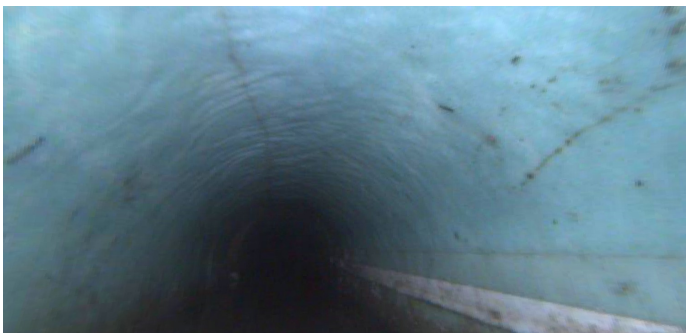
Code: **FL**
Description: **Fracture Longitudinal**

Distance (ft): **15.1**
Structural Grade: **3**
O&M Grade: **0**
Clock Start/From: **12**
Clock To:
1st Value:
2nd Value:
Value Percent:
Continuous Index: **S02**
Within 8" of Joint:
Remarks:

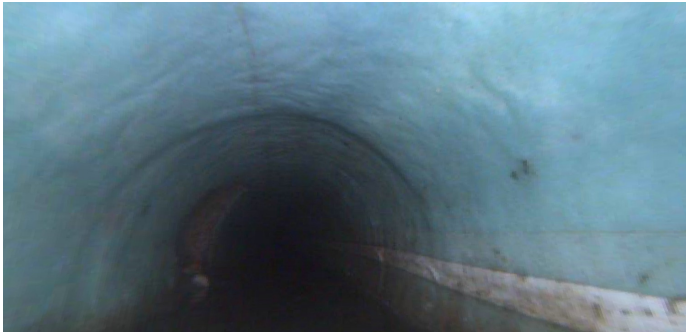
Code: **TF**
Description: **Tap Factory**

Distance (ft): **15.9**
Structural Grade: **0**
O&M Grade: **0**
Clock Start/From: **9**
Clock To:
1st Value: **4.000**
2nd Value:
Value Percent:
Continuous Index:
Within 8" of Joint:
Remarks:

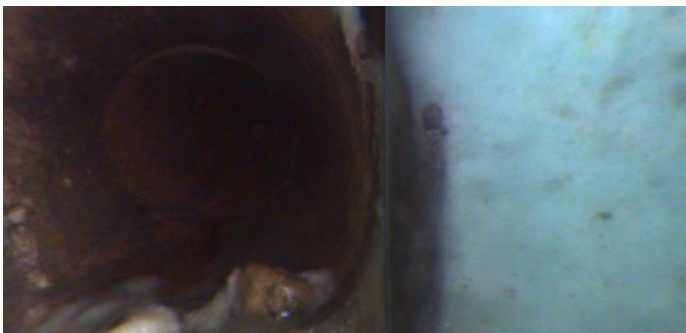
Code: **TF**
Description: **Tap Factory**

Distance (ft): **17.4**
Structural Grade: **0**
O&M Grade: **0**
Clock Start/From: **9**
Clock To:
1st Value: **4.000**
2nd Value:
Value Percent:
Continuous Index:
Within 8" of Joint:
Remarks:

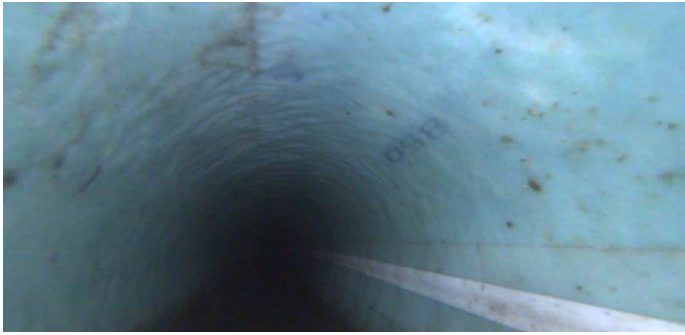
Code: **FL**
Description: **Fracture Longitudinal**

Distance (ft): **18.1**
Structural Grade: **3**
O&M Grade: **0**
Clock Start/From: **12**
Clock To:
1st Value:
2nd Value:
Value Percent:
Continuous Index: **F02**
Within 8" of Joint:
Remarks:

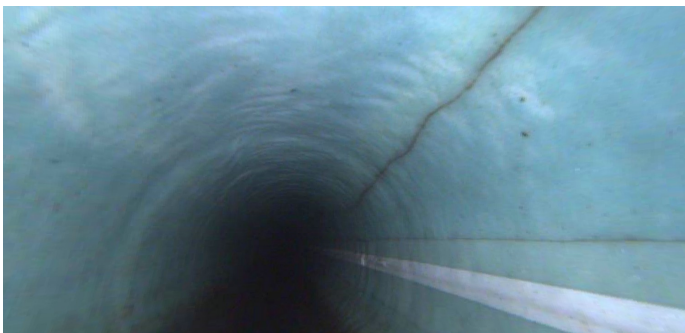
Code: **FL**
Description: **Fracture Longitudinal**

Distance (ft): **30.8**
Structural Grade: **3**
O&M Grade: **0**
Clock Start/From: **1**
Clock To:
1st Value:
2nd Value:
Value Percent:
Continuous Index:
Within 8" of Joint:
Remarks:

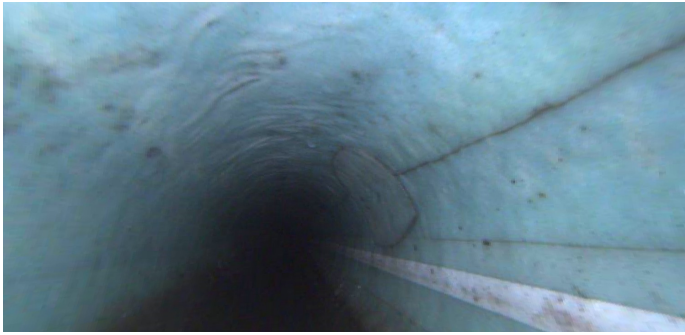
Code: **FL**
Description: **Fracture Longitudinal**

Distance (ft): **35.8**
Structural Grade: **3**
O&M Grade: **0**
Clock Start/From: **1**
Clock To:
1st Value:
2nd Value:
Value Percent:
Continuous Index:
Within 8" of Joint:
Remarks:

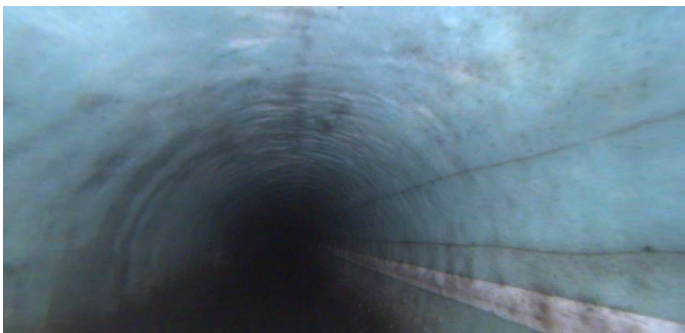
Code: **FL**
Description: **Fracture Longitudinal**

Distance (ft): **39.0**
Structural Grade: **3**
O&M Grade: **0**
Clock Start/From: **1**
Clock To:
1st Value:
2nd Value:
Value Percent:
Continuous Index:
Within 8" of Joint:
Remarks:

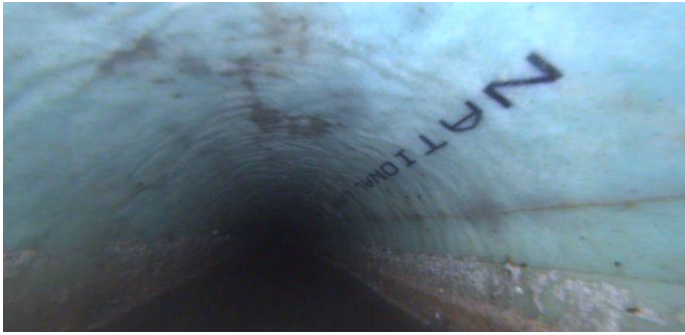
Code: **FL**
Description: **Fracture Longitudinal**

Distance (ft): **47.8**
Structural Grade: **3**
O&M Grade: **0**
Clock Start/From: **3**
Clock To:
1st Value:
2nd Value:
Value Percent:
Continuous Index: **F03**
Within 8" of Joint:
Remarks:

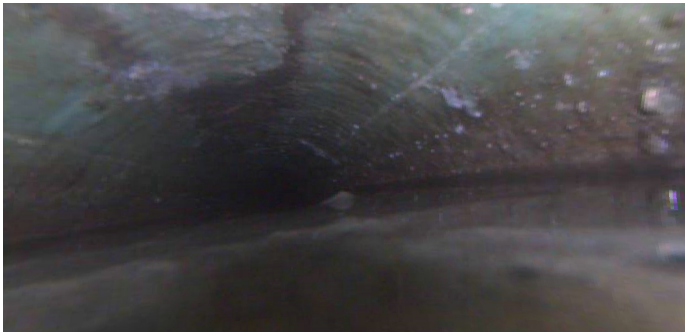
Code: **MWLS**
Description: **Water Level Sag**

Distance (ft): **56.3**
Structural Grade: **2**
O&M Grade: **3**
Clock Start/From:
Clock To:
1st Value:
2nd Value:
Value Percent: **5.000**
Continuous Index: **S04**
Within 8" of Joint: **NO**
Remarks:

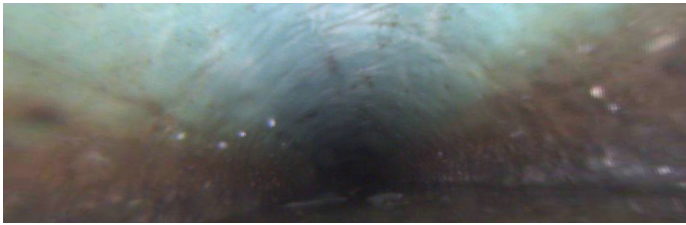
Code: **FL**
Description: **Fracture Longitudinal**

Distance (ft): **60.2**
Structural Grade: **3**
O&M Grade: **0**
Clock Start/From: **10**
Clock To:
1st Value:
2nd Value:
Value Percent:
Continuous Index: **S05**
Within 8" of Joint: **NO**
Remarks:

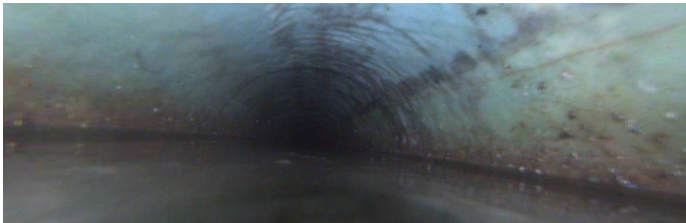
Code: **MWLS**
Description: **Water Level Sag**

Distance (ft): **63.2**
Structural Grade: **2**
O&M Grade: **3**
Clock Start/From:
Clock To:
1st Value:
2nd Value:
Value Percent: **5.000**
Continuous Index: **F04**
Within 8" of Joint: **NO**
Remarks:

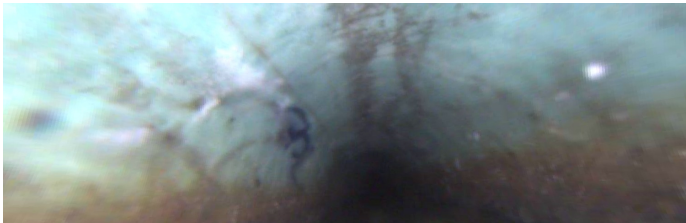
Code: **FL**
Description: **Fracture Longitudinal**

Distance (ft): **66.7**
Structural Grade: **3**
O&M Grade: **0**
Clock Start/From: **10**
Clock To:
1st Value:
2nd Value:
Value Percent:
Continuous Index: **F05**
Within 8" of Joint: **NO**
Remarks:

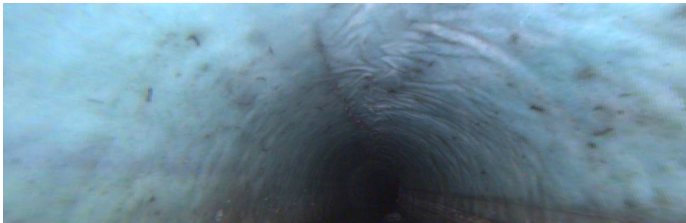
Code: **FL**
Description: **Fracture Longitudinal**

Distance (ft): **76.3**
Structural Grade: **3**
O&M Grade: **0**
Clock Start/From: **12**
Clock To:
1st Value:
2nd Value:
Value Percent:
Continuous Index:
Within 8" of Joint:
Remarks:

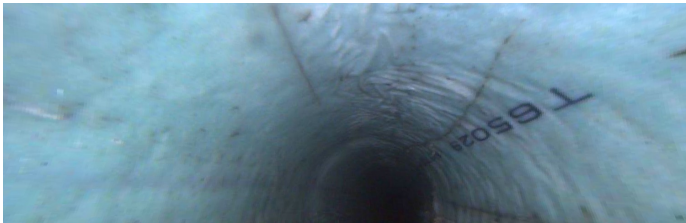
Code: **FL**
Description: **Fracture Longitudinal**

Distance (ft): **77.8**
Structural Grade: **3**
O&M Grade: **0**
Clock Start/From: **1**
Clock To:
1st Value:
2nd Value:
Value Percent:
Continuous Index:
Within 8" of Joint:
Remarks:

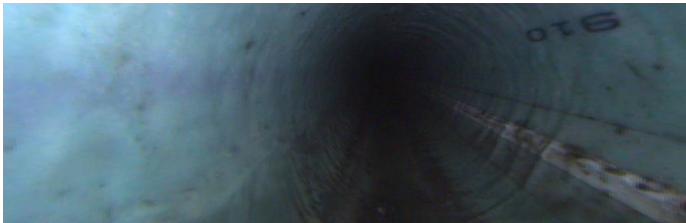
Code: **MSA**
Description: **Abandoned Survey**

Distance (ft): **79.4**
Structural Grade: **0**
O&M Grade: **0**
Clock Start/From:
Clock To:
1st Value:
2nd Value:
Value Percent:
Continuous Index:
Within 8" of Joint: **NO**
Remarks: **camera stopped**
