Profile/Photo Observation Report

Street:	38th pl	Flow Control:	Not Controlled
City:	Hobart, IN	Year Renewed:	
Location:	Other	Tape/Media #:	
Purpose:	Not Known	Dia/Height:	10"
Use:	Sanitary	Material:	VCP
Drain Area:	NA	Lining:	
Category:	NA		
Comment:

Location Details:		Direction of Survey:	Downstream
US MH:	M-902-059	DS MH:	M-902-048
		Total Length Surveyed (ft):	17.6

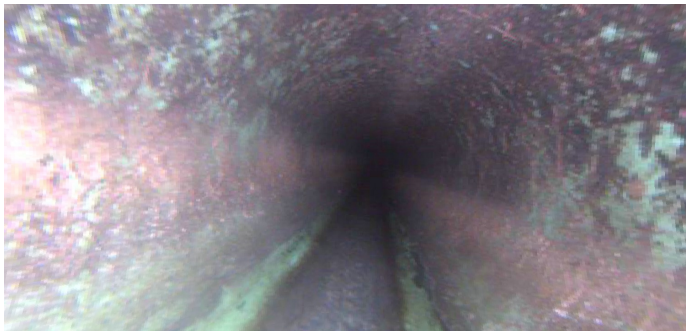
Code: **AMH**
Description: **Manhole**

Distance (ft): **.0**
Structural Grade: **0**
O&M Grade: **0**
Clock Start/From:
Clock To:
1st Value:
2nd Value:
Value Percent:
Continuous Index:
Within 8" of Joint: **NO**
Remarks: **M-902-059**

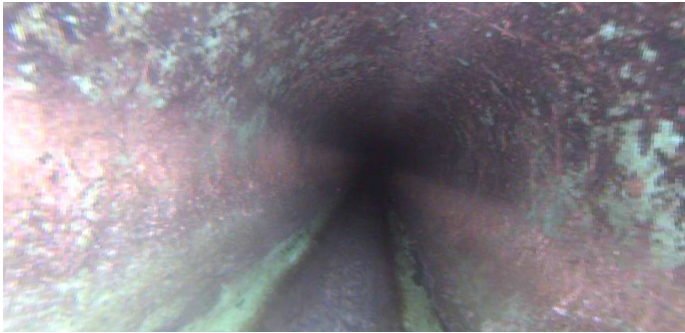
Code:	MWL
Description:	Water Level

Distance (ft):	.0
Structural Grade:	0
O&M Grade:	0
Clock Start/From:	
Clock To:	
1st Value:	
2nd Value:	
Value Percent:	5.000
Continuous Index:	
Within 8" of Joint:	NO
Remarks:

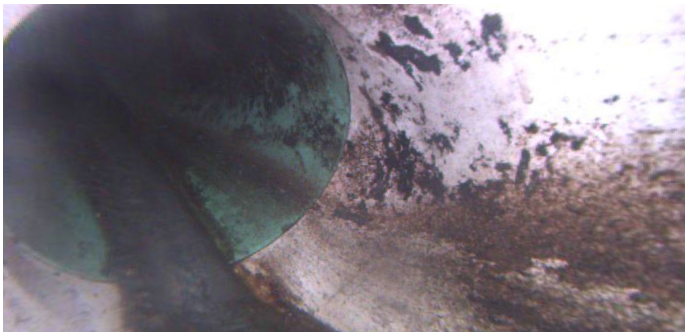
Code:	LLU
Description:	Alignment Left Up

Distance (ft):	15.9
Structural Grade:	0
O&M Grade:	1
Clock Start/From:	
Clock To:	
1st Value:	
2nd Value:	
Value Percent:	10.000
Continuous Index:	
Within 8" of Joint:	NO
Remarks:

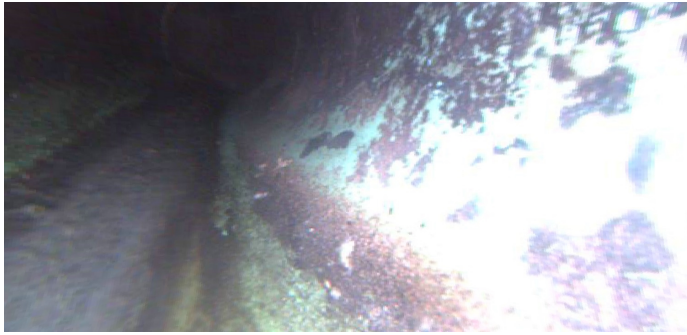
Code:	MSA
Description:	Abandoned Survey
Distance (ft):	17.6
Structural Grade:	0
O&M Grade:	0
Clock Start/From:	
Clock To:	
1st Value:	
2nd Value:	
Value Percent:	
Continuous Index:	
Within 8" of Joint:	NO
Remarks:	BEND
