Profile/Photo Observation Report

Date:	03/21/2018	Weather:		Coding:	PACP 6.0
Pipe Length (ft):	24.4	Owner:	NA	Pre Clean:	Not Known
P.O.#:		Surveyor:	Selasie Honu	PSR:	P-902-048-059
Customer:		Clean Date:	01/01/1900	Shape:	C

Street:	38th pl	Flow Control:	Not Controlled
City:	Hobart, IN	Year Renewed:	
Location:	Other	Tape/Media #:	
Purpose:	Not Known	Dia/Height:	10"
Use:	Sanitary	Material:	PVC
Drain Area:	NA	Lining:	
Category:	NA		
Comment:

Location Details:		Direction of Survey:	Upstream
US MH:	M-902-059	DS MH:	M-902-048
		Total Length Surveyed (ft):	3.3

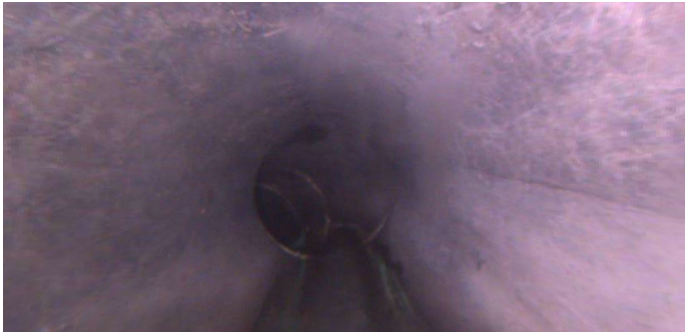
Code:	MWL
Description:	Water Level

Distance (ft):	.0
Structural Grade:	0
O&M Grade:	0
Clock Start/From:	
Clock To:	
1st Value:	
2nd Value:	
Value Percent:	5.000
Continuous Index:	
Within 8" of Joint:	NO
Remarks:

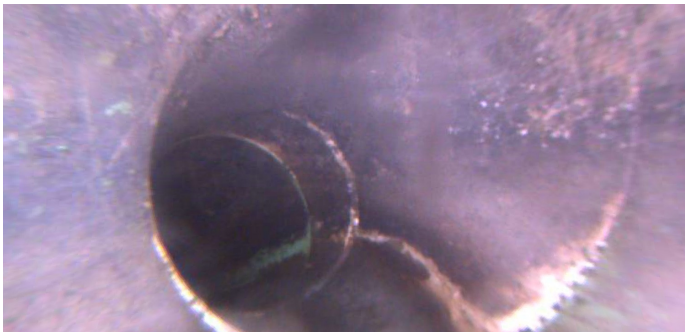
Code:	LLD
Description:	Alignment Left Down

Distance (ft):	2.0
Structural Grade:	0
O&M Grade:	1
Clock Start/From:	
Clock To:	
1st Value:	
2nd Value:	
Value Percent:	10.000
Continuous Index:	
Within 8" of Joint:	NO
Remarks:

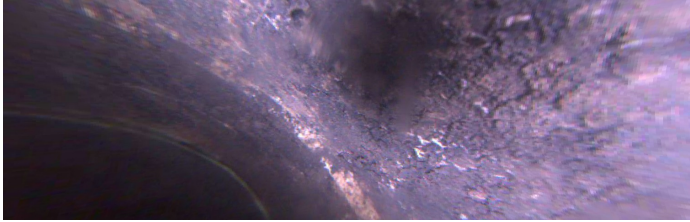
Code:	MSA
Description:	Abandoned Survey
Distance (ft):	3.3
Structural Grade:	0
O&M Grade:	0
Clock Start/From:	
Clock To:	
1st Value:	
2nd Value:	
Value Percent:	
Continuous Index:	
Within 8" of Joint:	NO
Remarks:	bend
