Profile/Photo Observation Report

Street:	RUSH PL	Flow Control:	Not Controlled
City:	Hobart, IN	Year Renewed:	
Location:	Other	Tape/Media #:	
Purpose:	Not Known	Dia/Height:	10"
Use:	Sanitary	Material:	PVC
Drain Area:	NA	Lining:	Cured in Place
Category:	NA		
Comment:

Location Details:		Direction of Survey:	Upstream
US MH:	M-902-060	DS MH:	M-902-059
		Total Length Surveyed (ft):	110.3

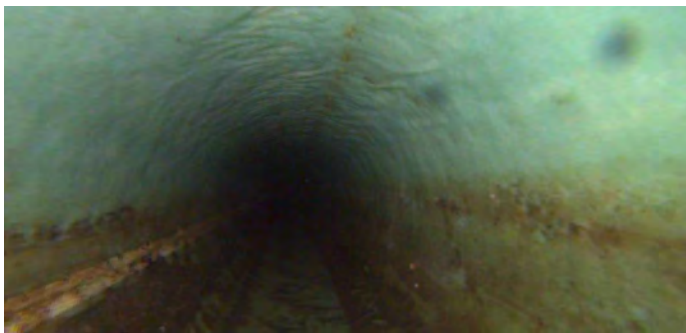
Code: **AMH**
Description: **Manhole**

Distance (ft): **.0**
Structural Grade: **0**
O&M Grade: **0**
Clock Start/From:
Clock To:
1st Value:
2nd Value:
Value Percent:
Continuous Index:
Within 8" of Joint: **NO**
Remarks: **M-902-059**

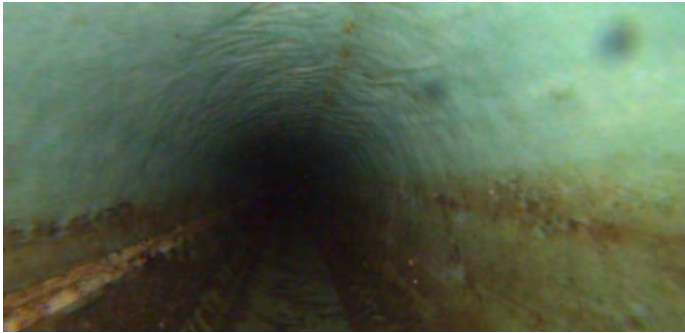
Code:	MWL
Description:	Water Level

Distance (ft):	.0
Structural Grade:	0
O&M Grade:	0
Clock Start/From:	
Clock To:	
1st Value:	
2nd Value:	
Value Percent:	5.000
Continuous Index:	
Within 8" of Joint:	NO
Remarks:

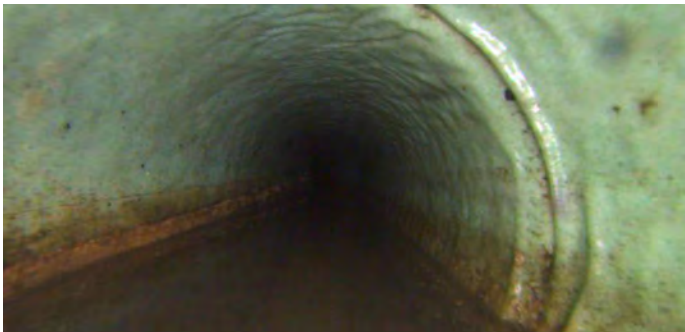
Code:	LR
Description:	Alignment Right

Distance (ft):	77.7
Structural Grade:	0
O&M Grade:	1
Clock Start/From:	
Clock To:	
1st Value:	
2nd Value:	
Value Percent:	5.000
Continuous Index:	
Within 8" of Joint:	NO
Remarks:

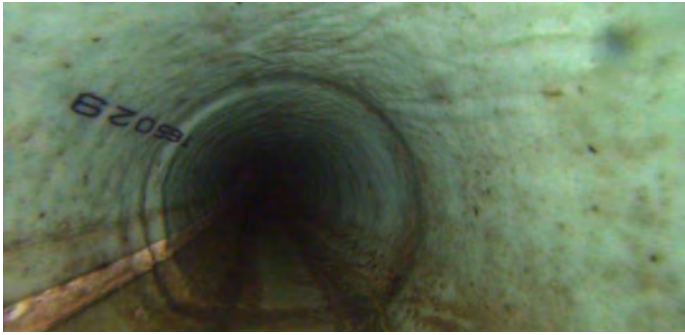
Code: **LL**
Description: **Alignment Left**

Distance (ft): **80.4**
Structural Grade: **0**
O&M Grade: **1**
Clock Start/From:
Clock To:
1st Value:
2nd Value:
Value Percent: **5.000**
Continuous Index:
Within 8" of Joint: **NO**
Remarks:

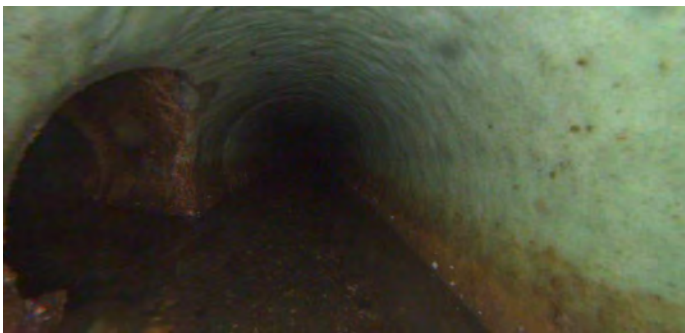
Code: **TFA**
Description: **Tap Factory Active**

Distance (ft): **91.5**
Structural Grade: **0**
O&M Grade: **0**
Clock Start/From: **9**
Clock To:
1st Value: **4.000**
2nd Value:
Value Percent:
Continuous Index:
Within 8" of Joint:
Remarks:

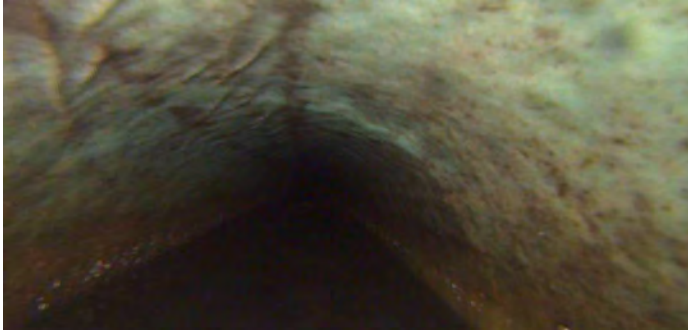
Code:	MSA
Description:	Abandoned Survey
Distance (ft):	110.3
Structural Grade:	0
O&M Grade:	0
Clock Start/From:	
Clock To:	
1st Value:	
2nd Value:	
Value Percent:	
Continuous Index:	
Within 8" of Joint:	NO
Remarks:	camera stopped
