Profile/Photo Observation Report

Street:	38th pl	Flow Control:	Not Controlled
City:	Hobart, IN	Year Renewed:	
Location:	Other	Tape/Media #:	
Purpose:	Not Known	Dia/Height:	10"
Use:	Sanitary	Material:	PVC
Drain Area:	NA	Lining:	Cured in Place
Category:	NA		
Comment:

Location Details:		Direction of Survey:	Upstream
US MH:	M-902-060	DS MH:	M-902-059
		Total Length Surveyed (ft):	110.3

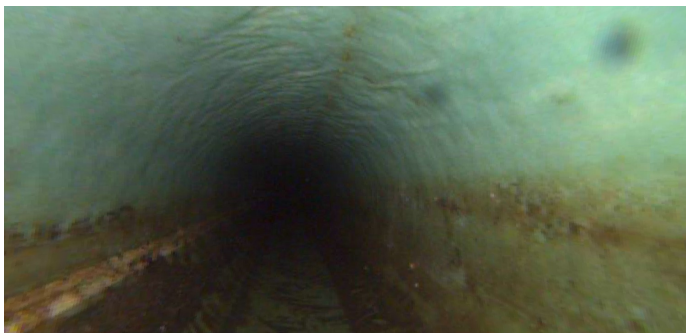
Code: **AMH**
Description: **Manhole**

Distance (ft): **.0**
Structural Grade: **0**
O&M Grade: **0**
Clock Start/From:
Clock To:
1st Value:
2nd Value:
Value Percent:
Continuous Index:
Within 8" of Joint: **NO**
Remarks: **M-902-059**

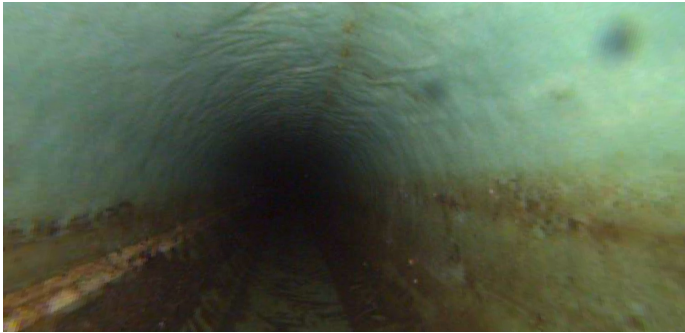
Code:	MWL
Description:	Water Level

Distance (ft):	.0
Structural Grade:	0
O&M Grade:	0
Clock Start/From:	
Clock To:	
1st Value:	
2nd Value:	
Value Percent:	5.000
Continuous Index:	
Within 8" of Joint:	NO
Remarks:

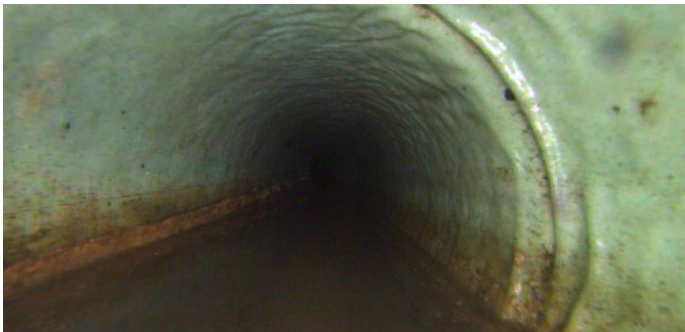
Code:	LR
Description:	Alignment Right

Distance (ft):	77.7
Structural Grade:	0
O&M Grade:	1
Clock Start/From:	
Clock To:	
1st Value:	
2nd Value:	
Value Percent:	5.000
Continuous Index:	
Within 8" of Joint:	NO
Remarks:

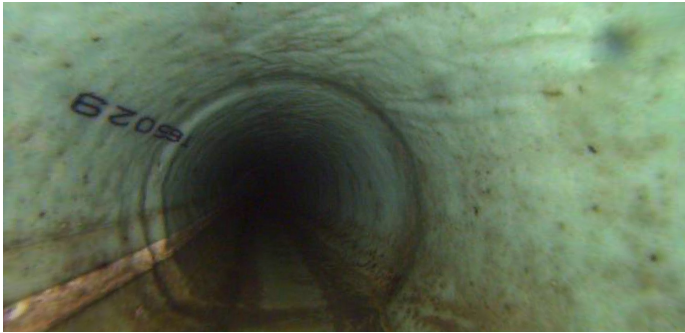
Code: **LL**
Description: **Alignment Left**

Distance (ft): **80.4**
Structural Grade: **0**
O&M Grade: **1**
Clock Start/From:
Clock To:
1st Value:
2nd Value:
Value Percent: **5.000**
Continuous Index:
Within 8" of Joint: **NO**
Remarks:

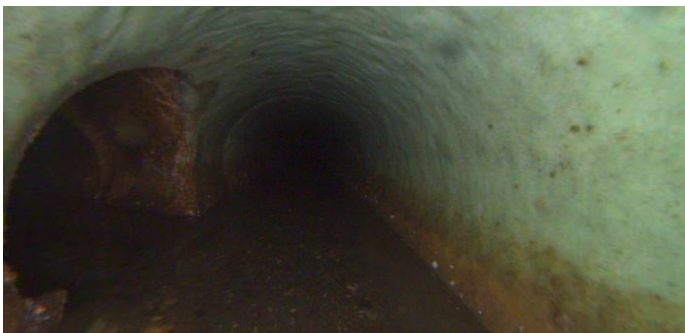
Code: **TFA**
Description: **Tap Factory Active**

Distance (ft): **91.5**
Structural Grade: **0**
O&M Grade: **0**
Clock Start/From: **9**
Clock To:
1st Value: **4.000**
2nd Value:
Value Percent:
Continuous Index:
Within 8" of Joint:
Remarks:

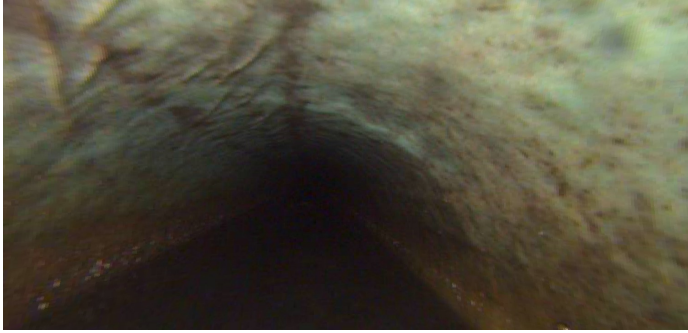
Code:	MSA
Description:	Abandoned Survey
Distance (ft):	110.3
Structural Grade:	0
O&M Grade:	0
Clock Start/From:	
Clock To:	
1st Value:	
2nd Value:	
Value Percent:	
Continuous Index:	
Within 8" of Joint:	NO
Remarks:	camera stopped
