Profile/Photo Observation Report

Date:	03/22/2018	Weather:		Coding:	PACP 6.0
Pipe Length (ft):	406.8	Owner:	NA	Pre Clean:	Not Known
P.O.#:		Surveyor:	Selasie Honu	PSR:	P-902-062-003.5
Customer:		Clean Date:	01/01/1900	Shape:	C

Street:	OFF SAINT JOSEPH PL	Flow Control:	Not Controlled
City:	Hobart, IN	Year Renewed:	
Location:	Other	Tape/Media #:	
Purpose:	Not Known	Dia/Height:	10"
Use:	Sanitary	Material:	PVC
Drain Area:	NA	Lining:	
Category:	NA		
Comment:

Location Details:		Direction of Survey:	Upstream
US MH:	M-902-062	DS MH:	M-902-003.5
		Total Length Surveyed (ft):	329.5

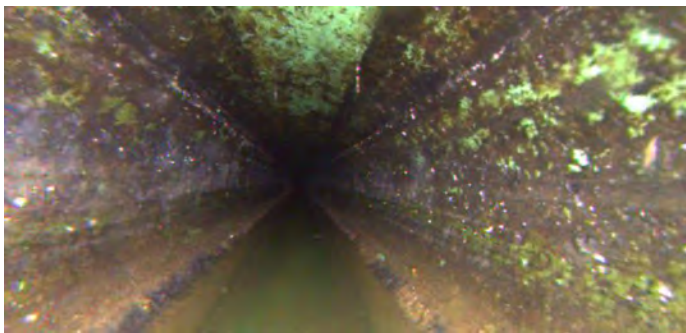
Code: **DAGS**
 Description: **Deposits Attached Grease**

Distance (ft): **.0**
 Structural Grade: **0**
 O&M Grade: **2**
 Clock Start/From: **8**
 Clock To: **4**
 1st Value:
 2nd Value:
 Value Percent: **5.000**
 Continuous Index: **S02**
 Within 8" of Joint: **NO**
 Remarks:

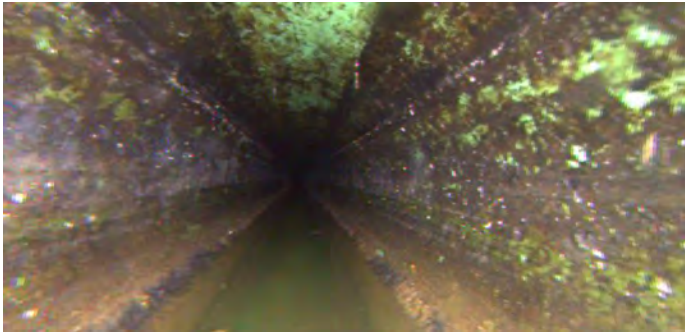
Code:	AMH
Description:	Manhole

Distance (ft):	.0
Structural Grade:	0
O&M Grade:	0
Clock Start/From:	
Clock To:	
1st Value:	
2nd Value:	
Value Percent:	
Continuous Index:	
Within 8" of Joint:	NO
Remarks:	M-902-003.5

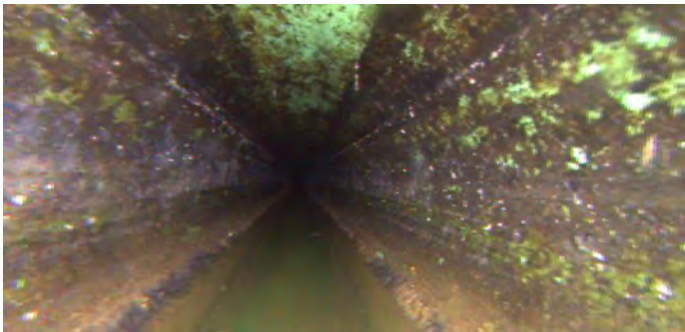
Code:	MWL
Description:	Water Level

Distance (ft):	.0
Structural Grade:	0
O&M Grade:	0
Clock Start/From:	
Clock To:	
1st Value:	
2nd Value:	
Value Percent:	5.000
Continuous Index:	
Within 8" of Joint:	NO
Remarks:

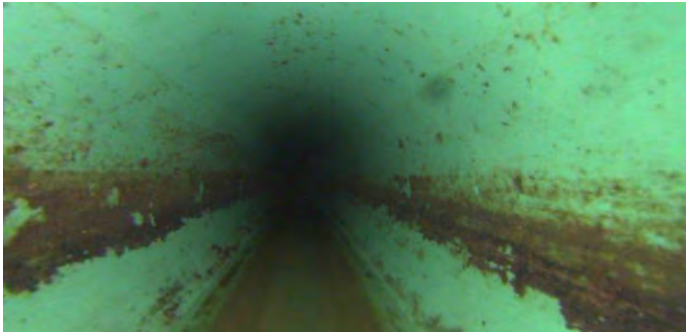
Code: **DAGS**
Description: **Deposits Attached Grease**

Distance (ft): **78.8**
Structural Grade: **0**
O&M Grade: **2**
Clock Start/From: **8**
Clock To: **4**
1st Value:
2nd Value:
Value Percent: **5.000**
Continuous Index: **F02**
Within 8" of Joint: **NO**
Remarks:

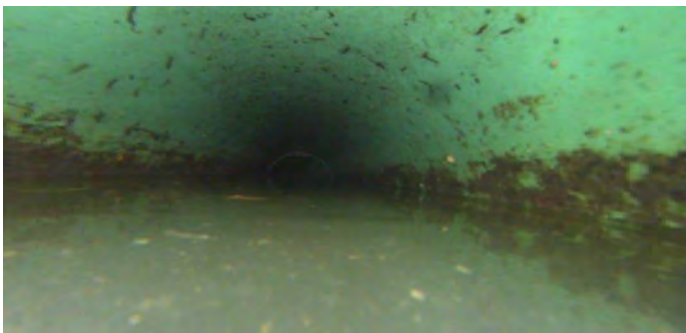
Code: **MWLS**
Description: **Water Level Sag**

Distance (ft): **287.1**
Structural Grade: **2**
O&M Grade: **3**
Clock Start/From:
Clock To:
1st Value:
2nd Value:
Value Percent: **10.000**
Continuous Index: **S01**
Within 8" of Joint: **NO**
Remarks:
