Profile/Photo Observation Report

Date:	03/22/2018	Weather:		Coding:	PACP 6.0
Pipe Length (ft):	406.8	Owner:	NA	Pre Clean:	Not Known
P.O.#:		Surveyor:	Selasie Honu	PSR:	P-902-062-003.5
Customer:		Clean Date:	01/01/1900	Shape:	C

Street:	saint joesph pl	Flow Control:	Not Controlled
City:	Hobart, IN	Year Renewed:	
Location:	Other	Tape/Media #:	
Purpose:	Not Known	Dia/Height:	10"
Use:	Sanitary	Material:	PVC
Drain Area:	NA	Lining:	
Category:	NA		
Comment:

Location Details:		Direction of Survey:	Upstream
US MH:	M-902-062	DS MH:	M-902-003.5
		Total Length Surveyed (ft):	329.5

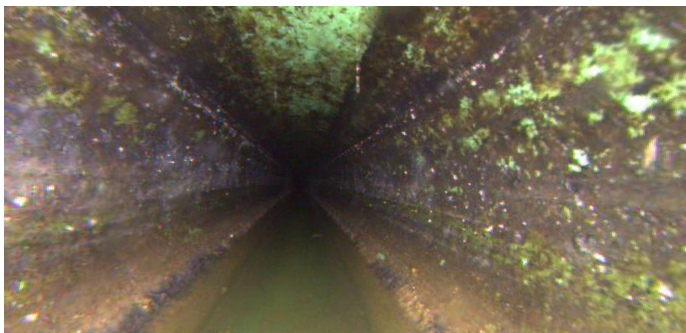
Code: **DAGS**
Description: **Deposits Attached Grease**

Distance (ft): **.0**
Structural Grade: **0**
O&M Grade: **2**
Clock Start/From: **8**
Clock To: **4**
1st Value:
2nd Value:
Value Percent: **5.000**
Continuous Index: **S02**
Within 8" of Joint: **NO**
Remarks:

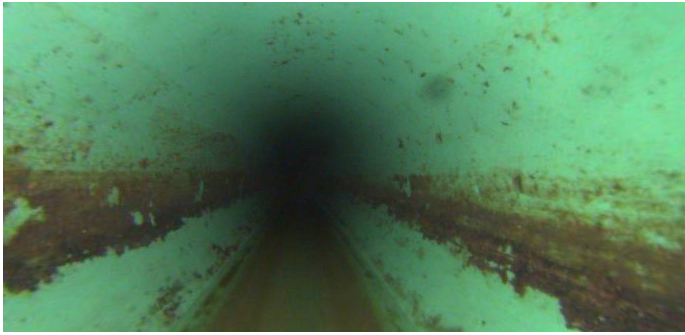
Code: **DAGS**
Description: **Deposits Attached Grease**

Distance (ft): **78.8**
Structural Grade: **0**
O&M Grade: **2**
Clock Start/From: **8**
Clock To: **4**
1st Value:
2nd Value:
Value Percent: **5.000**
Continuous Index: **F02**
Within 8" of Joint: **NO**
Remarks:

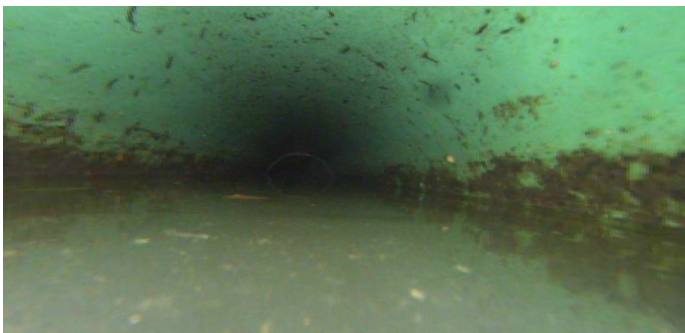
Code: **MWLS**
Description: **Water Level Sag**

Distance (ft): **287.1**
Structural Grade: **2**
O&M Grade: **3**
Clock Start/From:
Clock To:
1st Value:
2nd Value:
Value Percent: **10.000**
Continuous Index: **S01**
Within 8" of Joint: **NO**
Remarks:

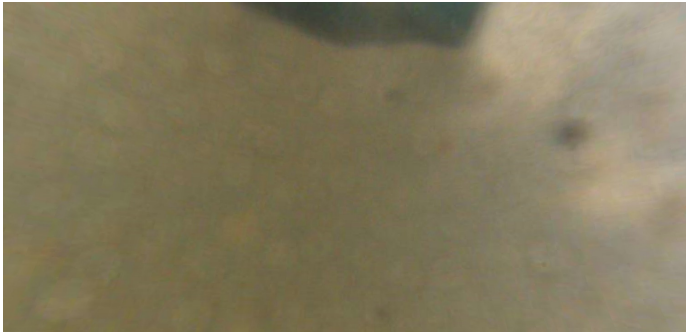
Code: **MCU**
Description: **Camera Underwater**

Distance (ft): **303.0**
Structural Grade: **0**
O&M Grade: **4**
Clock Start/From:
Clock To:
1st Value:
2nd Value:
Value Percent:
Continuous Index: **S03**
Within 8" of Joint: **NO**
Remarks:
