## Profile/Photo Observation Report

| P.O.#: | | Surveyor: | <b>Justin Gonzales</b> | PSR: | <b>P-902-063-062</b> |

| Street: | <b>OFF E 37TH AVE</b> | Flow Control: | <b>Not Controlled</b> |
| City: | <b>Hobart, IN</b> | Year Renewed: | |

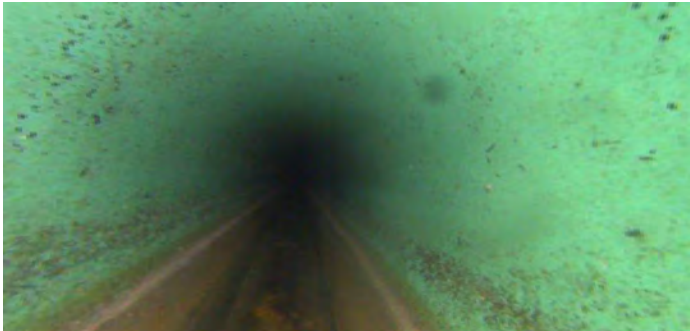
Distance (ft): .0

Code: AMH

Description: Manhole

Remarks: M-902-063

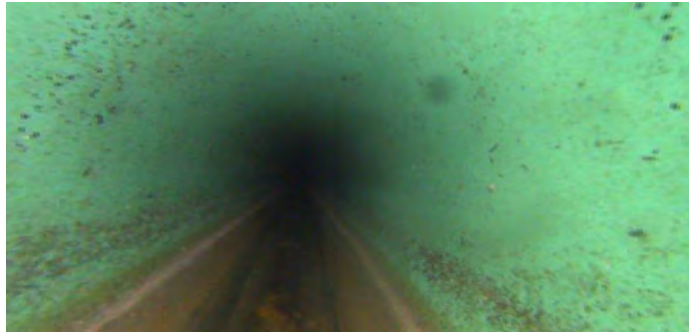
| Code: | MWL |
|---|---|
| Distance (ft): | .0 |

| Code: | MWL |
| Description: | Water Level |
| Value Percent: | 5.000 |

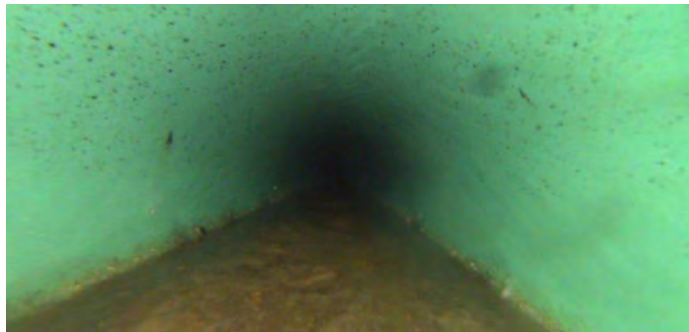
| Code: | MWL |
|---|---|
| Distance (ft): | 314.5 |

| Code: | MWL |
| Description: | Water Level |
| Value Percent: | 20.000 |

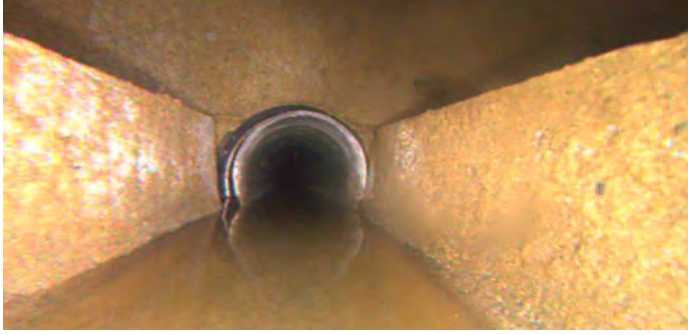
| Distance (ft): | <b>325.1</b> |

| Code: | <b>AMH</b> |
| Description: | <b>Manhole</b> |
| Remarks: | <b>M-902-062</b> |
