Profile/Photo Observation Report

Date:	04/25/2018	Weather:		Coding:	PACP 4.2
Pipe Length (ft):	39.0	Owner:	City of Hobart	Pre Clean:	No Pre-Cleaning
P.O.#:	2004	Surveyor:	SAN	PSR:	P-902-066-060
Customer:	Red Zone	Clean Date:		Shape:	C

Street:	3622 Rush Pl	Flow Control:	Not Controlled
City:	Hobart In	Year Renewed:	
Location:	Yard	Tape/Media #:	Deliverable 1
Purpose:	Routine Assessment	Dia/Height:	6"
Use:	Sanitary	Material:	VCP
Drain Area:	Northeast	Lining:	
Category:	NA		
Comment:	432-1. PSR incorrect in video overlay.		
Location Details:	Edge of street	Direction of Survey:	Upstream
US MH:	M-902-066	DS MH:	M-902-060
		Total Length Surveyed (ft):	39.0

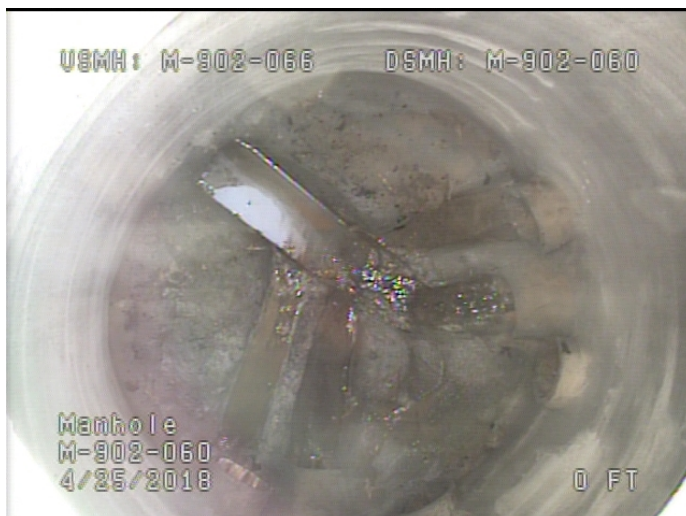
Code: **AMH**
 Description: **Manhole**

Distance (ft): **.0**
 Structural Grade: **0**
 O&M Grade: **0**
 Clock Start/From:
 Clock To:
 1st Value:
 2nd Value:
 Value Percent:
 Continuous Index:
 Within 8" of Joint: **NO**
 Remarks: **M-902-060**

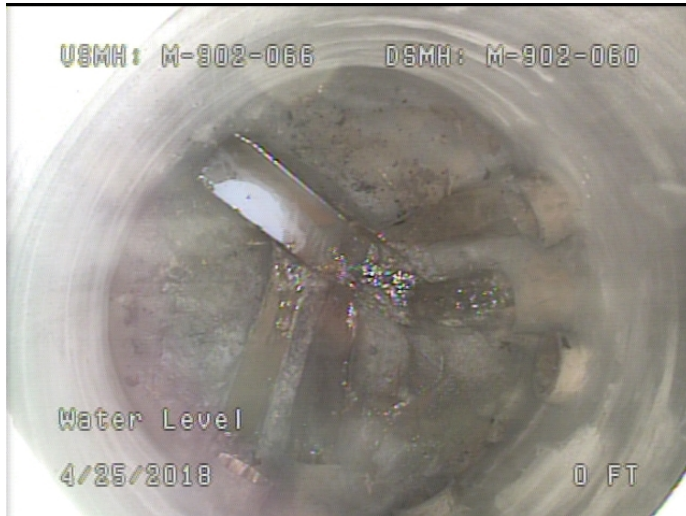
Code: **MWL**
Description: **Water Level**

Distance (ft): **.0**
Structural Grade: **0**
O&M Grade: **0**
Clock Start/From:
Clock To:
1st Value:
2nd Value:
Value Percent: **5.000**
Continuous Index:
Within 8" of Joint: **NO**
Remarks:

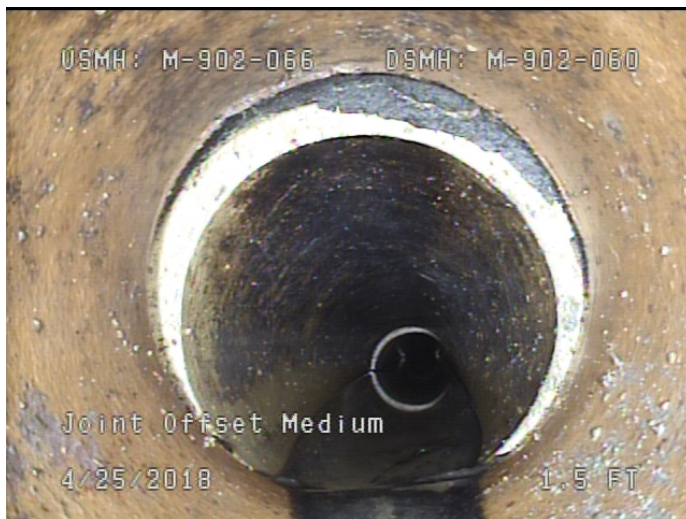
Code: **JOM**
Description: **Joint Offset Medium**

Distance (ft): **1.5**
Structural Grade: **1**
O&M Grade: **0**
Clock Start/From:
Clock To:
1st Value:
2nd Value:
Value Percent:
Continuous Index:
Within 8" of Joint: **NO**
Remarks:

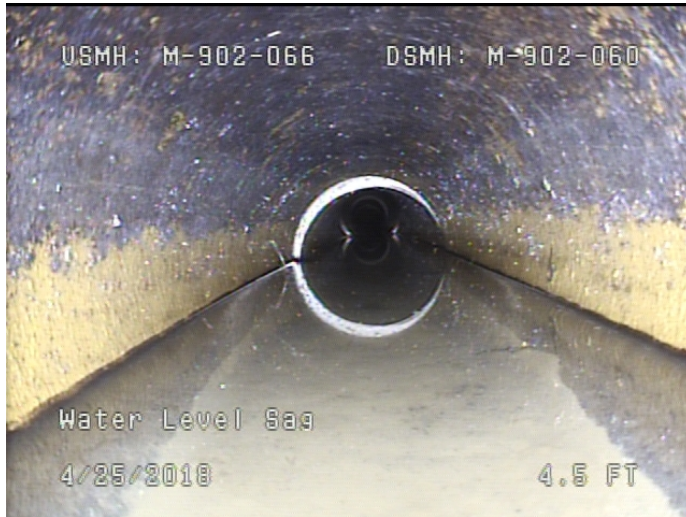
Code: **MWLS**
Description: **Water Level Sag**

Distance (ft): **4.5**
Structural Grade: **3**
O&M Grade: **3**
Clock Start/From:
Clock To:
1st Value:
2nd Value:
Value Percent: **50.000**
Continuous Index: **S01**
Within 8" of Joint: **NO**
Remarks:

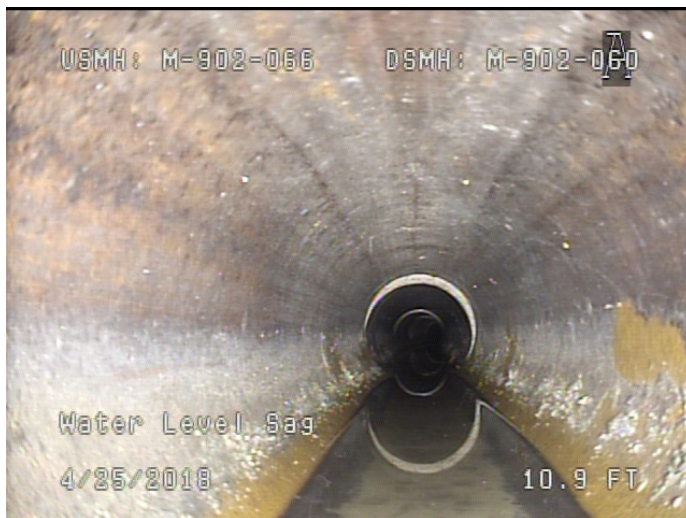
Code: **MWLS**
Description: **Water Level Sag**

Distance (ft): **10.9**
Structural Grade: **3**
O&M Grade: **3**
Clock Start/From:
Clock To:
1st Value:
2nd Value:
Value Percent: **50.000**
Continuous Index: **F01**
Within 8" of Joint: **NO**
Remarks:

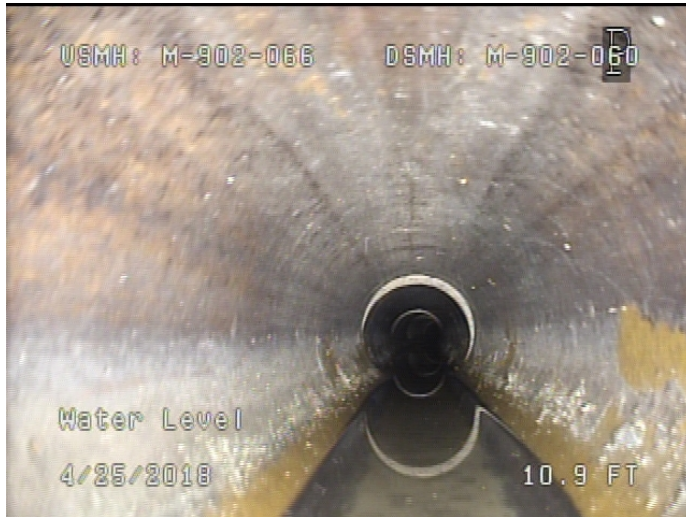
Code:	MWL
Description:	Water Level
Distance (ft):	10.9
Structural Grade:	0
O&M Grade:	0
Clock Start/From:	
Clock To:	
1st Value:	
2nd Value:	
Value Percent:	10.000
Continuous Index:	
Within 8" of Joint:	NO
Remarks:

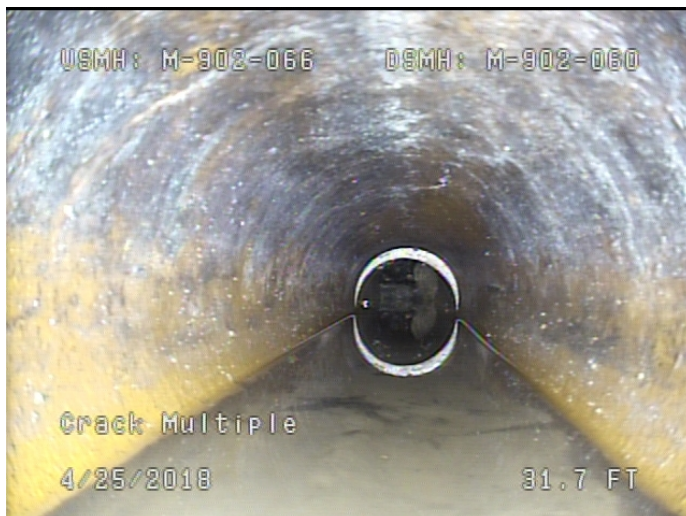
Code:	CM
Description:	Crack Multiple
Distance (ft):	31.7
Structural Grade:	3
O&M Grade:	0
Clock Start/From:	9
Clock To:	3
1st Value:	
2nd Value:	
Value Percent:	
Continuous Index:	
Within 8" of Joint:	NO
Remarks:

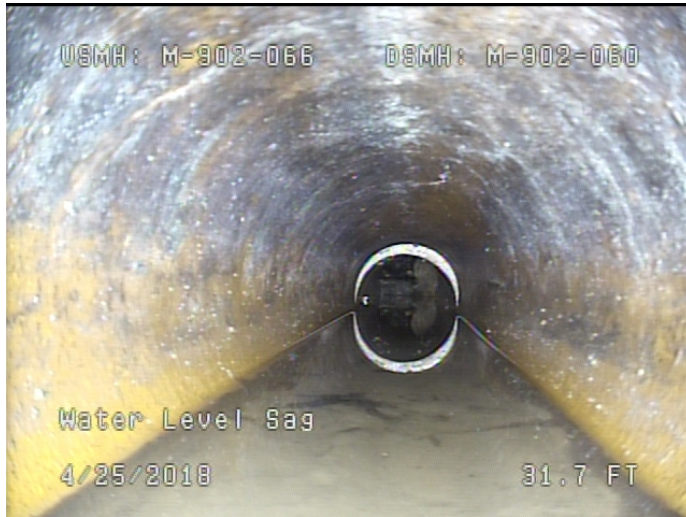
Code: **MWLS**
 Description: **Water Level Sag**

Distance (ft): **31.7**
 Structural Grade: **3**
 O&M Grade: **3**
 Clock Start/From:
 Clock To:
 1st Value:
 2nd Value:
 Value Percent: **35.000**
 Continuous Index: **S02**
 Within 8" of Joint: **NO**
 Remarks:

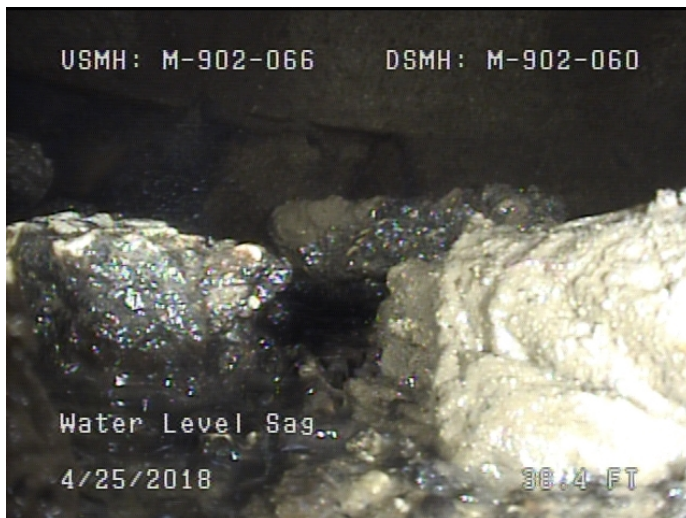
Code: **MWLS**
 Description: **Water Level Sag**

Distance (ft): **38.4**
 Structural Grade: **3**
 O&M Grade: **3**
 Clock Start/From:
 Clock To:
 1st Value:
 2nd Value:
 Value Percent: **35.000**
 Continuous Index: **F02**
 Within 8" of Joint: **NO**
 Remarks:

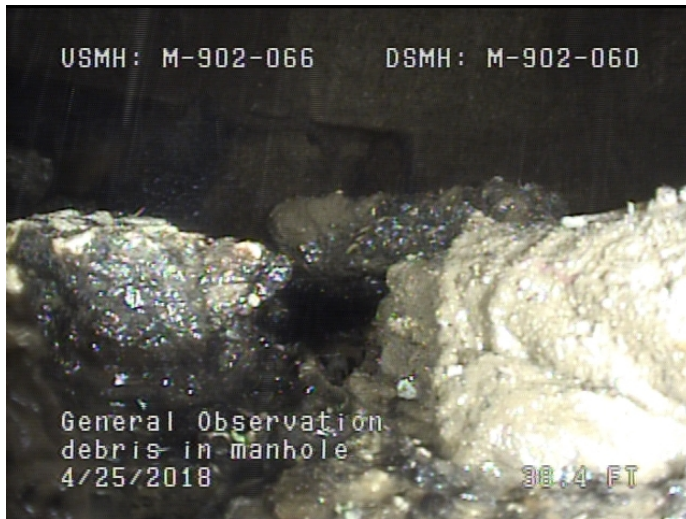
Code:	MGO
Description:	General Observation
Distance (ft):	38.4
Structural Grade:	0
O&M Grade:	0
Clock Start/From:	
Clock To:	
1st Value:	
2nd Value:	
Value Percent:	
Continuous Index:	
Within 8" of Joint:	NO
Remarks:	debris in manhole

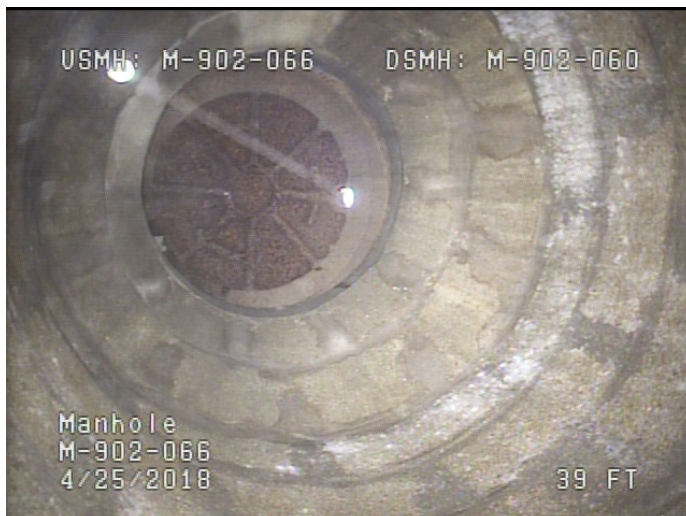
Code:	AMH
Description:	Manhole
Distance (ft):	39.0
Structural Grade:	0
O&M Grade:	0
Clock Start/From:	
Clock To:	
1st Value:	
2nd Value:	
Value Percent:	
Continuous Index:	
Within 8" of Joint:	NO
Remarks:	M-902-066
