Profile/Photo Observation Report

Street:	N HOBART RD	Flow Control:	Not Controlled
City:	Hobart, IN	Year Renewed:	
Location:	Other	Tape/Media #:	
Purpose:	Not Known	Dia/Height:	10"
Use:	Sanitary	Material:	PVC
Drain Area:	NA	Lining:	
Category:	NA		
Comment:

Location Details:		Direction of Survey:	Downstream
US MH:	M-902-068	DS MH:	M-902-020
		Total Length Surveyed (ft):	18.6

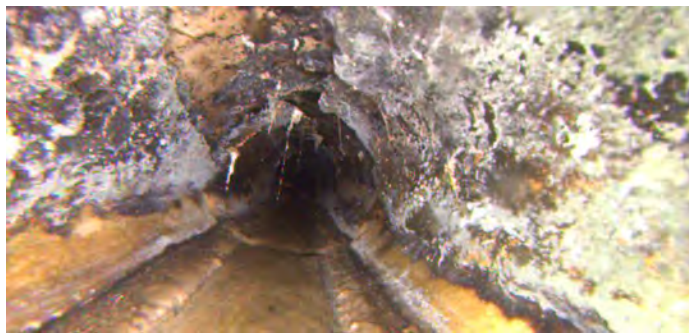
Code: **DAGS**
Description: **Deposits Attached Grease**

Distance (ft): **.0**
Structural Grade: **0**
O&M Grade: **2**
Clock Start/From: **8**
Clock To: **4**
1st Value:
2nd Value:
Value Percent: **10.000**
Continuous Index: **S01**
Within 8" of Joint: **NO**
Remarks:

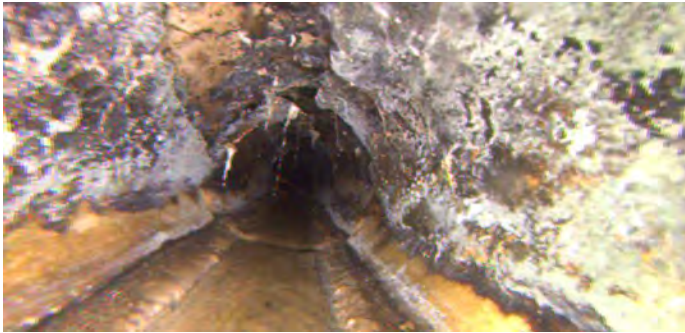
Code:	AMH
Description:	Manhole

Distance (ft):	.0
Structural Grade:	0
O&M Grade:	0
Clock Start/From:	
Clock To:	
1st Value:	
2nd Value:	
Value Percent:	
Continuous Index:	
Within 8" of Joint:	NO
Remarks:	M-902-068

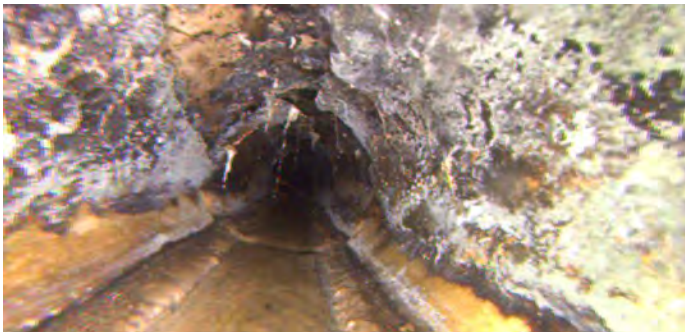
Code:	MWL
Description:	Water Level

Distance (ft):	.0
Structural Grade:	0
O&M Grade:	0
Clock Start/From:	
Clock To:	
1st Value:	
2nd Value:	
Value Percent:	5.000
Continuous Index:	
Within 8" of Joint:	NO
Remarks:

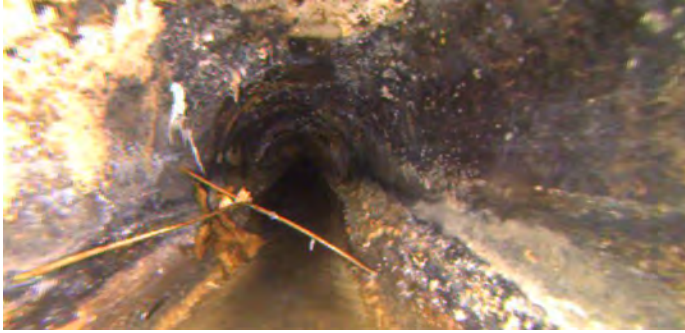
Code: **OBS**
Description: **Obstacle Built Into Structure**

Distance (ft): **4.4**
Structural Grade: **0**
O&M Grade: **2**
Clock Start/From: **8**
Clock To: **4**
1st Value:
2nd Value:
Value Percent: **5.000**
Continuous Index:
Within 8" of Joint: **NO**
Remarks:

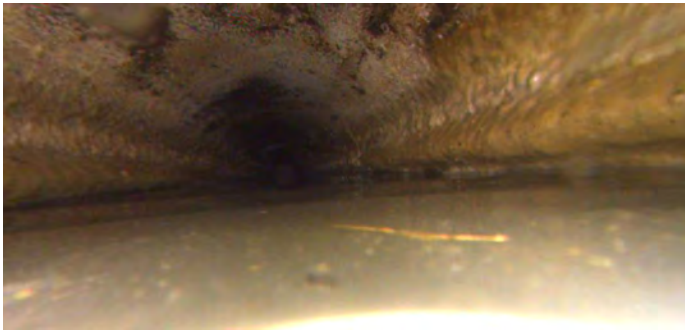
Code: **MWL**
Description: **Water Level**

Distance (ft): **11.9**
Structural Grade: **0**
O&M Grade: **0**
Clock Start/From:
Clock To:
1st Value:
2nd Value:
Value Percent: **40.000**
Continuous Index:
Within 8" of Joint: **NO**
Remarks:

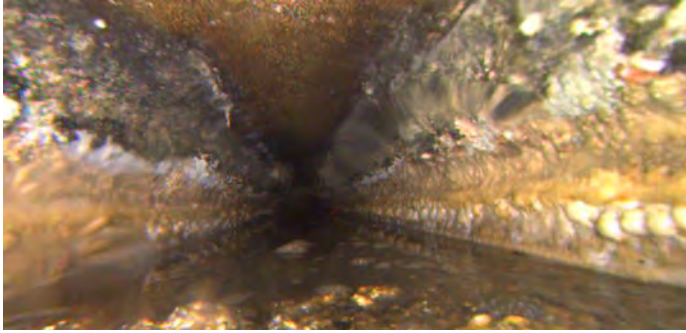
Code: **DAGS**
Description: **Deposits Attached Grease**

Distance (ft): **18.6**
Structural Grade: **0**
O&M Grade: **2**
Clock Start/From: **8**
Clock To: **4**
1st Value:
2nd Value:
Value Percent: **10.000**
Continuous Index: **F01**
Within 8" of Joint: **NO**
Remarks:

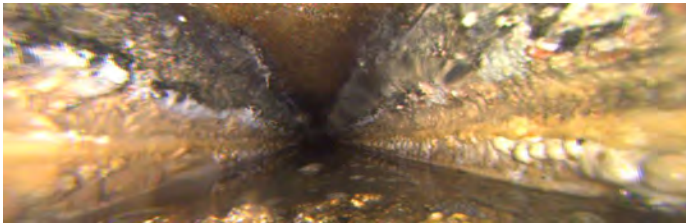
Code: **MSA**
Description: **Abandoned Survey**

Distance (ft): **18.6**
Structural Grade: **0**
O&M Grade: **0**
Clock Start/From:
Clock To:
1st Value:
2nd Value:
Value Percent:
Continuous Index:
Within 8" of Joint: **NO**
Remarks: **camera stopped**
