Profile/Photo Observation Report

Date:	03/21/2018	Weather:		Coding:	PACP 6.0
Pipe Length (ft):	135.3	Owner:	NA	Pre Clean:	Not Known
P.O.#:		Surveyor:	Selasie Honu	PSR:	P-902-068-020
Customer:		Clean Date:	01/01/1900	Shape:	C

Street:	37th ave	Flow Control:	Not Controlled
City:	Hobart, IN	Year Renewed:	
Location:	Other	Tape/Media #:	
Purpose:	Not Known	Dia/Height:	10"
Use:	Sanitary	Material:	PVC
Drain Area:	NA	Lining:	
Category:	NA		
Comment:

Location Details:		Direction of Survey:	Downstream
US MH:	M-902-068	DS MH:	M-902-020
		Total Length Surveyed (ft):	18.6

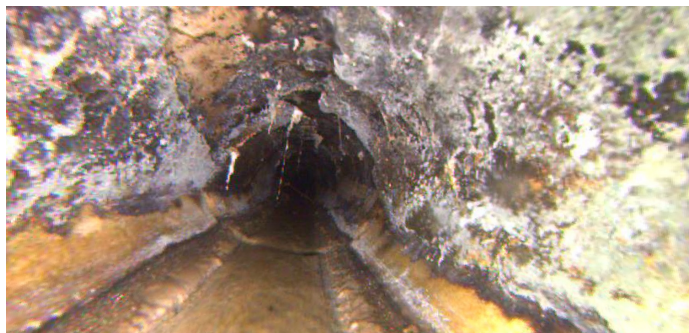
Code: **DAGS**
Description: **Deposits Attached Grease**

Distance (ft): **.0**
Structural Grade: **0**
O&M Grade: **2**
Clock Start/From: **8**
Clock To: **4**
1st Value:
2nd Value:
Value Percent: **10.000**
Continuous Index: **S01**
Within 8" of Joint: **NO**
Remarks:

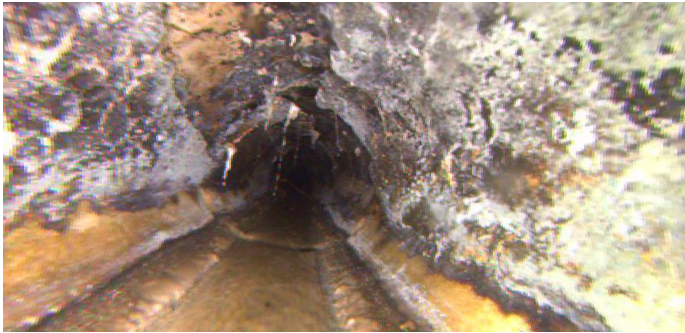
Code:	AMH
Description:	Manhole

Distance (ft):	.0
Structural Grade:	0
O&M Grade:	0
Clock Start/From:	
Clock To:	
1st Value:	
2nd Value:	
Value Percent:	
Continuous Index:	
Within 8" of Joint:	NO
Remarks:	M-902-068

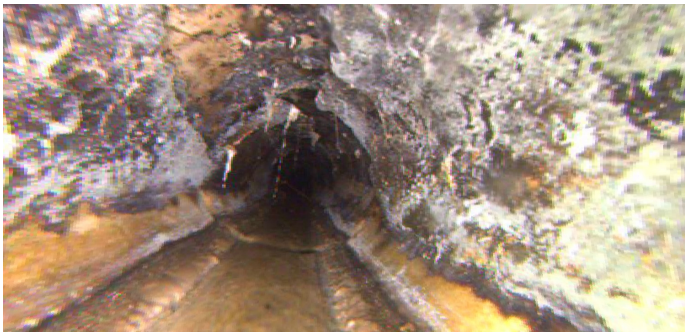
Code:	MWL
Description:	Water Level

Distance (ft):	.0
Structural Grade:	0
O&M Grade:	0
Clock Start/From:	
Clock To:	
1st Value:	
2nd Value:	
Value Percent:	5.000
Continuous Index:	
Within 8" of Joint:	NO
Remarks:

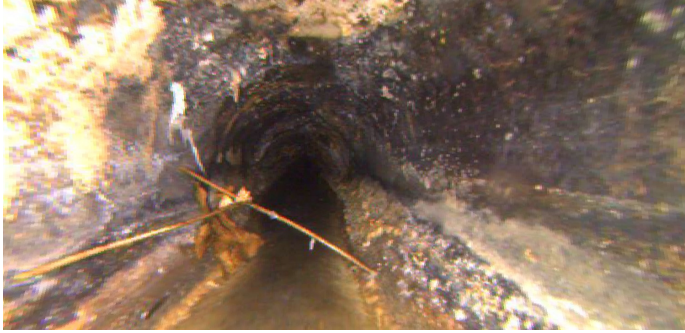
Code: **OBS**
Description: **Obstacle Built Into Structure**

Distance (ft): **4.4**
Structural Grade: **0**
O&M Grade: **2**
Clock Start/From: **8**
Clock To: **4**
1st Value:
2nd Value:
Value Percent: **5.000**
Continuous Index:
Within 8" of Joint: **NO**
Remarks:

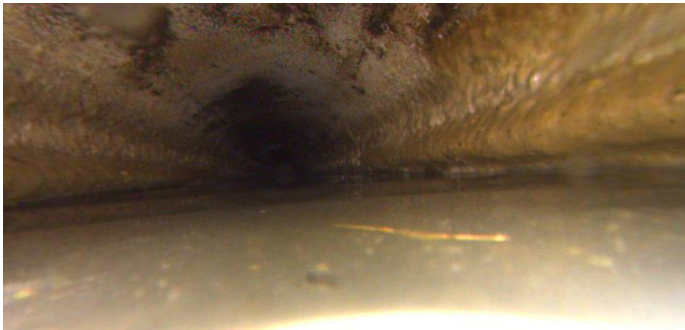
Code: **MWL**
Description: **Water Level**

Distance (ft): **11.9**
Structural Grade: **0**
O&M Grade: **0**
Clock Start/From:
Clock To:
1st Value:
2nd Value:
Value Percent: **40.000**
Continuous Index:
Within 8" of Joint: **NO**
Remarks:

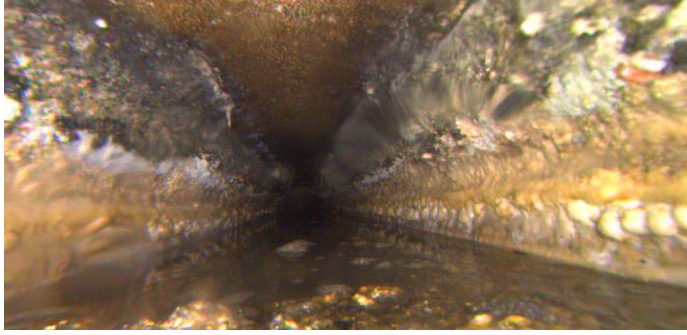
Code:	DAGS
Description:	Deposits Attached Grease
Distance (ft):	18.6
Structural Grade:	0
O&M Grade:	2
Clock Start/From:	8
Clock To:	4
1st Value:	
2nd Value:	
Value Percent:	10.000
Continuous Index:	F01
Within 8" of Joint:	NO
Remarks:

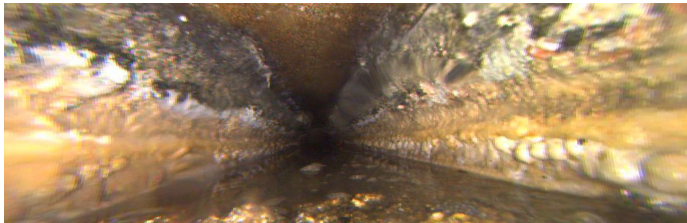
Code:	MSA
Description:	Abandoned Survey
Distance (ft):	18.6
Structural Grade:	0
O&M Grade:	0
Clock Start/From:	
Clock To:	
1st Value:	
2nd Value:	
Value Percent:	
Continuous Index:	
Within 8" of Joint:	NO
Remarks:	camera stopped
