Profile/Photo Observation Report

Street:	N HOBART RD	Flow Control:	Not Controlled
City:	Hobart, IN	Year Renewed:	
Location:	Other	Tape/Media #:	
Purpose:	Not Known	Dia/Height:	12"
Use:	Sanitary	Material:	PVC
Drain Area:	NA	Lining:	
Category:	NA		
Comment:

Location Details:		Direction of Survey:	Downstream
US MH:	M-902-068	DS MH:	M-902-020
		Total Length Surveyed (ft):	22.5

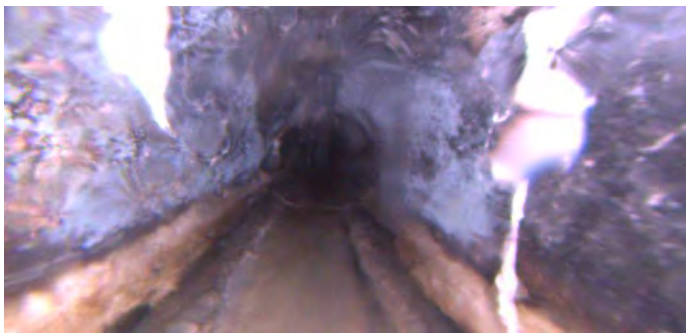
Code: **DAGS**
Description: **Deposits Attached Grease**

Distance (ft): **.0**
Structural Grade: **0**
O&M Grade: **2**
Clock Start/From: **8**
Clock To: **4**
1st Value:
2nd Value:
Value Percent: **10.000**
Continuous Index: **S01**
Within 8" of Joint: **NO**
Remarks:

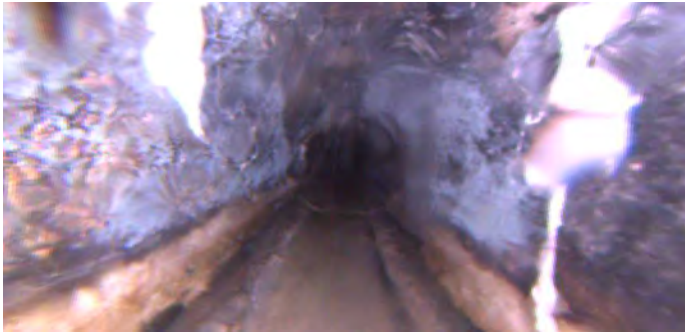
Code:	AMH
Description:	Manhole

Distance (ft):	.0
Structural Grade:	0
O&M Grade:	0
Clock Start/From:	
Clock To:	
1st Value:	
2nd Value:	
Value Percent:	
Continuous Index:	
Within 8" of Joint:	NO
Remarks:	M-902-068

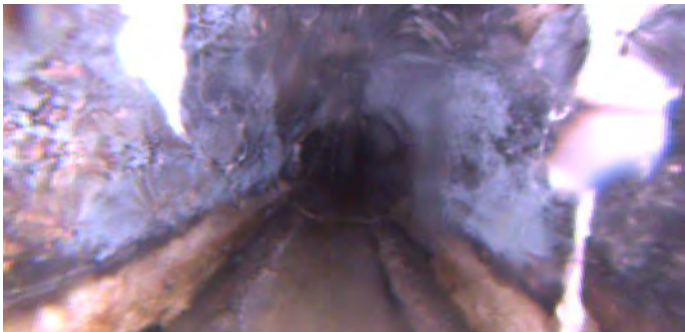
Code:	MWL
Description:	Water Level

Distance (ft):	.0
Structural Grade:	0
O&M Grade:	0
Clock Start/From:	
Clock To:	
1st Value:	
2nd Value:	
Value Percent:	5.000
Continuous Index:	
Within 8" of Joint:	NO
Remarks:
