## Profile/Photo Observation Report

Date:	<b>03/21/2018</b>	Weather:		Coding:	<b>PACP 6.0</b>
Pipe Length (ft):	<b>135.3</b>	Owner:	<b>NA</b>	Pre Clean:	<b>Not Known</b>
P.O.#:		Surveyor:	<b>Selasie Honu</b>	PSR:	<b>P-902-068-020</b>
Customer:		Clean Date:	<b>01/01/1900</b>	Shape:	<b>C</b>

Street:	<b>37th ave</b>	Flow Control:	<b>Not Controlled</b>
City:	<b>Hobart, IN</b>	Year Renewed:	
Location:	<b>Other</b>	Tape/Media #:	
Purpose:	<b>Not Known</b>	Dia/Height:	<b>12"</b>
Use:	<b>Sanitary</b>	Material:	<b>PVC</b>
Drain Area:	<b>NA</b>	Lining:	
Category:	<b>NA</b>		
Comment:

Location Details:		Direction of Survey:	<b>Downstream</b>
US MH:	<b>M-902-068</b>	DS MH:	<b>M-902-020</b>
		Total Length Surveyed (ft):	<b>22.5</b>

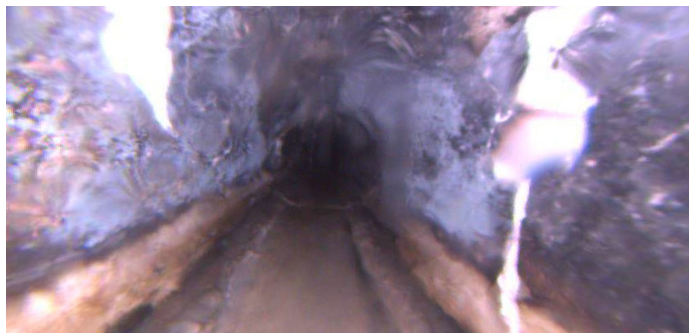
Code: **DAGS**  
Description: **Deposits Attached Grease**

Distance (ft): **.0**  
Structural Grade: **0**  
O&M Grade: **2**  
Clock Start/From: **8**  
Clock To: **4**  
1st Value:  
2nd Value:  
Value Percent: **10.000**  
Continuous Index: **S01**  
Within 8" of Joint: **NO**  
Remarks:

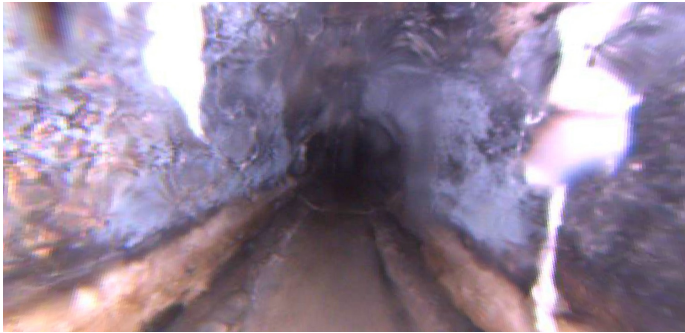
Code:	<b>AMH</b>
Description:	<b>Manhole</b>

Distance (ft):	<b>.0</b>
Structural Grade:	<b>0</b>
O&M Grade:	<b>0</b>
Clock Start/From:	
Clock To:	
1st Value:	
2nd Value:	
Value Percent:	
Continuous Index:	
Within 8" of Joint:	<b>NO</b>
Remarks:	<b>M-902-068</b>

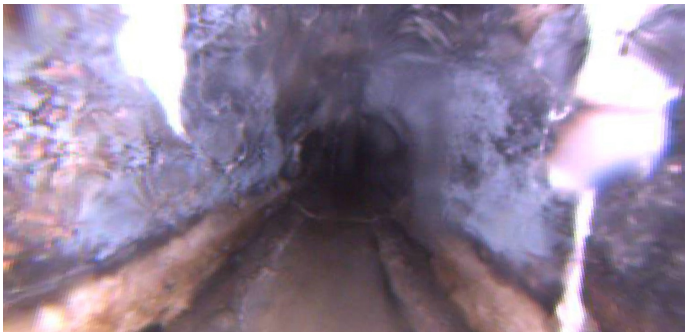
Code:	<b>MWL</b>
Description:	<b>Water Level</b>

Distance (ft):	<b>.0</b>
Structural Grade:	<b>0</b>
O&M Grade:	<b>0</b>
Clock Start/From:	
Clock To:	
1st Value:	
2nd Value:	
Value Percent:	<b>5.000</b>
Continuous Index:	
Within 8" of Joint:	<b>NO</b>
Remarks:
