Profile/Photo Observation Report

Street:	shelby pl	Flow Control:	Not Controlled
City:	Hobart, IN	Year Renewed:	
Location:	Other	Tape/Media #:	
Purpose:	Not Known	Dia/Height:	10"
Use:	Sanitary	Material:	VCP
Drain Area:	NA	Lining:	
Category:	NA		
Comment:

Location Details:		Direction of Survey:	Upstream
US MH:	M-902-069	DS MH:	M-902-015
		Total Length Surveyed (ft):	4.6

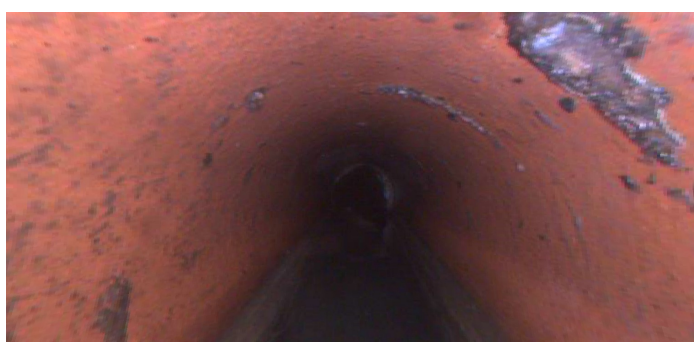
Code: **AMH**
Description: **Manhole**

Distance (ft): **.0**
Structural Grade: **0**
O&M Grade: **0**
Clock Start/From:
Clock To:
1st Value:
2nd Value:
Value Percent:
Continuous Index:
Within 8" of Joint: **NO**
Remarks: **M-902-015**

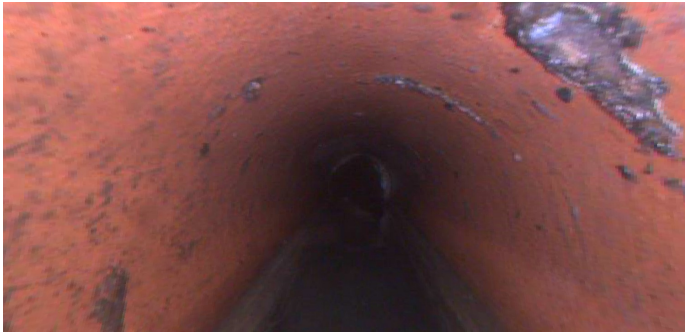
Code:	MWL
Description:	Water Level

Distance (ft):	.0
Structural Grade:	0
O&M Grade:	0
Clock Start/From:	
Clock To:	
1st Value:	
2nd Value:	
Value Percent:	5.000
Continuous Index:	
Within 8" of Joint:	NO
Remarks:

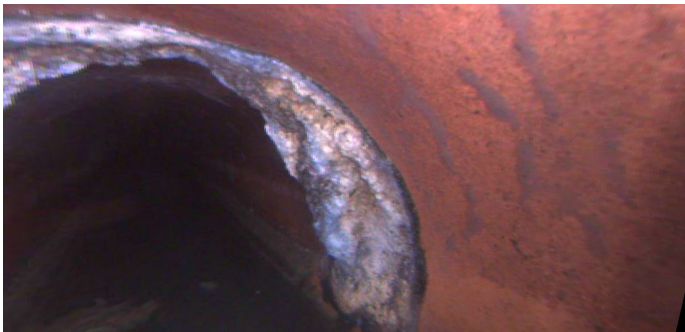
Code:	DAGS
Description:	Deposits Attached Grease

Distance (ft):	4.0
Structural Grade:	0
O&M Grade:	2
Clock Start/From:	7
Clock To:	5
1st Value:	
2nd Value:	
Value Percent:	5.000
Continuous Index:	
Within 8" of Joint:	YES
Remarks:

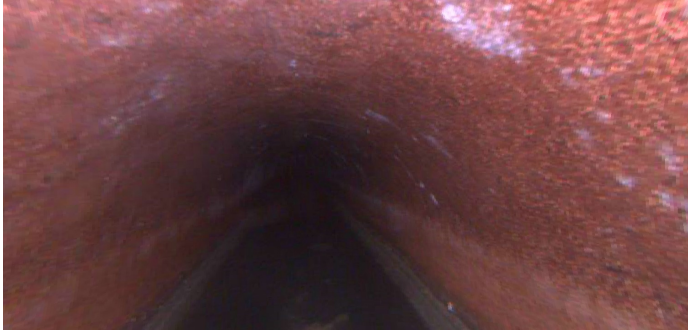
Code:	MSA
Description:	Abandoned Survey
Distance (ft):	4.6
Structural Grade:	0
O&M Grade:	0
Clock Start/From:	
Clock To:	
1st Value:	
2nd Value:	
Value Percent:	
Continuous Index:	
Within 8" of Joint:	NO
Remarks:	stuck on dags???
