## Profile/Photo Observation Report

| Customer: | <b>City of Hobart</b> | Clean Date: | <b>08/25/2021</b> | Shape: | <b>C</b> |

| Street: | <b>East Ridge Road</b> | Flow Control: | <b>Not Controlled</b> |

| US MH: | <b>M-902-075</b> | DS MH: | <b>M-902-047</b> |

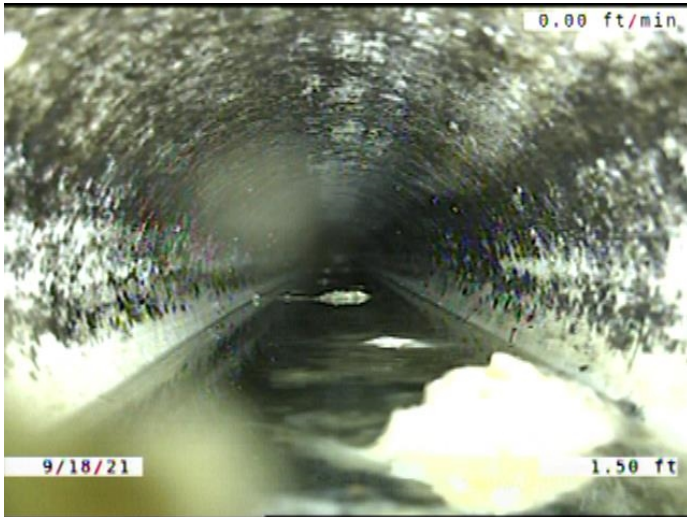
| Description: | <b>Miscellaneous General Observation</b> |
| Distance (ft): | <b>1.5</b> |
| Remarks: | <b>TIGHT ACCESS IN THE MANHOLE.<br/>HAD TO START IN THE PIPE.</b> |

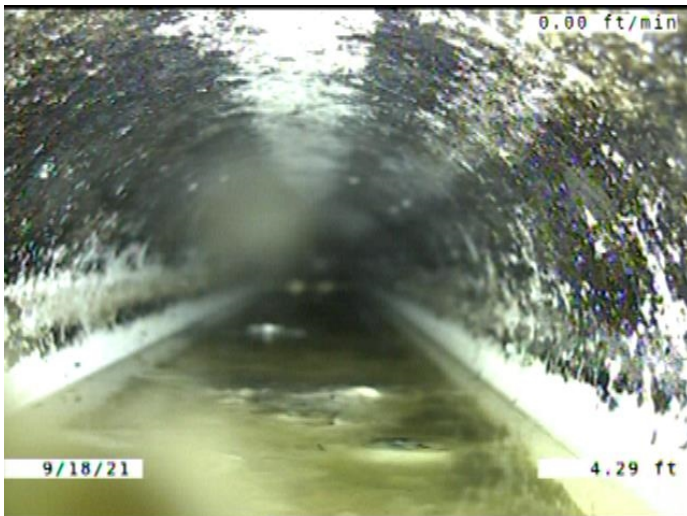
| | Position | Code | Observation | Video (sec) | Grade |
|--|---|---|---|---|---|
| | 4.3 | DSF(F01) | Deposits Settled Fine | 77 | M 2 |

| Description: | <b>Deposits Settled Fine</b> |
| Distance (ft): | <b>4.3</b> |
| O&M Grade: | <b>2</b> |
| Value Percent: | <b>5.000</b> |
