Profile/Photo Observation Report

Date:	09/18/2021	Weather:		Coding:	PACP 7.0
Pipe Length (ft):	332.0	Owner:	City of Hobart	Pre Clean:	Light Cleaning
P.O.#:	YES502259	Surveyor:	S. Bucklin	PSR:	P-902-047-075
Customer:	City of Hobart	Clean Date:	08/25/2021	Shape:	C

Street:	East Ridge Road	Flow Control:	Not Controlled
City:	Hobart, IN	Year Renewed:	
Location:	Yard	Tape/Media #:	
Purpose:	Routine Assessment	Dia/Height:	6"
Use:	Sanitary Sewage Pipe	Material:	PVC
Drain Area:		Lining:	None
Category:	NA		
Comment:

Location Details:		Direction of Survey:	Downstream
US MH:	M-902-075	DS MH:	M-902-047
		Total Length Surveyed (ft):	4.3

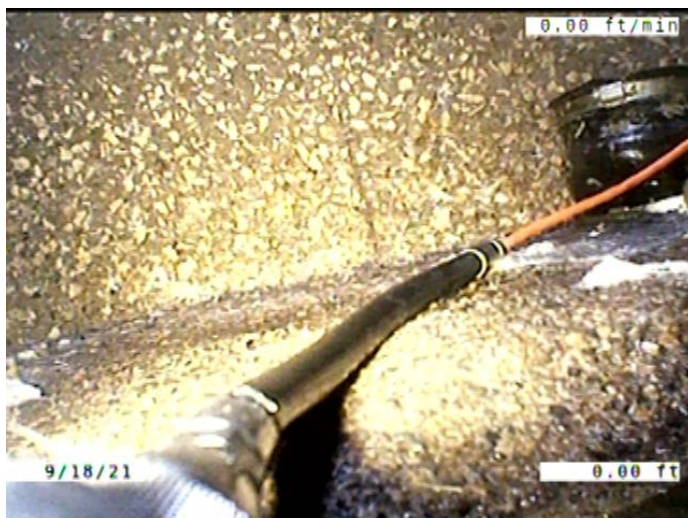
Code: **AMH**
Description: **Manhole**

Distance (ft): **.0**
Structural Grade: **0**
O&M Grade: **0**
Clock Start/From:
Clock To:
1st Value:
2nd Value:
Value Percent:
Continuous Index:
Within 8" of Joint: **NO**
Remarks: **M-902-075**

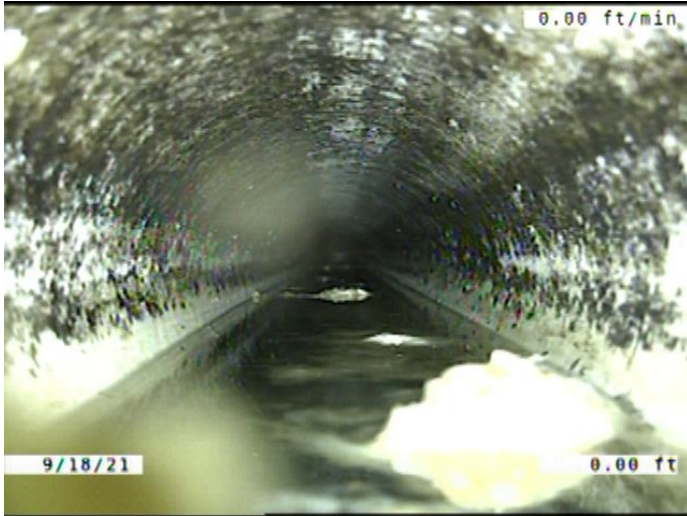
Code: **MWL**
Description: **Miscellaneous Water Level**

Distance (ft): **.0**
Structural Grade: **0**
O&M Grade: **0**
Clock Start/From:
Clock To:
1st Value:
2nd Value:
Value Percent: **10.000**
Continuous Index:
Within 8" of Joint: **NO**
Remarks:

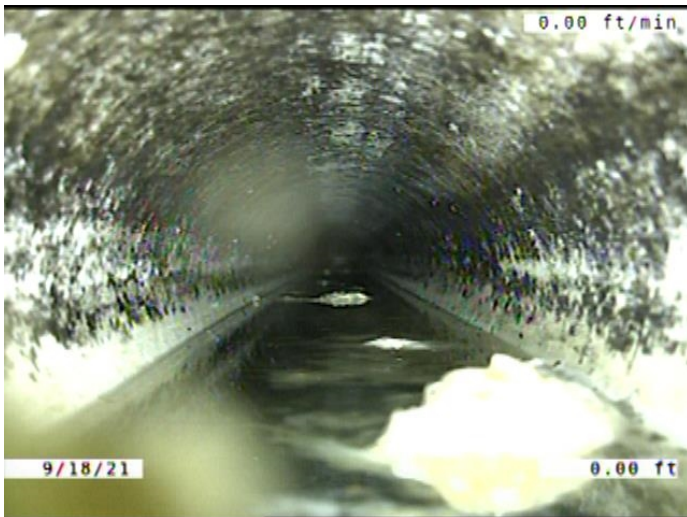
Code: **DSF**
Description: **Deposits Settled Fine**

Distance (ft): **.0**
Structural Grade: **0**
O&M Grade: **2**
Clock Start/From: **5**
Clock To: **7**
1st Value:
2nd Value:
Value Percent: **5.000**
Continuous Index: **S01**
Within 8" of Joint: **YES**
Remarks:

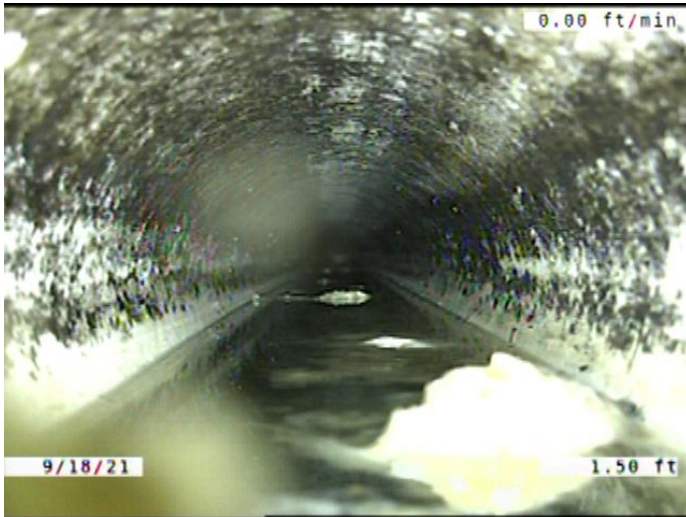
Code: **MGO**
 Description: **Miscellaneous General Observation**

Distance (ft): **1.5**
 Structural Grade: **0**
 O&M Grade: **0**
 Clock Start/From:
 Clock To:
 1st Value:
 2nd Value:
 Value Percent:
 Continuous Index:
 Within 8" of Joint: **NO**
 Remarks: **TIGHT ACCESS IN THE MANHOLE. HAD TO START IN THE PIPE.**

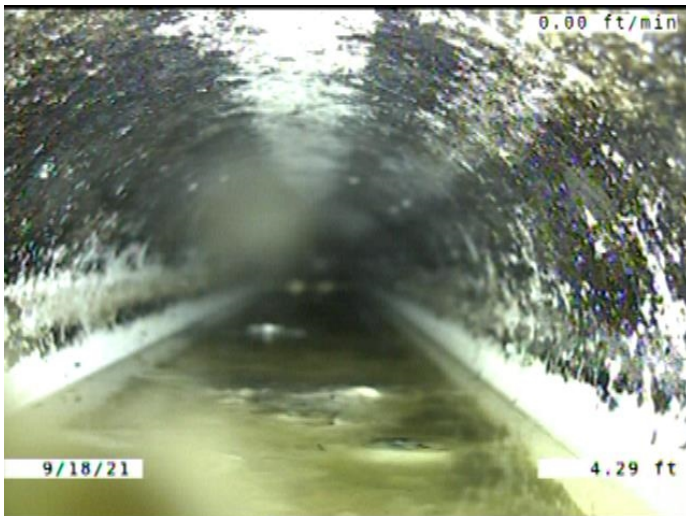
Code: **DSF**
 Description: **Deposits Settled Fine**

Distance (ft): **4.3**
 Structural Grade: **0**
 O&M Grade: **2**
 Clock Start/From: **5**
 Clock To: **7**
 1st Value:
 2nd Value:
 Value Percent: **5.000**
 Continuous Index: **F01**
 Within 8" of Joint: **YES**
 Remarks:

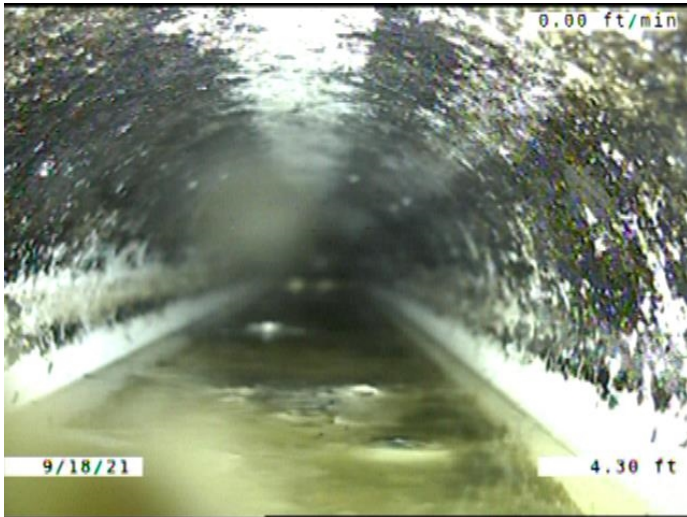
MSA

Miscellaneous Survey Abandoned

4.3

**CAMERA CANT MAKE IT PAST
DEBRIS.**
