Profile/Photo Observation Report

Date: 04/10/2018 Weather: Coding: **PACP 4.2** Pipe Length (ft): 145.9 Owner: **City of Hobart** Pre Clean: No Pre-Cleaning P.O.#: 2004 Surveyor: SAN PSR: P-902-045-039 Customer: **Red Zone** Clean Date: Shape:

Street: 3815 34th Pl Flow Control: Not Controlled

US MH: M-902-076 DS MH: M-902-039 Total Length Surveyed (ft): 5.0

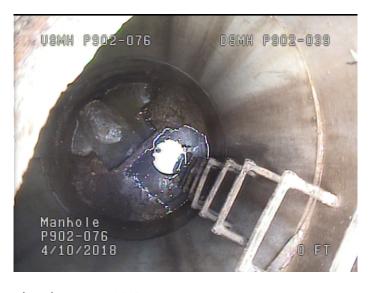
Code:	AMH
Description:	Manhole
D: (61)	_
Distance (ft):	.0
Structural Grade:	0
O&M Grade:	0
Clock Start/From:	
Clock To:	
1st Value:	
2nd Value:	
Value Percent:	
Continuous Index:	
Within 8" of Joint:	NO
Remarks:	P902-076

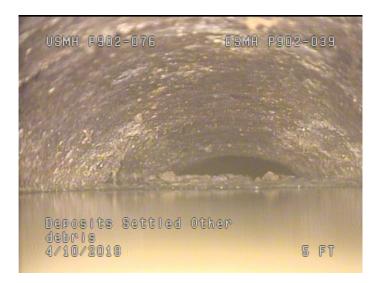
Code: DSZ Description: **Deposits Settled Other** Distance (ft): 5.0 Structural Grade: 0 O&M Grade: 5 Clock Start/From: 3 Clock To: 9 1st Value: 2nd Value: Value Percent: 75.000 Continuous Index: Within 8" of Joint: NO Remarks: debris

Comment: 401-1/ Incomplete line-needs cleaning.

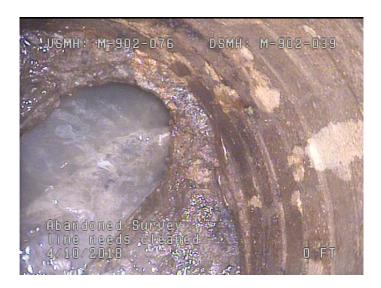
Code: MSA

Description: Abandoned Survey

Distance (ft): 5.0
Structural Grade: 0
O&M Grade: 0

Remarks: line needs cleaned
