## Profile/Photo Observation Report

Date:	<b>04/10/2018</b>	Weather:		Coding:	<b>PACP 6.0</b>
Pipe Length (ft):	<b>145.8</b>	Owner:	<b>City of Hobart</b>	Pre Clean:	<b>No Pre-Cleaning</b>
P.O.#:	<b>2004</b>	Surveyor:	<b>SAN</b>	PSR:	<b>P-902-045-039</b>
Customer:	<b>Red Zone</b>	Clean Date:		Shape:	<b>C</b>

Street:	<b>3815 34th Pl</b>	Flow Control:	<b>Not Controlled</b>
City:	<b>Hobart In</b>	Year Renewed:	
Location:	<b>Light Highway</b>	Tape/Media #:	<b>Deliverable 1</b>
Purpose:	<b>Routine Assessment</b>	Dia/Height:	<b>15"</b>
Use:	<b>Sanitary</b>	Material:	<b>RCP</b>
Drain Area:	<b>unknown</b>	Lining:	
Category:	<b>NA</b>		
Comment:	<b>402-1/Reverse setup due to debris.</b>		
Location Details:	<b>Backyards</b>	Direction of Survey:	<b>Upstream</b>
US MH:	<b>M-902-076</b>	DS MH:	<b>M-902-039</b>
		Total Length Surveyed (ft):	<b>.1</b>

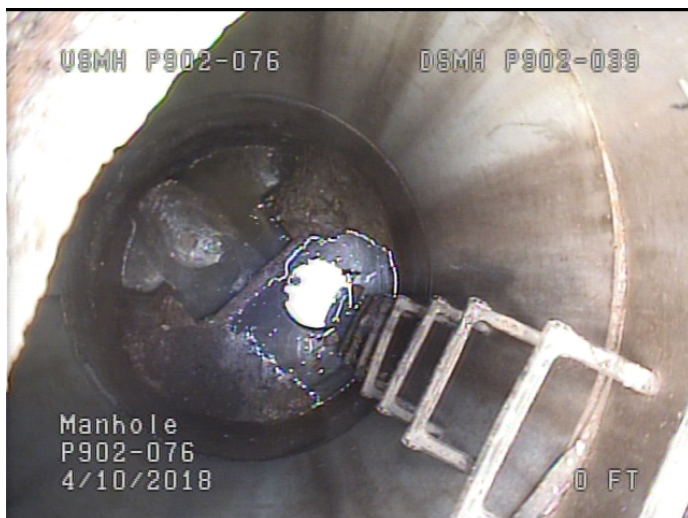
Code:	<b>AMH</b>
Description:	<b>Manhole</b>
Distance (ft):	<b>.0</b>
Structural Grade:	<b>0</b>
O&M Grade:	<b>0</b>
Clock Start/From:	
Clock To:	
1st Value:	
2nd Value:	
Value Percent:	
Continuous Index:	
Within 8" of Joint:	<b>NO</b>
Remarks:	<b>M-902-039</b>

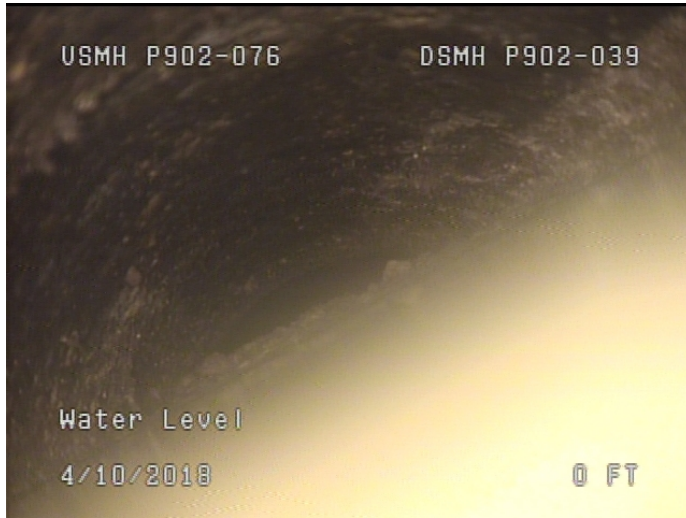
Code:	<b>MWL</b>
Description:	<b>Water Level</b>
Distance (ft):	<b>.0</b>
Structural Grade:	<b>0</b>
O&M Grade:	<b>0</b>
Clock Start/From:	
Clock To:	
1st Value:	
2nd Value:	
Value Percent:	<b>15.000</b>
Continuous Index:	
Within 8" of Joint:	<b>NO</b>
Remarks:

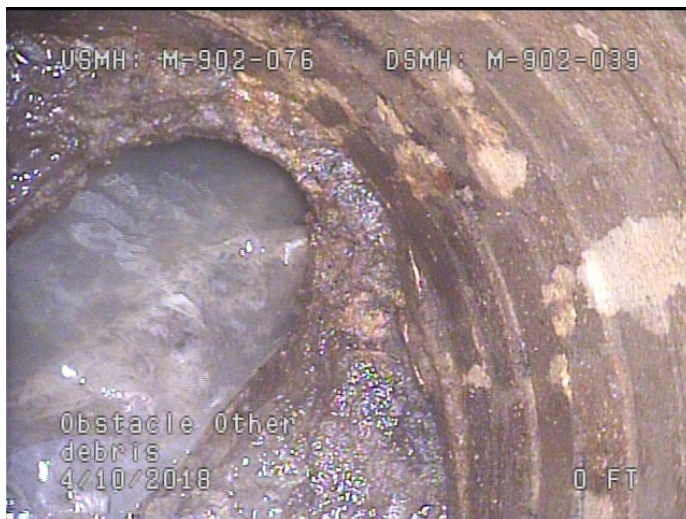
Code:	<b>OBZ</b>
Description:	<b>Obstacle Other</b>
Distance (ft):	<b>.0</b>
Structural Grade:	<b>0</b>
O&M Grade:	<b>5</b>
Clock Start/From:	<b>3</b>
Clock To:	<b>9</b>
1st Value:	
2nd Value:	
Value Percent:	<b>40.000</b>
Continuous Index:	
Within 8" of Joint:	<b>NO</b>
Remarks:	<b>debris</b>

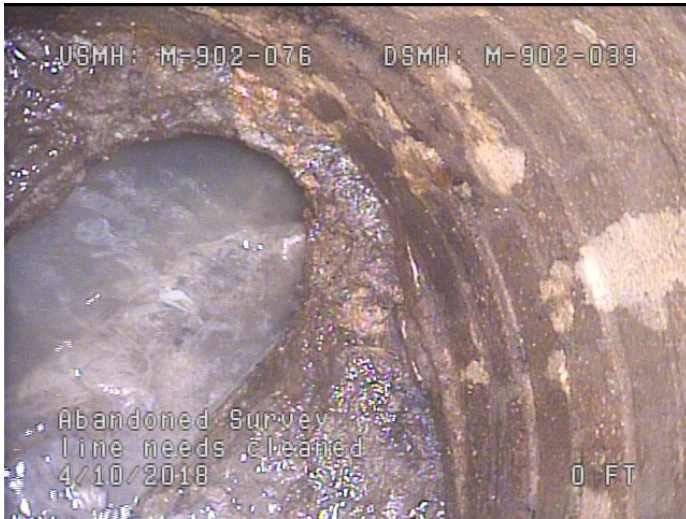
Code:	<b>MSA</b>
Description:	<b>Abandoned Survey</b>
Distance (ft):	<b>.0</b>
Structural Grade:	<b>0</b>
O&M Grade:	<b>0</b>
Clock Start/From:	
Clock To:	
1st Value:	
2nd Value:	
Value Percent:	
Continuous Index:	
Within 8" of Joint:	<b>NO</b>
Remarks:	<b>line needs cleaned</b>
