Profile/Photo Observation Report

Date:	06/13/2023	Weather:		Coding:	PACP 7.0
Pipe Length (ft):	146.0	Owner:	City of Hobart	Pre Clean:	Heavy Cleaning
P.O.#:	YES502259	Surveyor:	S. Bucklin	PSR:	P-902-076-039
Customer:	City of Hobart	Clean Date:	05/10/2023	Shape:	C

Street:	East 34th Lane	Flow Control:	Not Controlled
City:	Hobart, IN	Year Renewed:	
Location:	Local rural streets with light traffic, t	Tape/Media #:	
Purpose:	Routine Assessment	Dia/Height:	18"
Use:	Sanitary Sewage Pipe	Material:	RCP
Drain Area:		Lining:	None
Category:	NA		
Comment:			
Location Details:		Direction of Survey:	Downstream
US MH:	M-902-076	DS MH:	M-902-039
		Total Length Surveyed (ft):	146.8

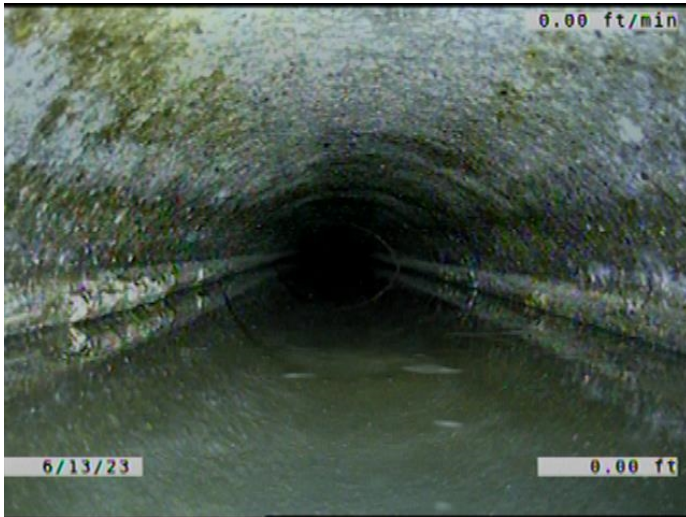
Code: **DAGS**
Description: **Deposits Attached Grease**

Distance (ft): **.0**
Structural Grade: **0**
O&M Grade: **2**
Clock Start/From: **9**
Clock To: **3**
1st Value:
2nd Value:
Value Percent: **5.000**
Continuous Index: **S01**
Within 8" of Joint: **YES**
Remarks:

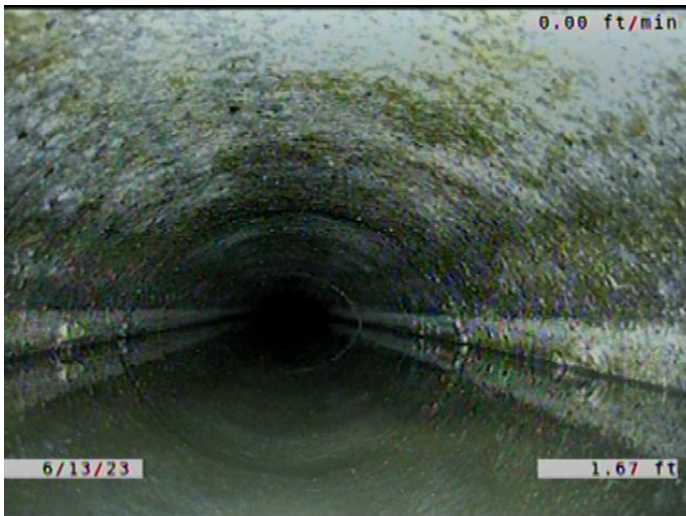
Code: **MWLS**
Description: **Miscellaneous Water Level Sag**

Distance (ft): **1.7**
Structural Grade: **5**
O&M Grade: **0**
Clock Start/From:
Clock To:
1st Value:
2nd Value:
Value Percent: **85.000**
Continuous Index: **S02**
Within 8" of Joint: **NO**
Remarks:

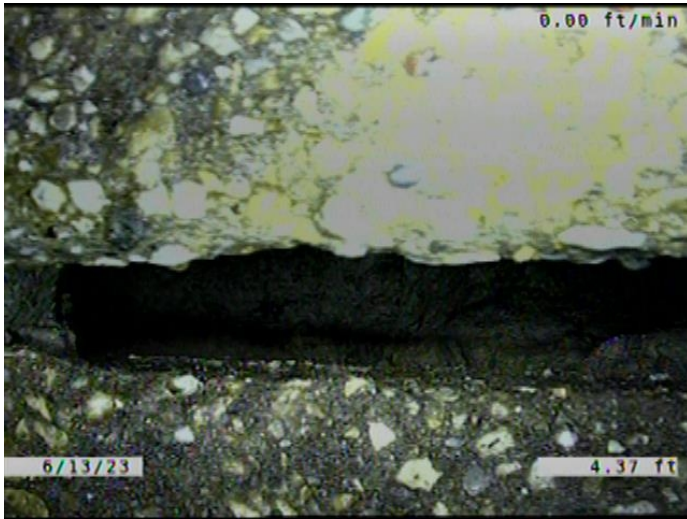
Code: **SMW**
Description: **Surface Damage Missing Wall**

Distance (ft): **4.4**
Structural Grade: **5**
O&M Grade: **0**
Clock Start/From: **10**
Clock To: **2**
1st Value:
2nd Value:
Value Percent:
Continuous Index:
Within 8" of Joint: **YES**
Remarks: **THE OUTSIDE OF THE BELL IS MISSING. SOIL AND VOID VISIBLE.**

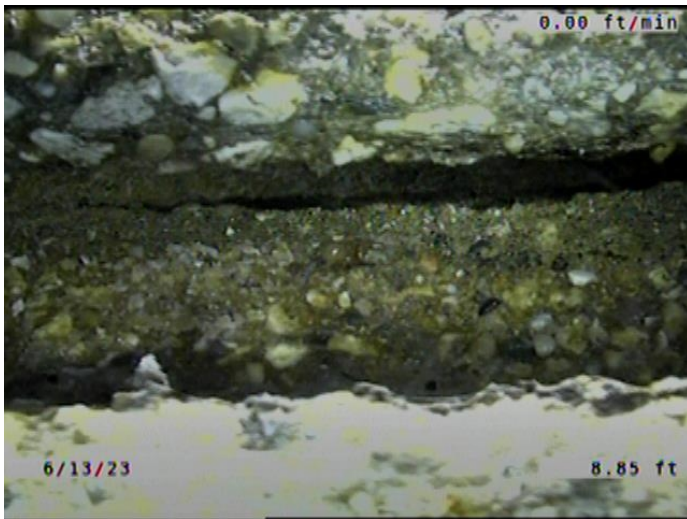
Code: **JSL**
Description: **Joint Separated Large**

Distance (ft): **8.8**
Structural Grade: **4**
O&M Grade: **0**
Clock Start/From:
Clock To:
1st Value:
2nd Value:
Value Percent:
Continuous Index:
Within 8" of Joint: **NO**
Remarks: **SOIL AND VOID VISIBLE.**

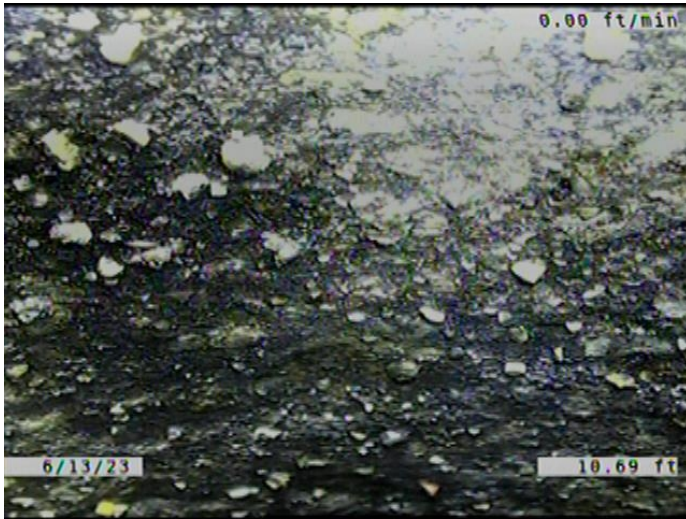
Code: **SAP**
 Description: **Surface Damage Aggregate Projecting**

Distance (ft): **10.7**
 Structural Grade: **3**
 O&M Grade: **0**
 Clock Start/From: **10**
 Clock To: **2**
 1st Value:
 2nd Value:
 Value Percent:
 Continuous Index: **S03**
 Within 8" of Joint: **YES**
 Remarks:

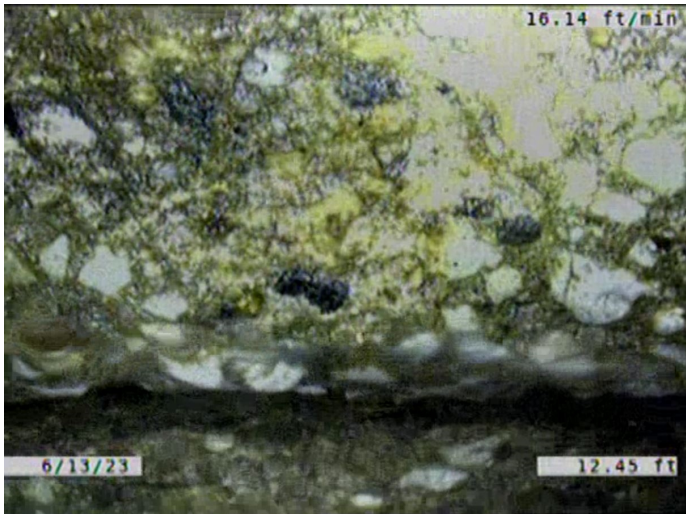
Code: **MWLS**
 Description: **Miscellaneous Water Level Sag**

Distance (ft): **12.5**
 Structural Grade: **5**
 O&M Grade: **0**
 Clock Start/From:
 Clock To:
 1st Value:
 2nd Value:
 Value Percent: **85.000**
 Continuous Index: **F02**
 Within 8" of Joint: **NO**
 Remarks:

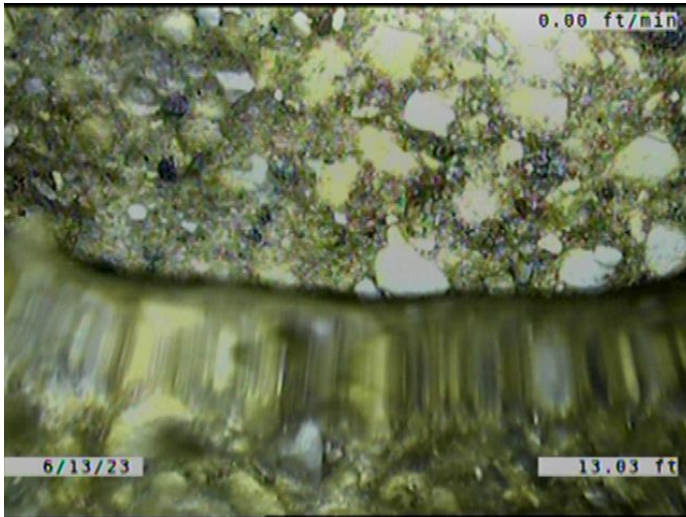
Code: **MCU**
Description: **Miscellaneous Camera Underwater**

Distance (ft): **13.0**
Structural Grade: **0**
O&M Grade: **4**
Clock Start/From:
Clock To:
1st Value:
2nd Value:
Value Percent:
Continuous Index:
Within 8" of Joint: **NO**
Remarks: **Out at 15**

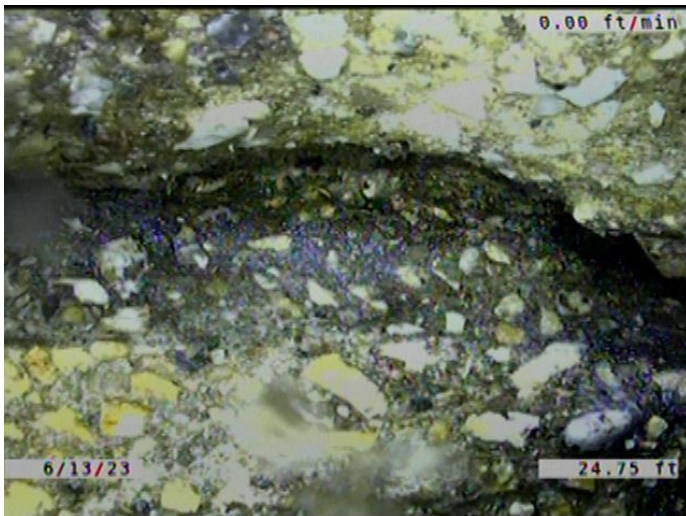
Code: **SMW**
Description: **Surface Damage Missing Wall**

Distance (ft): **24.8**
Structural Grade: **5**
O&M Grade: **0**
Clock Start/From: **10**
Clock To: **2**
1st Value:
2nd Value:
Value Percent:
Continuous Index:
Within 8" of Joint: **YES**
Remarks: **THE OUTSIDE OF THE JOINT/ BELL. SOIL VISIBLE.**

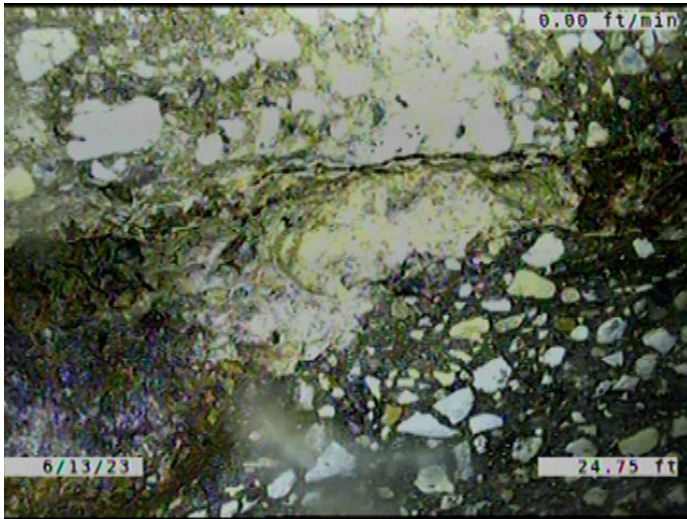
Code: **DAE**
 Description: **Deposits Attached Encrustation**

Distance (ft): **24.8**
 Structural Grade: **0**
 O&M Grade: **2**
 Clock Start/From: **2**
 Clock To: **3**
 1st Value:
 2nd Value:
 Value Percent: **5.000**
 Continuous Index:
 Within 8" of Joint: **YES**
 Remarks:

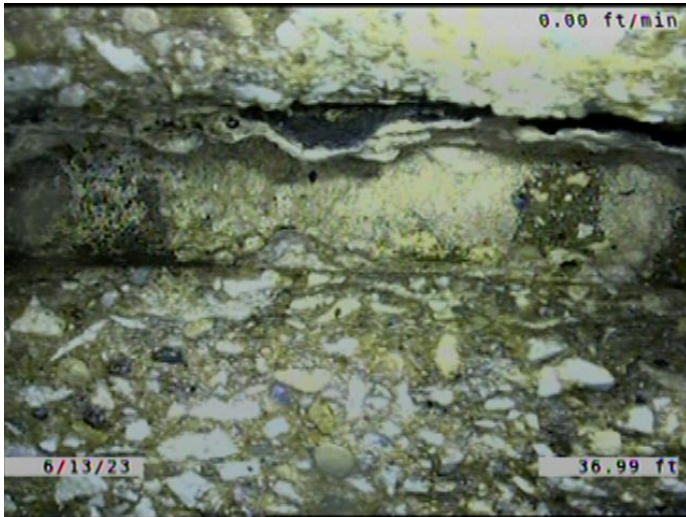
Code: **DAE**
Description: **Deposits Attached Encrustation**

Distance (ft): **37.0**
Structural Grade: **0**
O&M Grade: **2**
Clock Start/From: **9**
Clock To: **3**
1st Value:
2nd Value:
Value Percent: **5.000**
Continuous Index: **S04**
Within 8" of Joint: **YES**
Remarks:

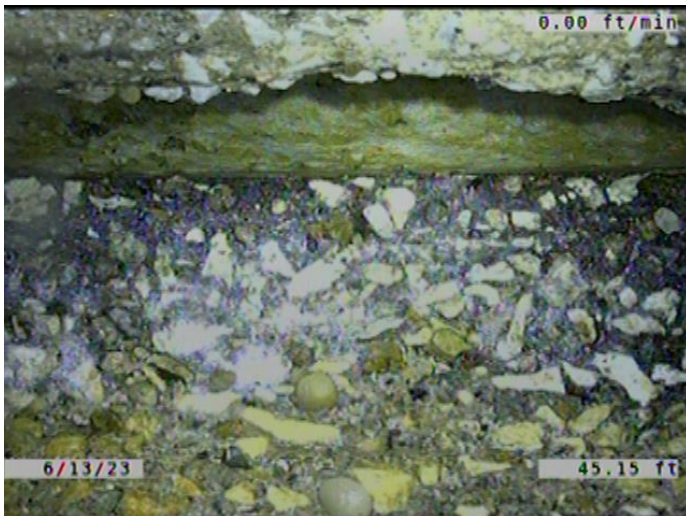
Code: **JSL**
Description: **Joint Separated Large**

Distance (ft): **45.2**
Structural Grade: **4**
O&M Grade: **0**
Clock Start/From:
Clock To:
1st Value:
2nd Value:
Value Percent:
Continuous Index:
Within 8" of Joint: **NO**
Remarks:

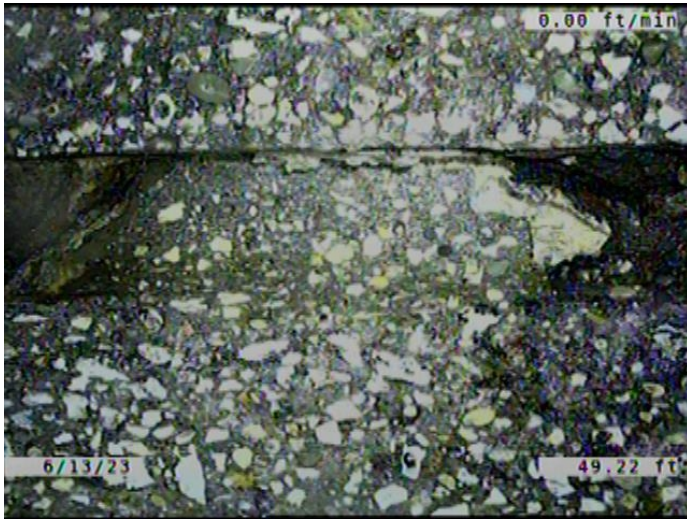
Code: **JSM**
Description: **Joint Separated Medium**

Distance (ft): **49.2**
Structural Grade: **3**
O&M Grade: **0**
Clock Start/From:
Clock To:
1st Value:
2nd Value:
Value Percent:
Continuous Index: **S05**
Within 8" of Joint: **NO**
Remarks:

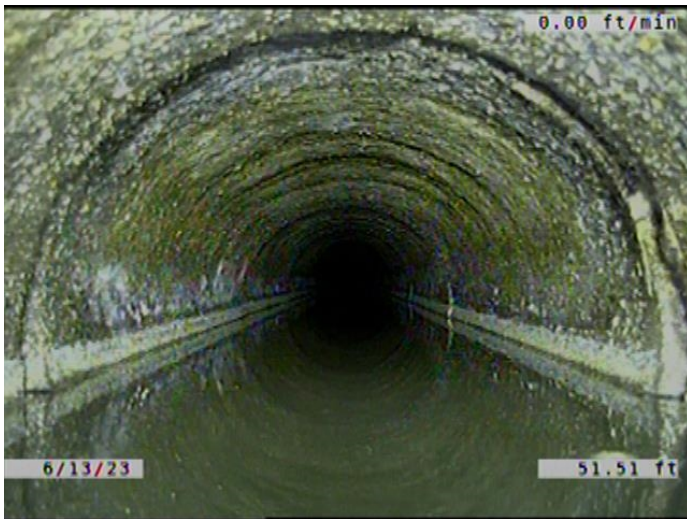
Code: **MWLS**
Description: **Miscellaneous Water Level Sag**

Distance (ft): **51.5**
Structural Grade: **3**
O&M Grade: **0**
Clock Start/From:
Clock To:
1st Value:
2nd Value:
Value Percent: **40.000**
Continuous Index: **S06**
Within 8" of Joint: **NO**
Remarks:

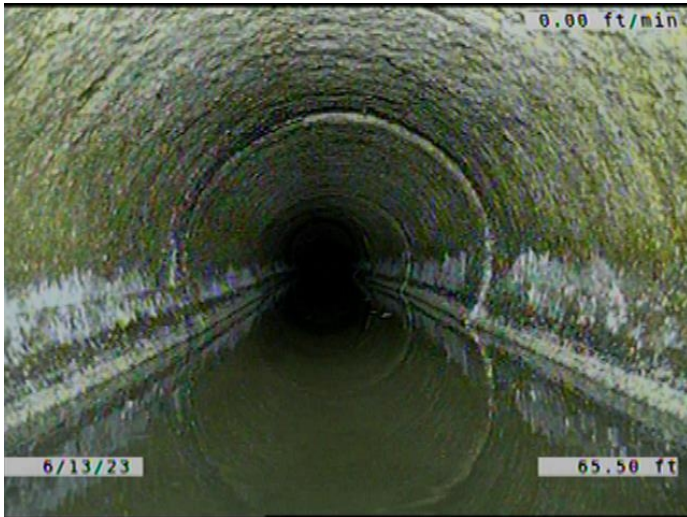
Code: **MWLS**
 Description: **Miscellaneous Water Level Sag**

Distance (ft): **65.5**
 Structural Grade: **3**
 O&M Grade: **0**
 Clock Start/From:
 Clock To:
 1st Value:
 2nd Value:
 Value Percent: **40.000**
 Continuous Index: **F06**
 Within 8" of Joint: **NO**
 Remarks:

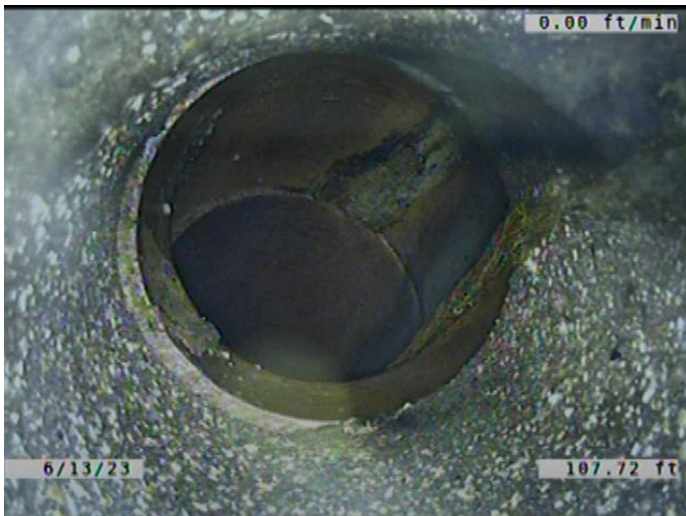
Code: **TF**
Description: **Tap Factory**

Distance (ft): **107.7**
Structural Grade: **0**
O&M Grade: **0**
Clock Start/From: **1**
Clock To:
1st Value: **6.000**
2nd Value:
Value Percent:
Continuous Index:
Within 8" of Joint: **YES**
Remarks: **ROOTS GROWING DOWN THE SERVICE. ENCRUSTATION COMING F**

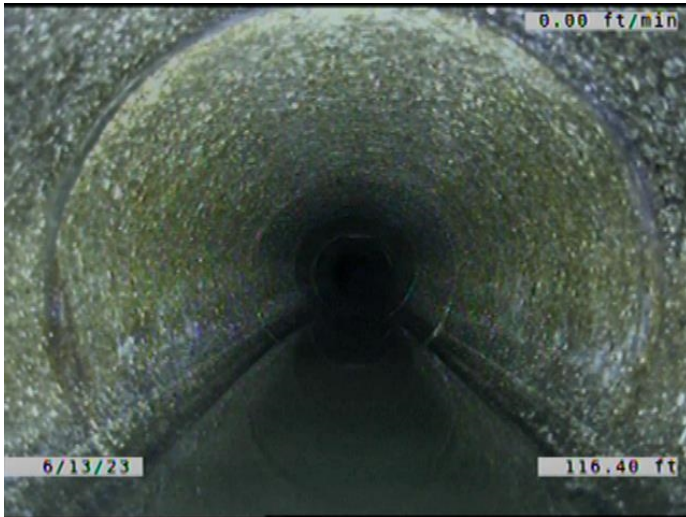
Code: **DAGS**
Description: **Deposits Attached Grease**

Distance (ft): **116.4**
Structural Grade: **0**
O&M Grade: **2**
Clock Start/From: **9**
Clock To: **3**
1st Value:
2nd Value:
Value Percent: **5.000**
Continuous Index: **F01**
Within 8" of Joint: **YES**
Remarks:

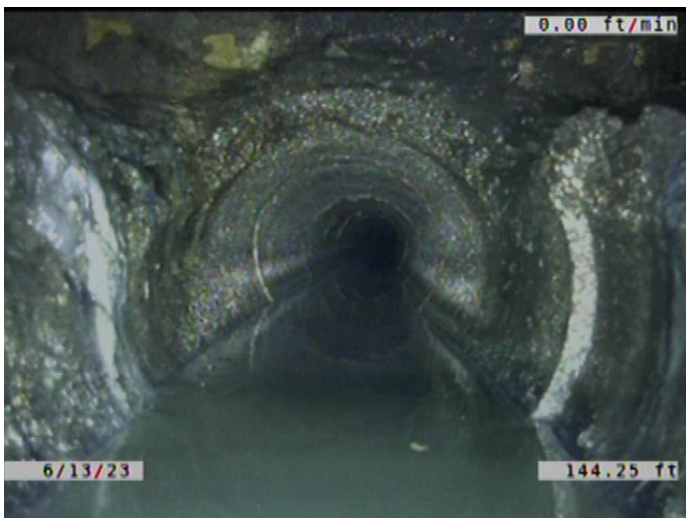
Code: **SAP**
Description: **Surface Damage Aggregate Projecting**

Distance (ft): **144.2**
Structural Grade: **3**
O&M Grade: **0**
Clock Start/From: **10**
Clock To: **2**
1st Value:
2nd Value:
Value Percent:
Continuous Index: **F03**
Within 8" of Joint: **YES**
Remarks:

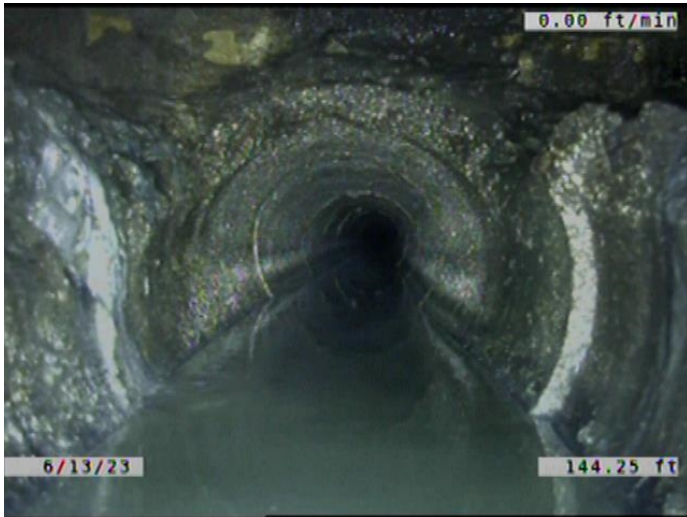
Code: **DAE**
Description: **Deposits Attached Encrustation**

Distance (ft): **144.2**
Structural Grade: **0**
O&M Grade: **2**
Clock Start/From: **9**
Clock To: **3**
1st Value:
2nd Value:
Value Percent: **5.000**
Continuous Index: **F04**
Within 8" of Joint: **YES**
Remarks:

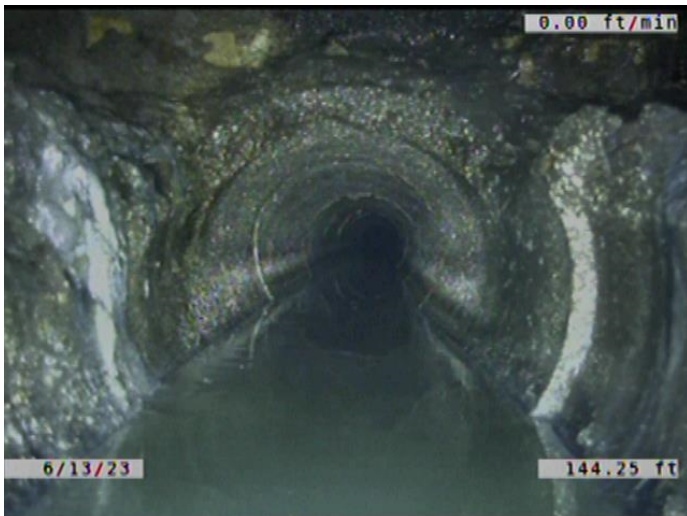
Code: **JSM**
Description: **Joint Separated Medium**

Distance (ft): **144.2**
Structural Grade: **3**
O&M Grade: **0**
Clock Start/From:
Clock To:
1st Value:
2nd Value:
Value Percent:
Continuous Index: **F05**
Within 8" of Joint: **NO**
Remarks:
