Profile/Photo Observation Report

Date:	04/10/2018	Weather:		Coding:	PACP 4.2
Pipe Length (ft):	124.9	Owner:	City of Hobart	Pre Clean:	No Pre-Cleaning
P.O.#:	2004	Surveyor:	SAN	PSR:	P-902-077-076
Customer:	Red Zone	Clean Date:		Shape:	C

Street:	3800 34th Pl	Flow Control:	Not Controlled
City:	Hobart In	Year Renewed:	
Location:	Light Highway	Tape/Media #:	Deliverable 1
Purpose:	Routine Assessment	Dia/Height:	15"
Use:	Sanitary	Material:	PVC
Drain Area:	unknown	Lining:	
Category:	NA		
Comment:	D400-1/ Incomplete due to debris.		
Location Details:	Edge of street	Direction of Survey:	Downstream
US MH:	M-902-077	DS MH:	M-902-076
		Total Length Surveyed (ft):	25.6

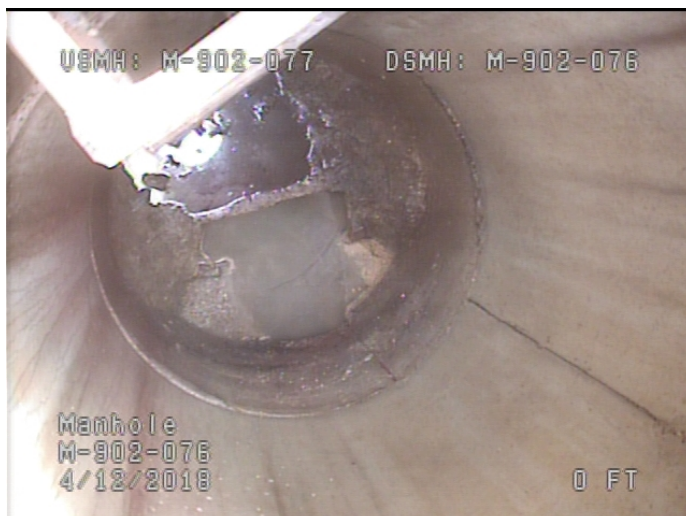
Code: **AMH**
Description: **Manhole**

Distance (ft): **.0**
Structural Grade: **0**
O&M Grade: **0**
Clock Start/From:
Clock To:
1st Value:
2nd Value:
Value Percent:
Continuous Index:
Within 8" of Joint: **NO**
Remarks: **P902-077**

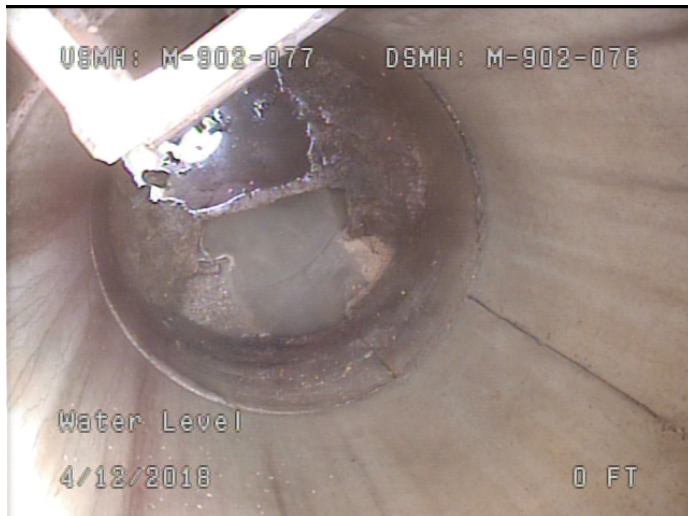
Code: **MWL**
Description: **Water Level**

Distance (ft): **.0**
Structural Grade: **0**
O&M Grade: **0**
Clock Start/From:
Clock To:
1st Value:
2nd Value:
Value Percent: **25.000**
Continuous Index:
Within 8" of Joint: **NO**
Remarks:

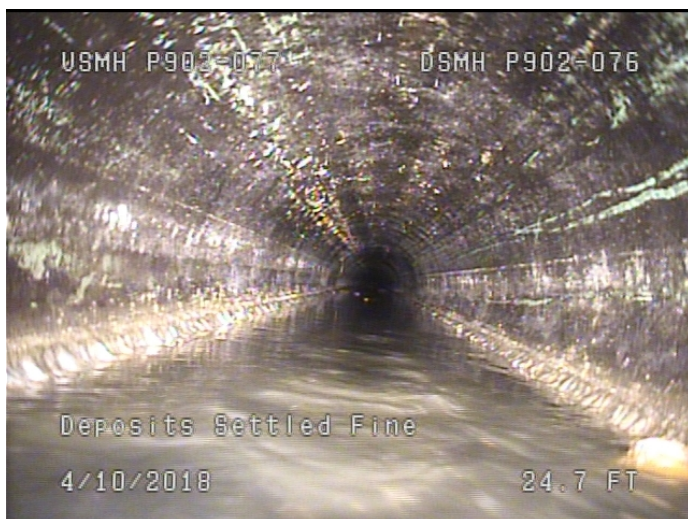
Code: **DSF**
Description: **Deposits Settled Fine**

Distance (ft): **24.7**
Structural Grade: **0**
O&M Grade: **3**
Clock Start/From: **5**
Clock To: **7**
1st Value:
2nd Value:
Value Percent: **15.000**
Continuous Index:
Within 8" of Joint: **NO**
Remarks:
