## Profile/Photo Observation Report

Date:	<b>04/12/2018</b>	Weather:		Coding:	<b>PACP 4.2</b>
Pipe Length (ft):	<b>124.9</b>	Owner:	<b>City of Hobart</b>	Pre Clean:	<b>No Pre-Cleaning</b>
P.O.#:	<b>2004</b>	Surveyor:	<b>SAN</b>	PSR:	<b>P-902-077-076</b>
Customer:	<b>Red Zone</b>	Clean Date:		Shape:	<b>C</b>

Street:	<b>3800 34th Pl</b>	Flow Control:	<b>Not Controlled</b>
City:	<b>Hobart In</b>	Year Renewed:	
Location:	<b>Light Highway</b>	Tape/Media #:	<b>Deliverable 1</b>
Purpose:	<b>Routine Assessment</b>	Dia/Height:	<b>15"</b>
Use:	<b>Sanitary</b>	Material:	<b>PVC</b>
Drain Area:	<b>Northeast</b>	Lining:	
Category:	<b>NA</b>		
Comment:	<b>405-1/Reverse setup due to debris/Incomplete line needs cleaning.</b>		
Location Details:	<b>Edge of street</b>	Direction of Survey:	<b>Upstream</b>
US MH:	<b>M-902-077</b>	DS MH:	<b>M-902-076</b>
		Total Length Surveyed (ft):	<b>12.4</b>

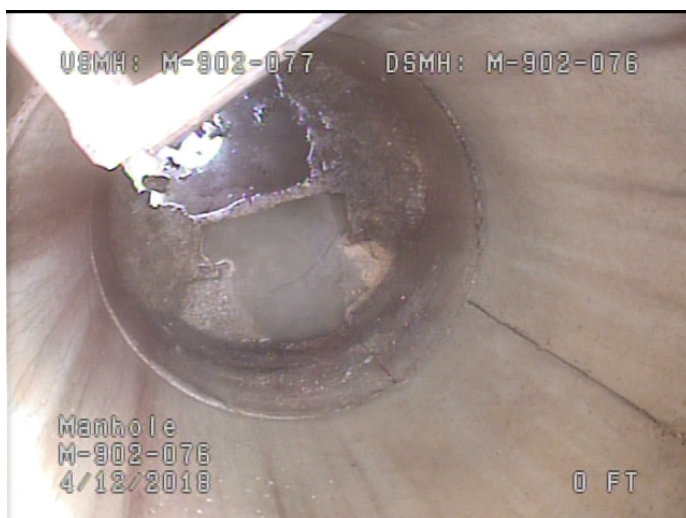
Code: **AMH**  
 Description: **Manhole**

Distance (ft): **.0**  
 Structural Grade: **0**  
 O&M Grade: **0**  
 Clock Start/From:  
 Clock To:  
 1st Value:  
 2nd Value:  
 Value Percent:  
 Continuous Index:  
 Within 8" of Joint: **NO**  
 Remarks: **M-902-076**

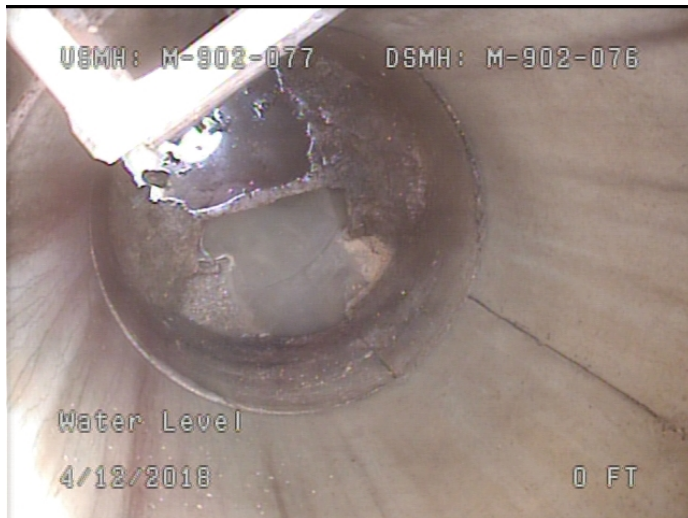
Code: **MWL**  
Description: **Water Level**

Distance (ft): **.0**  
Structural Grade: **0**  
O&M Grade: **0**  
Clock Start/From:  
Clock To:  
1st Value:  
2nd Value:  
Value Percent: **35.000**  
Continuous Index:  
Within 8" of Joint: **NO**  
Remarks:

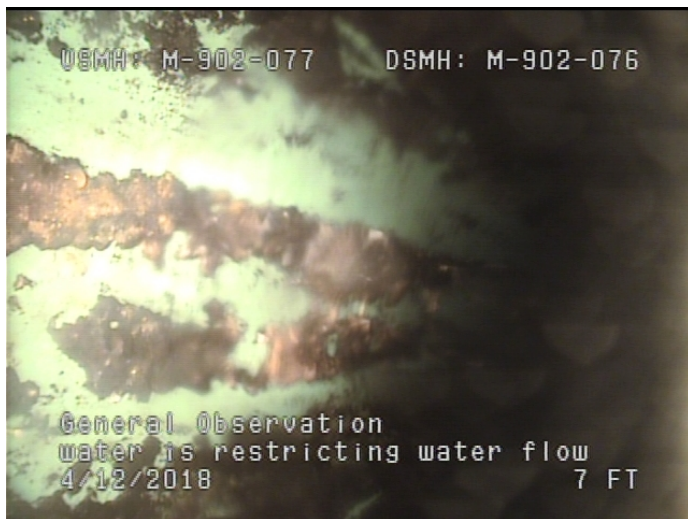
Code: **MGO**  
Description: **General Observation**

Distance (ft): **7.0**  
Structural Grade: **0**  
O&M Grade: **0**  
Clock Start/From:  
Clock To:  
1st Value:  
2nd Value:  
Value Percent:  
Continuous Index:  
Within 8" of Joint: **NO**  
Remarks: **water is restricting water flow**

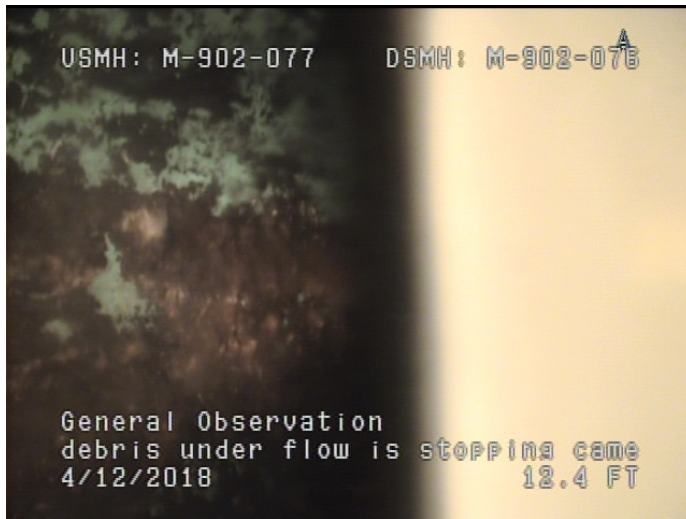
Code:	<b>MGO</b>
Description:	<b>General Observation</b>
Distance (ft):	<b>12.4</b>
Structural Grade:	<b>0</b>
O&M Grade:	<b>0</b>
Clock Start/From:	
Clock To:	
1st Value:	
2nd Value:	
Value Percent:	
Continuous Index:	
Within 8" of Joint:	<b>NO</b>
Remarks:	<b>debris under flow is stopping camera</b>

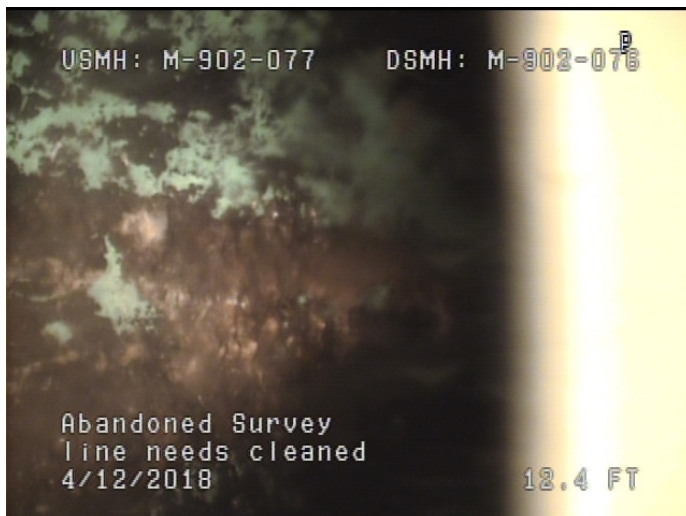
Code:	<b>MSA</b>
Description:	<b>Abandoned Survey</b>
Distance (ft):	<b>12.4</b>
Structural Grade:	<b>0</b>
O&M Grade:	<b>0</b>
Clock Start/From:	
Clock To:	
1st Value:	
2nd Value:	
Value Percent:	
Continuous Index:	
Within 8" of Joint:	<b>NO</b>
Remarks:	<b>line needs cleaned</b>
