Profile/Photo Observation Report

| Street: | N Hobart Rd | Flow Control: | Not Controlled |
| City: | Hobart, IN | Year Renewed: | |

| US MH: | M-902-078 | DS MH: | M-902-046 |

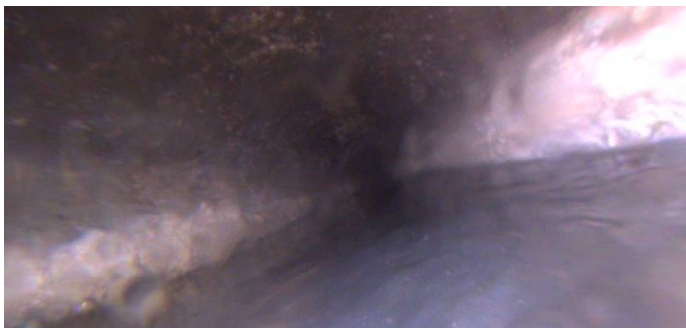
Code: **AMH**
Description: **Manhole**

Distance (ft): **.0**
Structural Grade: **0**
O&M Grade: **0**
Clock Start/From:
Clock To:
1st Value:
2nd Value:
Value Percent:
Continuous Index:
Within 8" of Joint: **NO**
Remarks: **M-902-046**

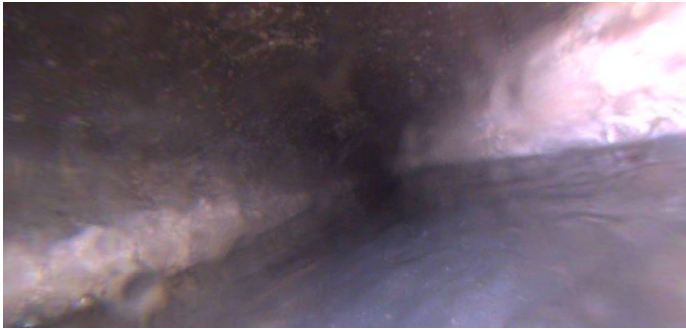
| Code: | MWL |
| Description: | Water Level |

| Value Percent: | 40.000 |

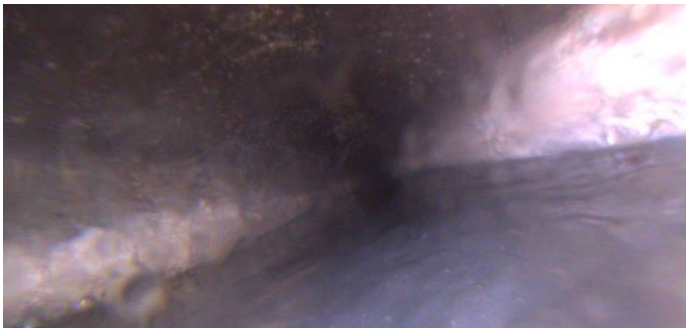
| Code: | DAGS |
| Description: | Deposits Attached Grease |

| O&M Grade: | 2 |
| Value Percent: | 10.000 |

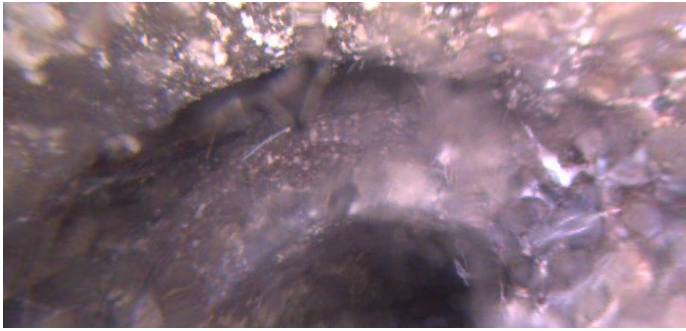
Code: **JOL**
Description: **Joint Offset Large**

Distance (ft): **4.1**
Structural Grade: **2**
O&M Grade: **0**
Clock Start/From:
Clock To:
1st Value:
2nd Value:
Value Percent:
Continuous Index:
Within 8" of Joint: **NO**
Remarks:

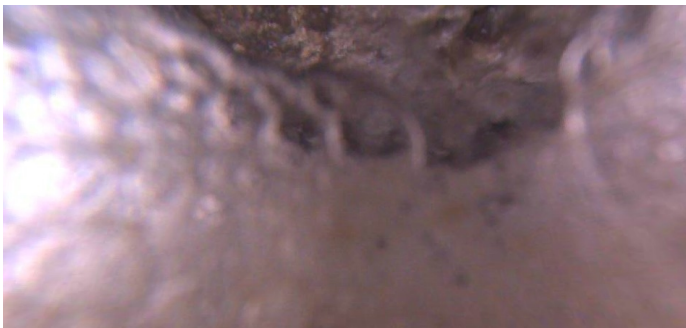
Code: **DAGS**
Description: **Deposits Attached Grease**

Distance (ft): **9.8**
Structural Grade: **0**
O&M Grade: **2**
Clock Start/From: **3**
Clock To: **9**
1st Value:
2nd Value:
Value Percent: **10.000**
Continuous Index: **F01**
Within 8" of Joint: **NO**
Remarks: **Clock positions vary**

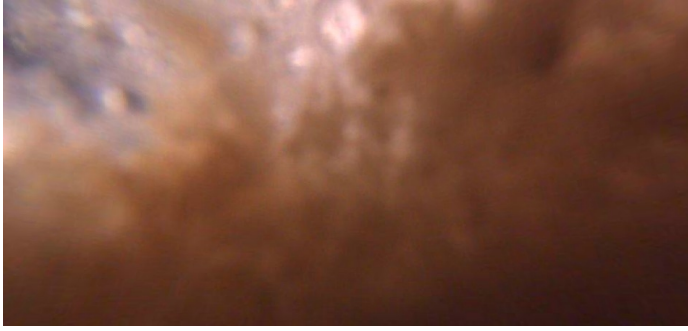
| Code: | MSA |
| Description: | Abandoned Survey |
| Distance (ft): | 11.5 |
| Remarks: | mcu |
