## Profile/Photo Observation Report

Street:	<b>SAINT JOSEPH PL</b>	Flow Control:	<b>Not Controlled</b>
City:	<b>Hobart, IN</b>	Year Renewed:	
Location:	<b>Other</b>	Tape/Media #:	
Purpose:	<b>Not Known</b>	Dia/Height:	<b>10"</b>
Use:	<b>Sanitary</b>	Material:	<b>PVC</b>
Drain Area:	<b>NA</b>	Lining:	
Category:	<b>NA</b>		
Comment:

Location Details:		Direction of Survey:	<b>Downstream</b>
US MH:	<b>M-902-078</b>	DS MH:	<b>M-902-046</b>
		Total Length Surveyed (ft):	<b>87.1</b>

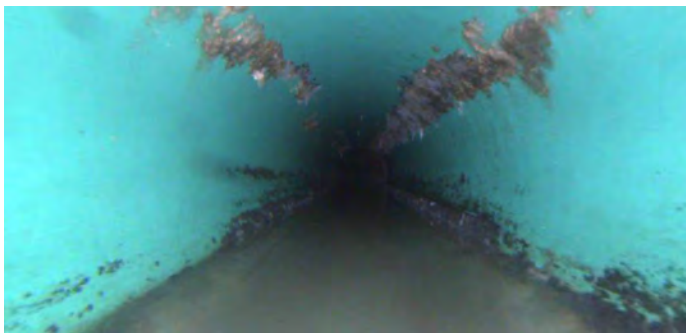
Code: **DAGS**  
Description: **Deposits Attached Grease**

Distance (ft): **.0**  
Structural Grade: **0**  
O&M Grade: **2**  
Clock Start/From: **8**  
Clock To: **4**  
1st Value:  
2nd Value:  
Value Percent: **5.000**  
Continuous Index: **S02**  
Within 8" of Joint: **NO**  
Remarks:

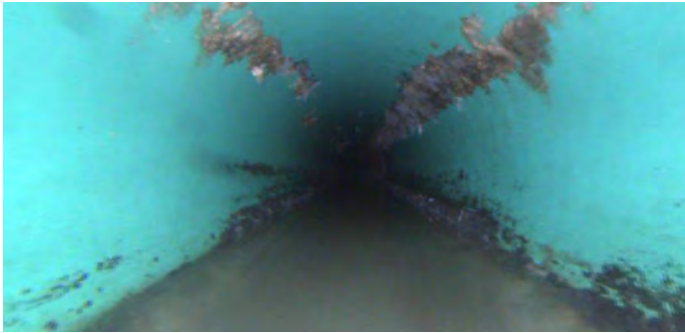
Code:	<b>AMH</b>
Description:	<b>Manhole</b>

Distance (ft):	<b>.0</b>
Structural Grade:	<b>0</b>
O&M Grade:	<b>0</b>
Clock Start/From:	
Clock To:	
1st Value:	
2nd Value:	
Value Percent:	
Continuous Index:	
Within 8" of Joint:	<b>NO</b>
Remarks:	<b>M-902-078</b>

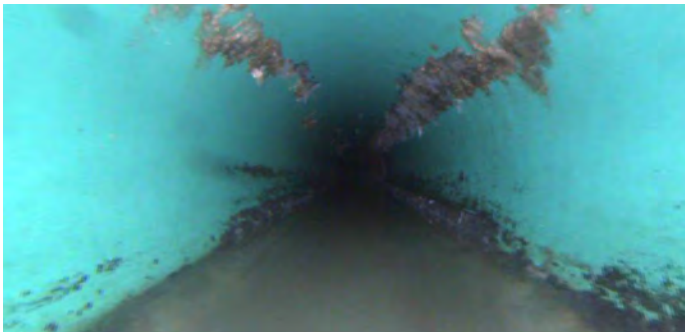
Code:	<b>MWL</b>
Description:	<b>Water Level</b>

Distance (ft):	<b>.0</b>
Structural Grade:	<b>0</b>
O&M Grade:	<b>0</b>
Clock Start/From:	
Clock To:	
1st Value:	
2nd Value:	
Value Percent:	<b>10.000</b>
Continuous Index:	
Within 8" of Joint:	<b>NO</b>
Remarks:

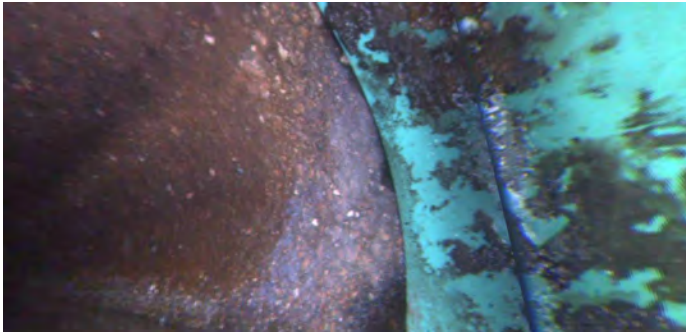
Code: **MMC**  
Description: **Material Change**

Distance (ft): **5.8**  
Structural Grade: **0**  
O&M Grade: **0**  
Clock Start/From:  
Clock To:  
1st Value:  
2nd Value:  
Value Percent:  
Continuous Index:  
Within 8" of Joint: **NO**  
Remarks: **concrete?**

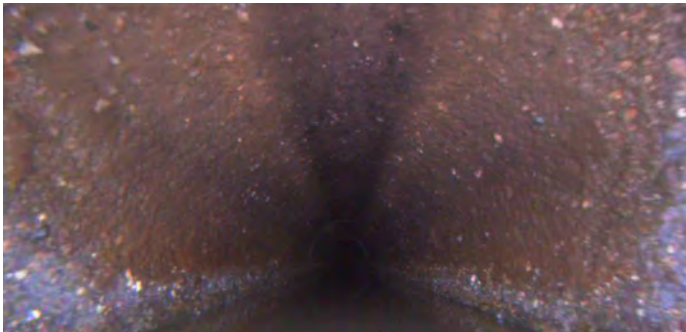
Code: **DAGS**  
Description: **Deposits Attached Grease**

Distance (ft): **6.0**  
Structural Grade: **0**  
O&M Grade: **2**  
Clock Start/From: **8**  
Clock To: **4**  
1st Value:  
2nd Value:  
Value Percent: **5.000**  
Continuous Index: **F02**  
Within 8" of Joint: **NO**  
Remarks:

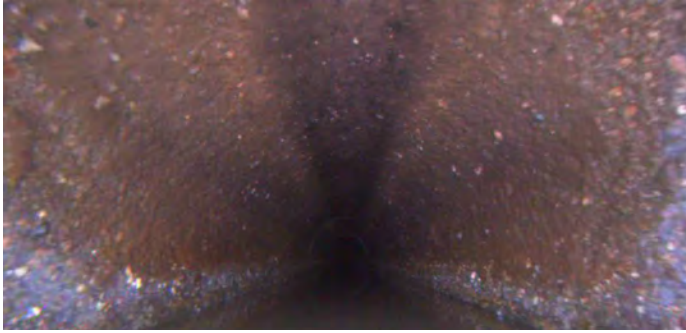
Code: **SAV**  
Description: **Surface Aggregate Visible**

Distance (ft): **6.0**  
Structural Grade: **3**  
O&M Grade: **0**  
Clock Start/From: **8**  
Clock To: **4**  
1st Value:  
2nd Value:  
Value Percent:  
Continuous Index: **S03**  
Within 8" of Joint:  
Remarks:

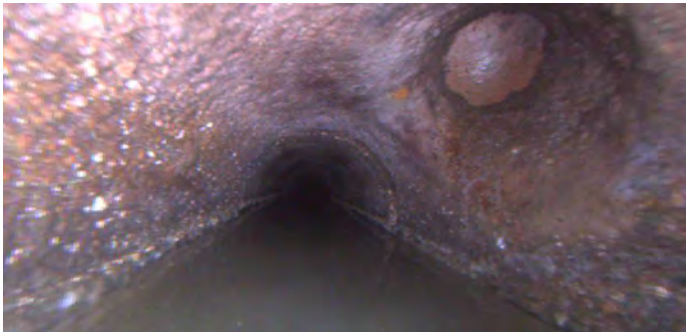
Code: **TFC**  
Description: **Tap Factory Capped**

Distance (ft): **36.3**  
Structural Grade: **0**  
O&M Grade: **0**  
Clock Start/From: **2**  
Clock To:  
1st Value: **4.000**  
2nd Value:  
Value Percent:  
Continuous Index:  
Within 8" of Joint:  
Remarks:

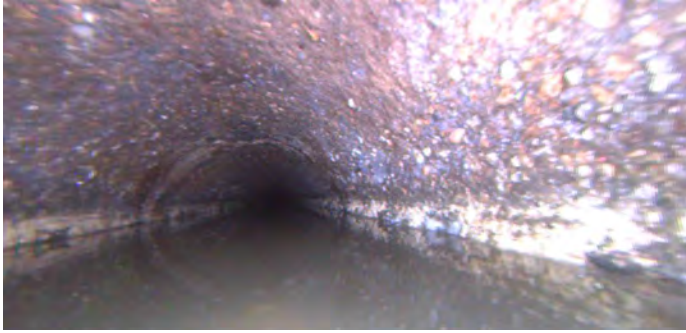
Code: **MWL**  
Description: **Water Level**

Distance (ft): **60.7**  
Structural Grade: **0**  
O&M Grade: **0**  
Clock Start/From:  
Clock To:  
1st Value:  
2nd Value:  
Value Percent: **30.000**  
Continuous Index:  
Within 8" of Joint: **NO**  
Remarks:
